VOLVO CAR
SERVICE AND PARTS BUSINESS

Technical Journal

Steering wheel off center

REF NO:	ISSUING DEPARTMENT:	CAR MARKET:	
TJ 33715.3.0	Technical Service	United States and Canada	
PARTNER: 3 US 7510 Volvo Car USA		ISSUE DATE: 2018-09-04	STATUS DATE: 2018-09-11
FUNC GROUP: 6410	FUNC DESC: Steering wheel, column lock, steering co	Page 1 of 3

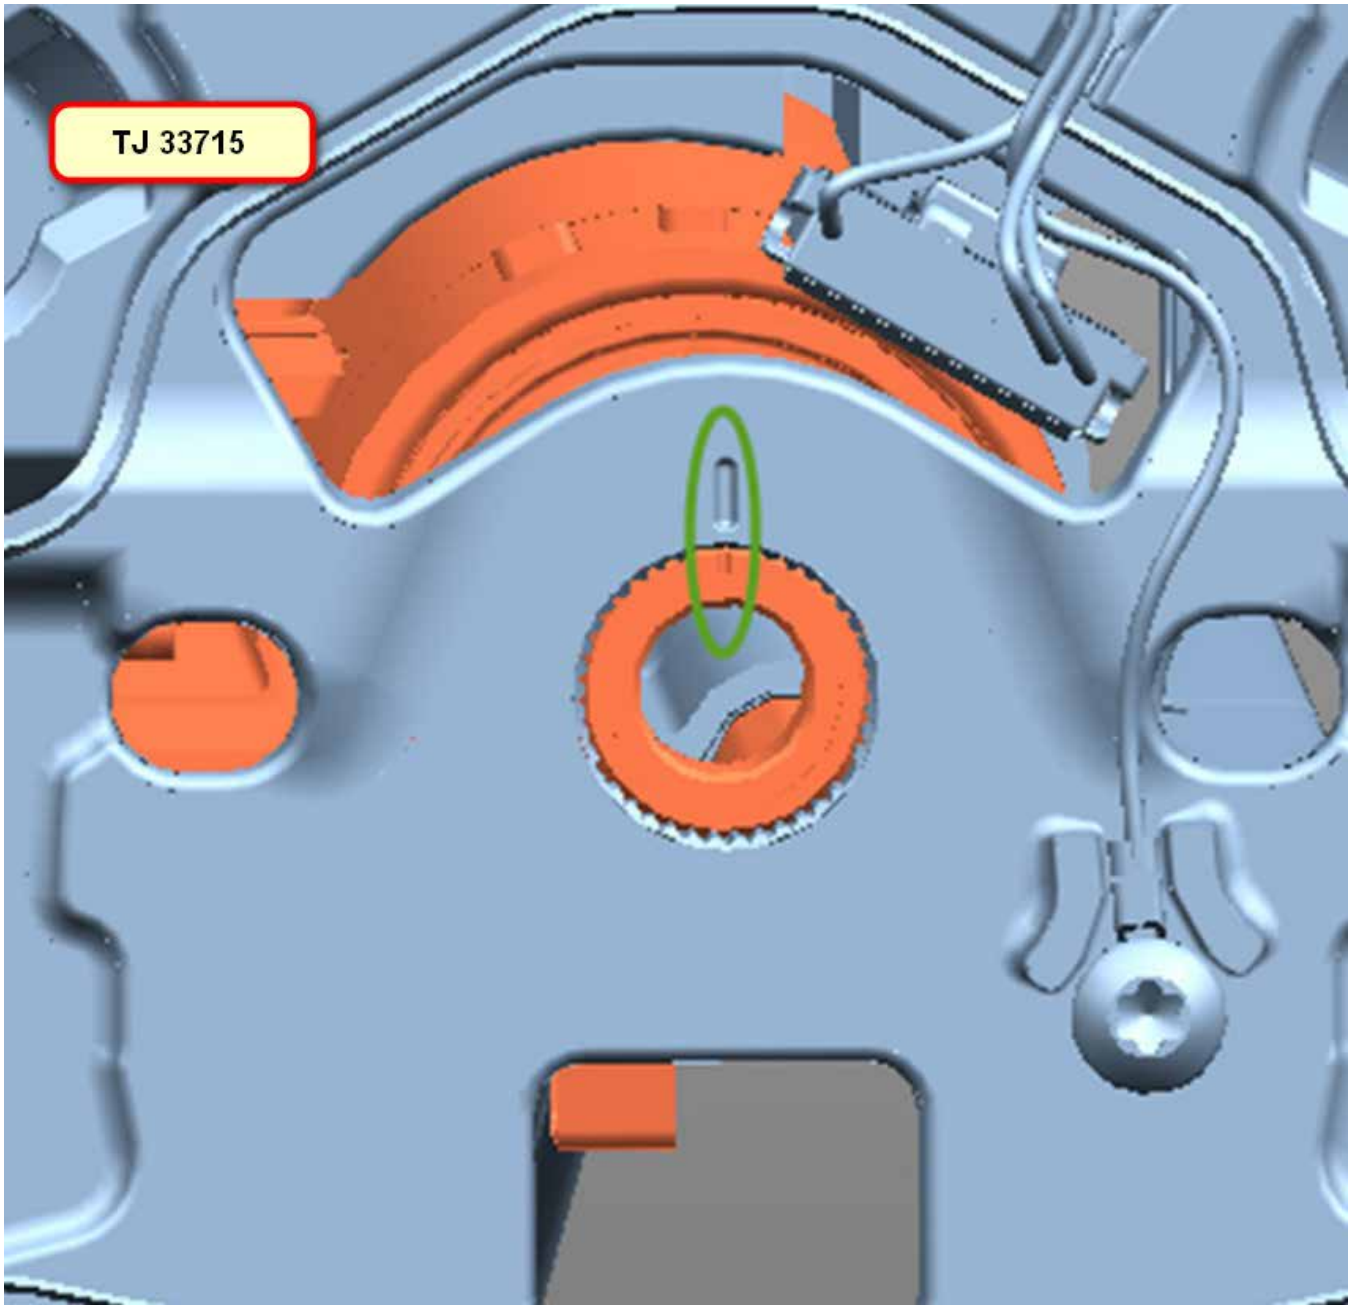
TJ 33715

DESCRIPTION:
If steering wheel is off center while driving straight forward, then follow Service below.

The steering wheel is always correct positioned at the assembly line, but if later removing the steering wheel for various adjustments it might happen that the steering wheel is reinstalled incorrectly on the steering column.

SERVICE:
1. Remove driver's airbag according to VIDA (VCC-ID: VCC-502656-1)
2. Remove the screw for steering wheel according to VIDA (VCC-ID: VCC-502279-1)
3. Align the steering wheel to the steering column, follow the markings according to picture TJ 33715.jpg
4. Reinstall all parts according to VIDA (torque screw 60 N)
5. Perform a wheel alignment on front wheels according to VIDA (VCC-ID: VCC-502859-1)
5. Verify repair
