REFERENCE:	Nova Bus Manuals
SECTION:	11: Fuel Tank & Accessories
RS Nº:	MQR 7621-1850
EFFECTIVE IN PROD.:	LC32-052

SUBJECT:	Fuel tank
JUSTIFICATION:	Possibility of fuel leakage

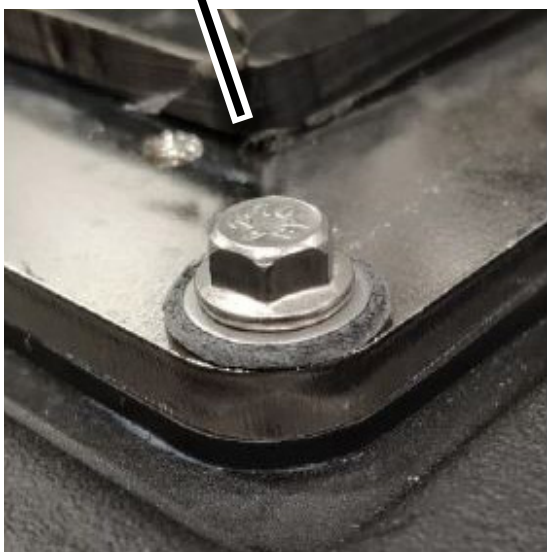
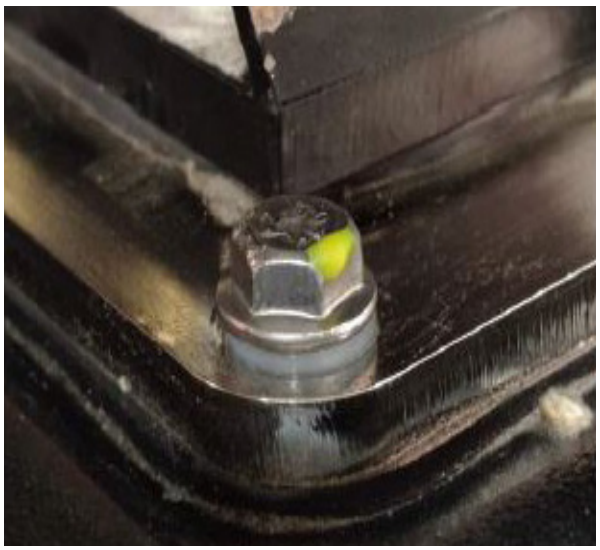
Figure 1 - Replace One Washer at a Time

This type of washer needs to be replaced at the fourteen places.

If this type of washer is present, there is no action to take.

1.2. To replace the washers: remove one bolt at a time, replace the washer by a 10568958, apply a thread adhesive such as Loctite 242 or equivalent (# 9985283) before tightening to 5.1 lb-ft (7 N•m) and apply a torque marker.
