Campaign code:
L636-A.11.19.

Campaign Name:
Safety belt buckle replacement.

Model:
Urus.

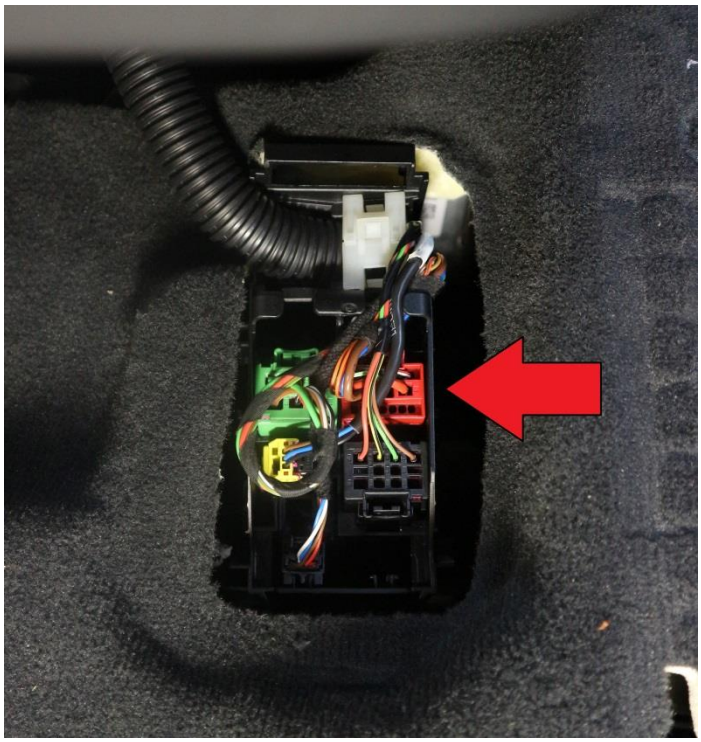
2. Disconnect the seat connectors.

1. Release and remove the seat connections cover.

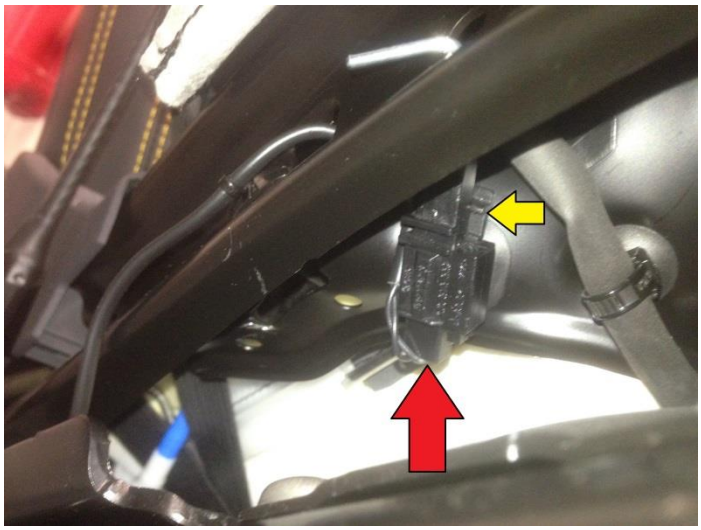
6. Release from the fastening and disconnect the connector of the safety belt buckle.

10. Fit the new seat belt buckle (4K8857755JMNB).

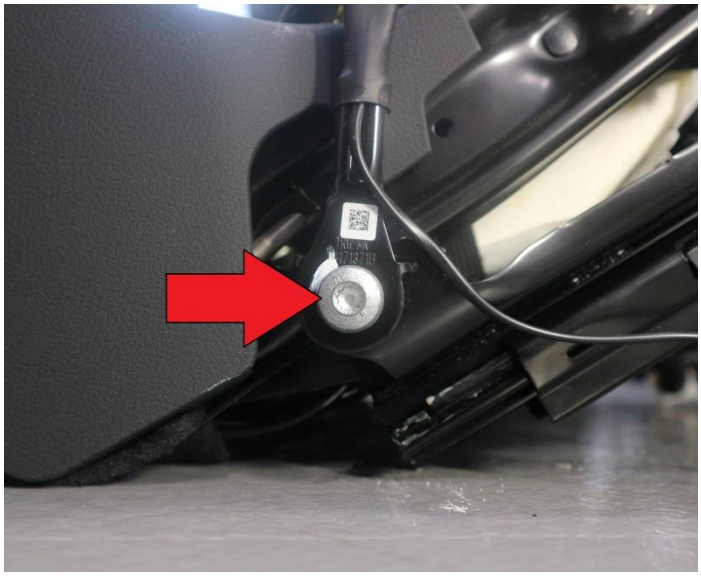
8. Remove the screw.

9. Remove the safety belt buckle.

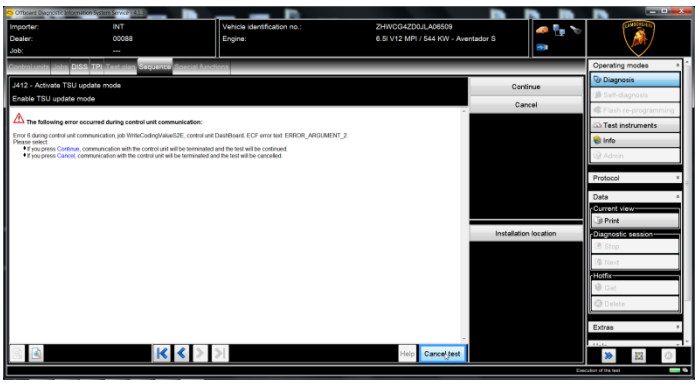
i. If the following error screen is displayed, abort the guided function by clicking on "Cancel Test" and contact Technical Support.

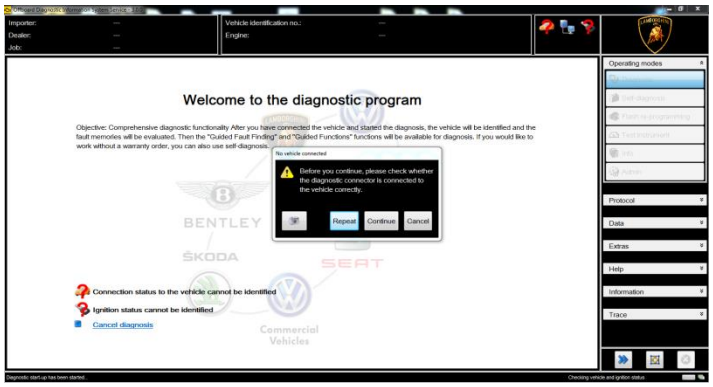
ii. If an error is displayed that regards the hardware interface, and the "connection to vehicle" and "key state" icons appear as shown in the figure below:

- Click "Cancel"
- Repeat installation of the interface VAS5054/6154/6154A per the instruc-

tions in procedure (*) “VCI Manager v2.0”, selecting the right-hand “Extras” menu in ODIS and clicking on the “Diagnostic interface” button.

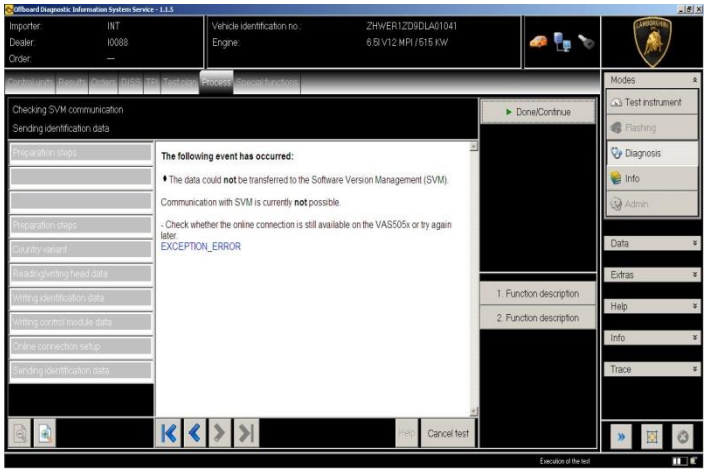
iii. If one of the following connection errors is displayed like in the following example screenshots:

- It is not possible to connect to the central server; check that your laptop is correctly connected to the Internet and retry by clicking on “Yes” or “Done/Continue”, as appropriate.

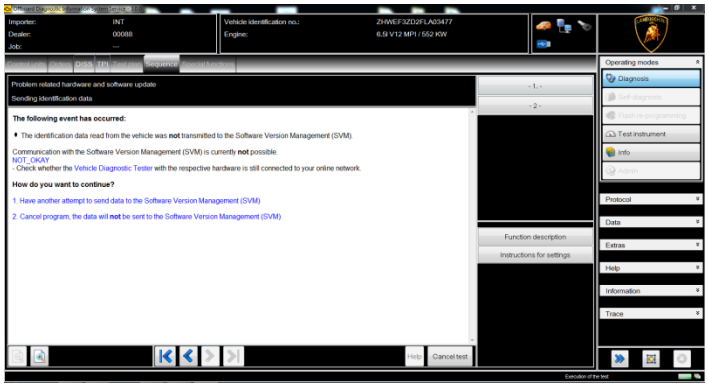
iv. If the connection is dropped during the course of the target/actual comparison during the SVM procedure:

- It is not possible to connect to the central server; check that your laptop is correctly connected to the Internet and retry by clicking on “1”.

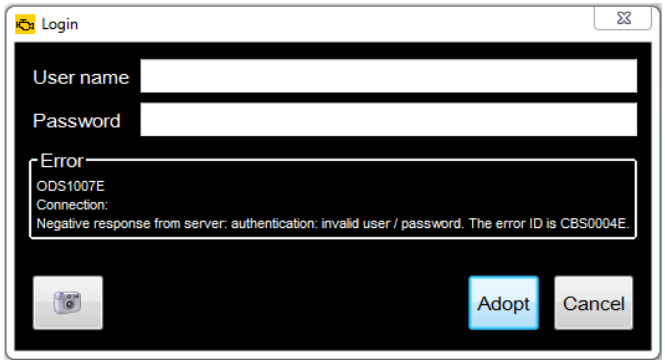
v. If the authentication error as shown in the following screenshot is displayed (error code: ODS1007E):

- Ensure you have a valid GeKO user account
- Ensure that the “GeKo” label is printed on the token you are using
- Ensure you have entered the correct password

- Click on "Cancel" and run the application test (see document "ODIS_ControlloConnessione_Server_SVM_2.0" (*)).

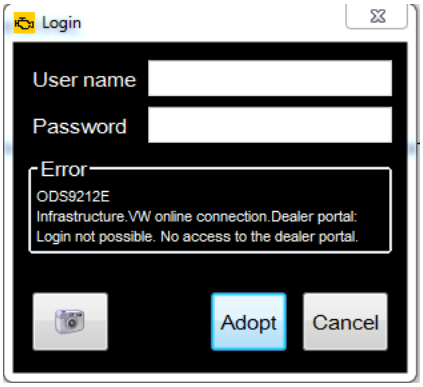
vi. If the infrastructure error as shown in the following screenshot is displayed (error code: ODS9212E):

- Ensure you have a valid GeKO user account
- Ensure that the "GeKo" label is printed on the token you are using
- Check that the Internet is set in ODIS settings and not CPN (see document "Setup_Iniziale_ODIS_2.0" (*))
- Click on "Cancel" and run the application test (see document "ODIS_ControlloConnessione_Server_SVM_2.0" (*)).
