Technical Service Bulletin

27 No start due to low voltage; GFF battery test OK

27 19 33 2045081/5 October 22, 2019. Supersedes Technical Service Bulletin Group 27 number 18-32 dated October 3, 2018 for reasons listed below.

Model(s)	Year	VIN Range	Vehicle-Specific Equipment
Q3	2015 - 2018	All	Not Applicable

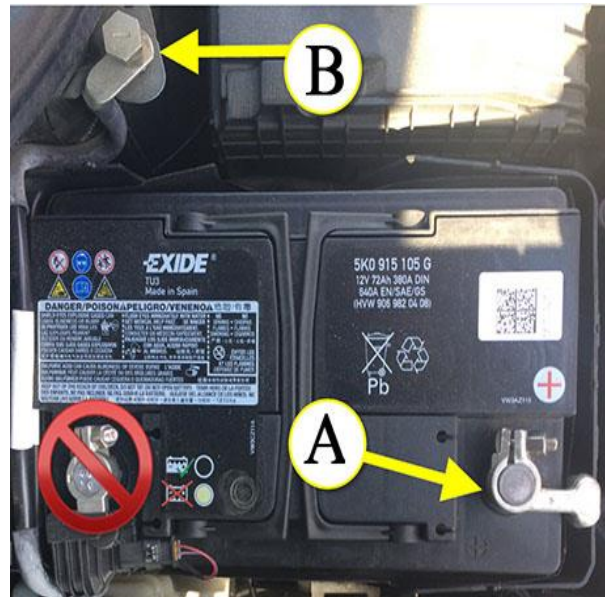
Figure 1. Install an approved battery maintainer/charger. Hook up the positive clamp to battery positive terminal (A), and hook the negative clamp up to battery negative terminal (B). Do not hook the maintainer/charger negative clamp directly to the battery.

1. Install an approved battery maintainer/charger on the jump posts (Figure 1):

- Positive (+) Clamp of maintainer/charger to the positive (+) post of the 12V battery.

- Negative (-) claim of the maintainer/charger to the ground post in the engine bay.

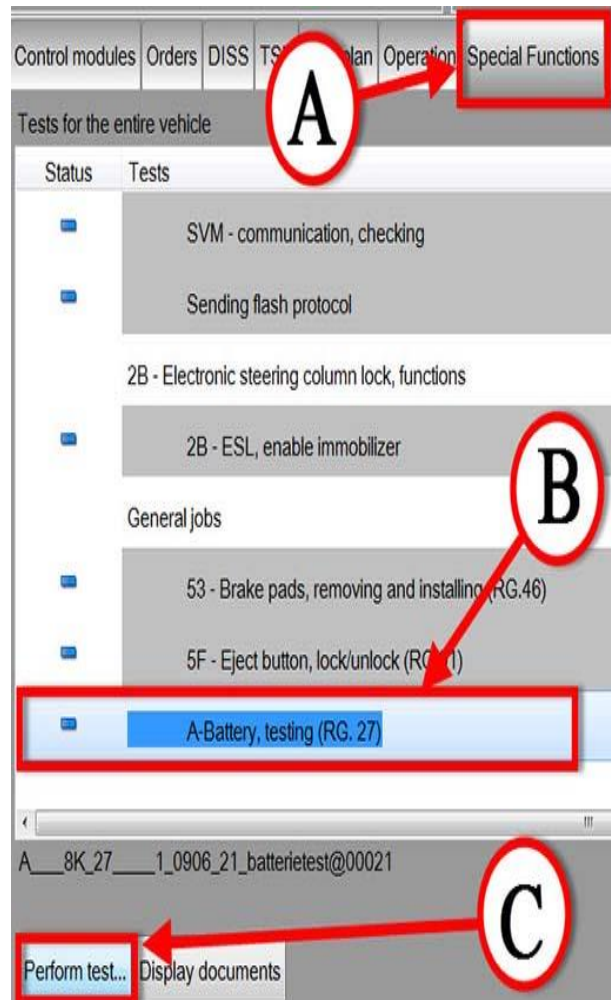
Figure 2. *(A): Select "Special Functions" tab. (B): Select A-Battery, testing (RG.27). (C): Click "Perform test…"*

4. Perform GFF battery test (Figure 2):

- Click on the "Special Functions" tab.

- Under the General jobs section, select "A-Battery, testing (RG.27)".

- Click "Perform test…"

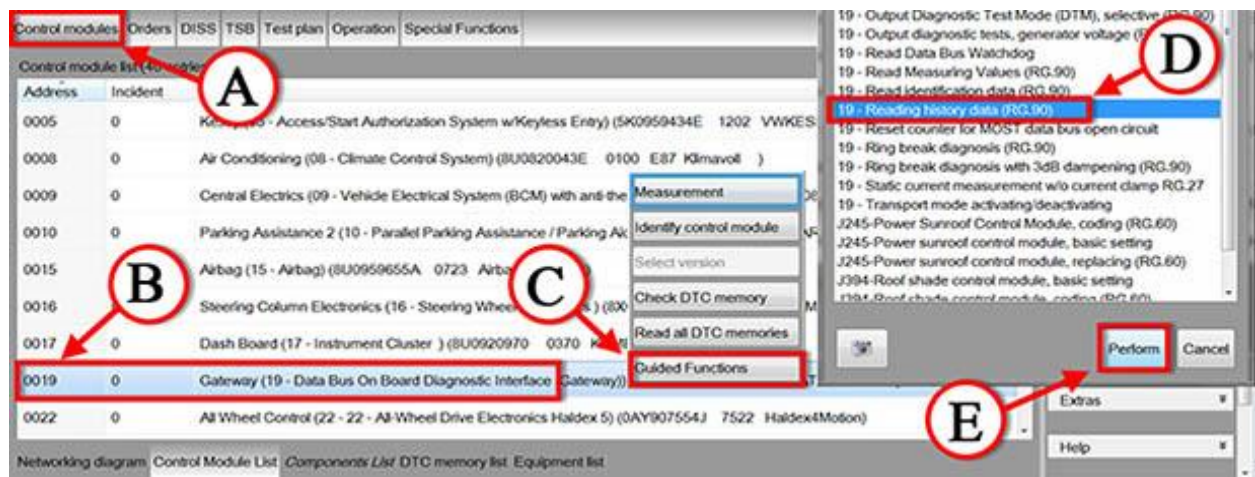
Figure 3. (A): Select "Control modules" tab. (B): Right-click the Gateway control module, J533 (address 0019). (C): Click "Guided Functions" from the pop-up window. (D): Select "Reading history data (RG.90) from the popup selection box. (E): Then click "Perform".

7. In GFF (Figure 3):

- Return to the "Control modules" tab.

- Right click on the gateway control module, J533 (address 0019).

- Select "Guided Functions".

- Select "19 – Reading history data (RG.90).

- Click "Perform".
