Technical Service Bulletin

20 Fuel cannot be added to vehicle or fueling the vehicle is difficult

20 19 22 2044039/7 November 12, 2019. Supersedes Technical Service Bulletin Group 20 number 19-17 dated June 5, 2019 for reasons listed below.

Model(s)	Year	VIN Range	Vehicle-Specific Equipment
Q7	2017 - 2018	All	Not Applicable

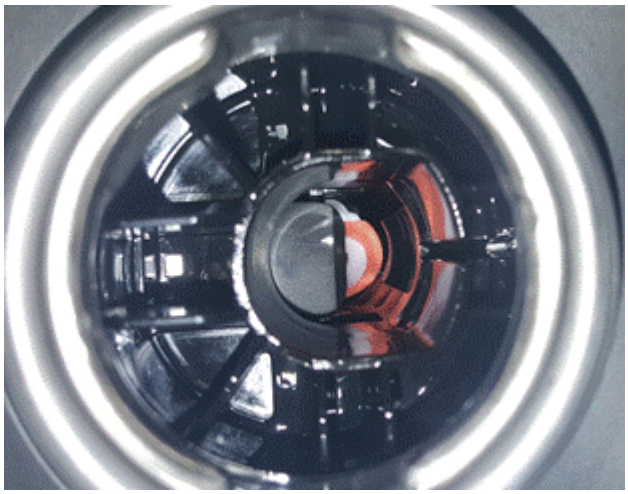
- The vehicle does not accept fuel, is slow to refuel, or it is difficult to insert the fuel pump nozzle.

There is a broken flap inside of the filler neck (Figure 1).

Figure 1. *The broken flap inside of filler neck.*

Improved flap design of the filler neck.

Replace complete fuel tank according to the instructions in Elsa at Repair Manual, *Power Unit >> Fuel Supply >> Fuel tank >> Removing and installing fuel tank.*
