SS 1034607 WST 4700 In Cab Floor Raceway Cover Corrosion

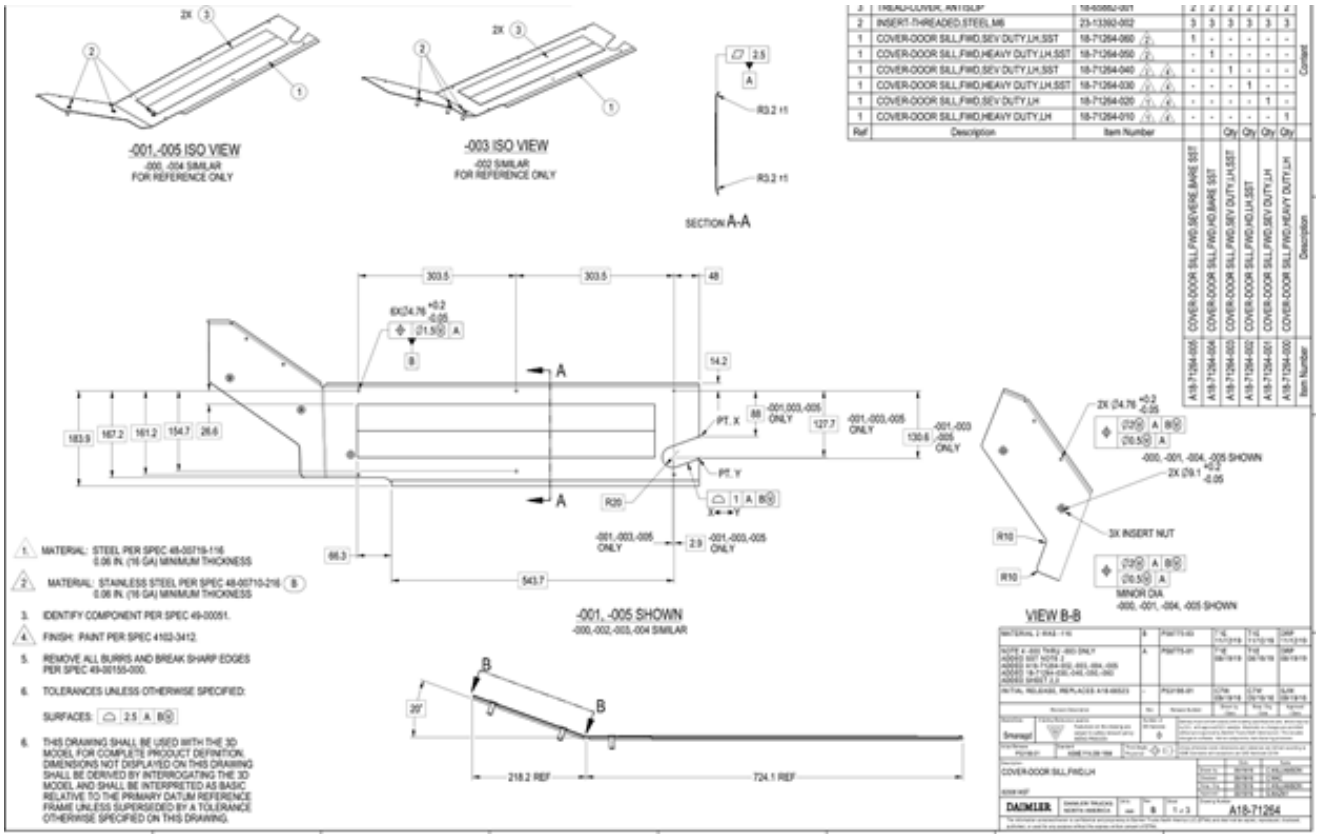
Some Western Star 4700 trucks experience rust through of the steel raceway covers located on the cab floor. This is typically seen in applications where the truck is run in environments where harsh chemicals are used such as salt in snowplow applications.

Replace raceway with new stainless steel option.

Part numbers: A18-71264-004/-005
