SERVICE BULLETIN

M1525 **2021-05-03**

M1525: 2021 PAN AMERICA - FAIRING LOWER RUNNING CHANGE

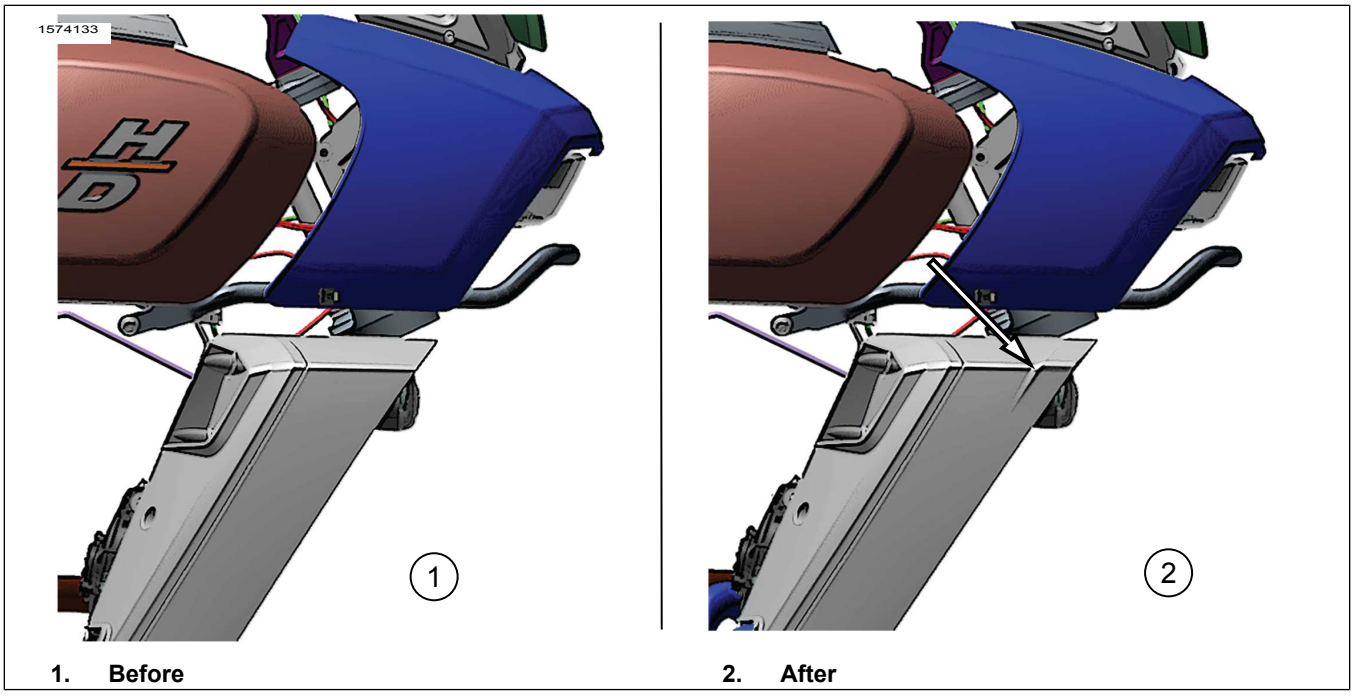
Is to inform dealers that there has been a running change to the 2021 Pan America fairing lowers. The only service replacements offered are the revised version of the fairing lowers. If a cosmetic issue is discovered during Predelivery Inspection (PDI), order and replace both left and right fairing lower components. The replacement of both components only applies to vehicles built before the running change.

1. Before
2. After

Figure 1. Pan America Running Change (Right Shown, Left Similar)

If a cosmetic issue is discovered to the lower fairings at PDI, or a warrantable issue is seen during the warranty period, then replace both left and right side components. File the appropriate warranty claim. If one of the lower fairings is replaced as a non-warrantable concern, replacement of the opposite side would be non-warrantable as well.
