Case Number: S2123000001

Symptom/Vehicle Issue: Rear Wheel Spat Has A Gap Or Appears Loose

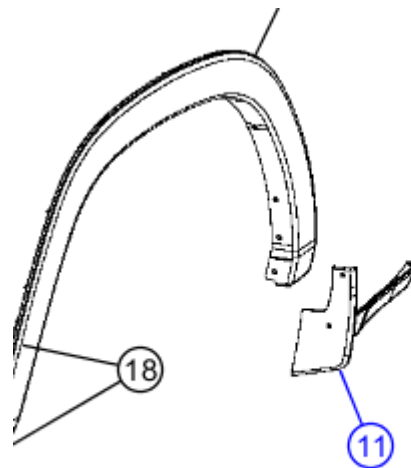
Discussion: Review Fig 1 for the condition. If the rear wheel opening spat has a gap or appears loose follow the below instruction.

Fig 1 Wheel spat location. Item 11
