Case Number: S2123000054

Release Date: July 2021

Symptom/Vehicle Issue: Hood Bezel Nameplate 6.2L Supercharged Is Missing, Coming Off, Loose Or Crooked

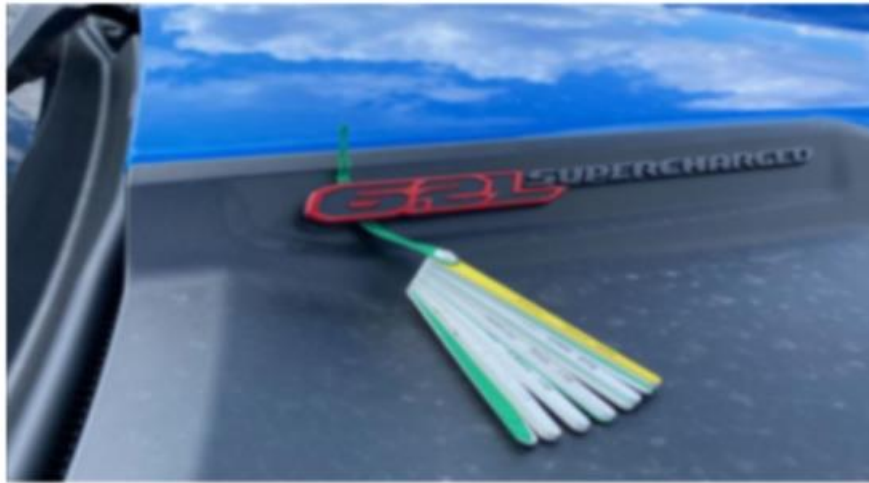
DT TRX Hood Bezel Nameplate "6.2L Supercharged" – P/N 68444262AB

Discussion: If the 6.2L hood bezel nameplate has the above conditions it is not necessary to replace the entire bezel. The nameplate is available separately. See fig 1.

1. Remove the existing Hood Bezel Nameplate "6.2L Supercharged" that is coming off, loose or crooked using the standard removal procedure specified in the Service Library Service Information; 23-Body; Exterior; Name Plate Remove And Install.

2. Clean the Hood Bezel surface with isopropyl alcohol or an alcohol wipe. Make sure that there is no adhesive residue remaining and the surface is clean.

3. Install the new Hood Bezel Nameplate "6.2L Supercharged" P/N 68444262AB (or higher nic level) using the 23-Body; Exterior; Name Plate Remove And Install.
