Bulletin #: C32-0122-0606	☐ Take Note ☒ Take Action
☐ Retail Operator ☐ Sales Pre-Owned	☐ Business Manager ☒ Parts & Accessories
☐ General Manager ☐ Sales New Car	☐ Service ☐ Administration
Name: Kenny Inoa	Phone Number: 201-571-5623
Title: Material Flow & Inventory Integrity	Source: Parts Logistics
Date: January 25, 2022	Supersedes:

BMW PARTS BULLETIN

TEC379 GEARSHIFT STEPTRONIC RETURN

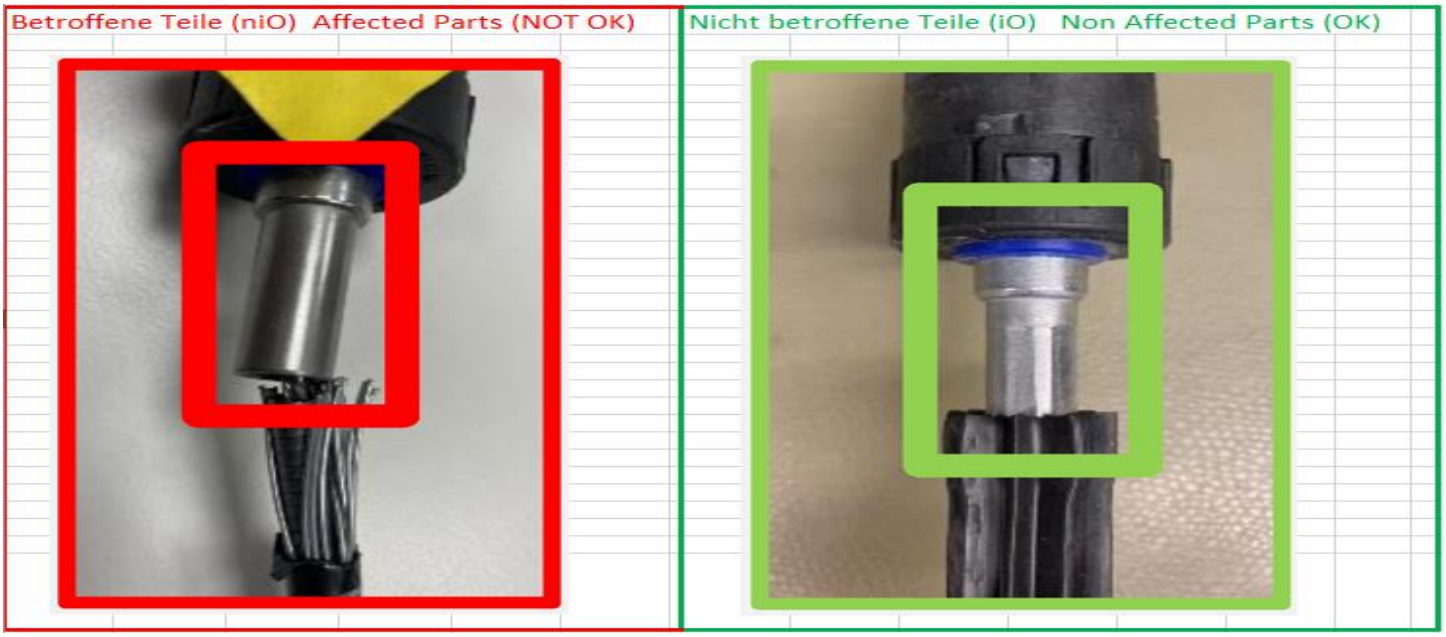
Stock should not be sold or installed on any vehicle.

Concerned are all parts delivered and shipped so far containing rope pull end piece not crimped. Parts with crimped end piece are ok for use. Pease view images below.

Please return all affected part(s) to your facing Regional Distribution Center (RDC). Submit for return using a YR26 damage claim with order reason BM2. A valid BMW delivery and delivery item number must be entered, and TEC379 must appear in the text of your TEC claim.
