Service Bulletin

Bulletin No.: 19-NA-232
Date: January, 2022

Subject: **Diagnostic Tip for Misfire, Malfunction Indicator Lamp (MIL) Illuminated - DTCs P0300, P0301, P0302, P0303, P0304, P0305, P0306, P0307 and/or P0308**

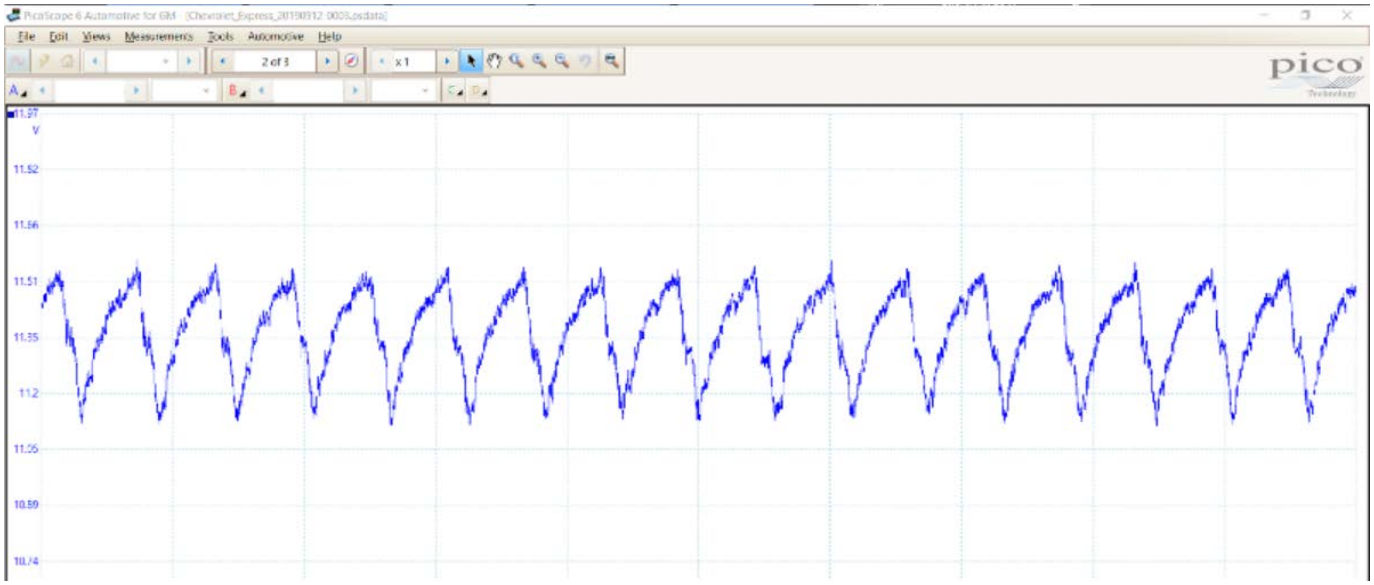
5419821

The graph above illustrates an engine that will pass a compression test and there is no reason to think that there is anything mechanically wrong with the engine.

⇒ If the graph does not look like the graph above, Refer to Analyzing Relative Compression Graphs section below.

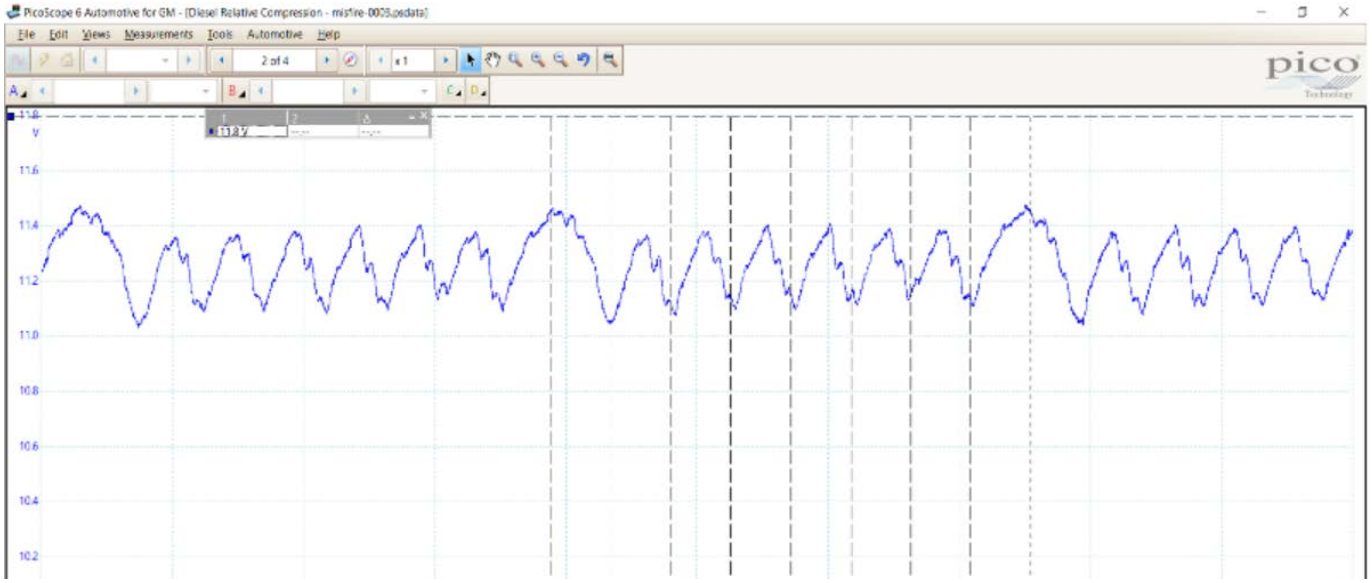
5420017

The graphic above depicts an example of an eight-cylinder engine with a cylinder that has no compression in one cylinder.

Note that one of the dips is missing and it repeats every eight dips.

– This is a clear indication that there is an issue with this engine.

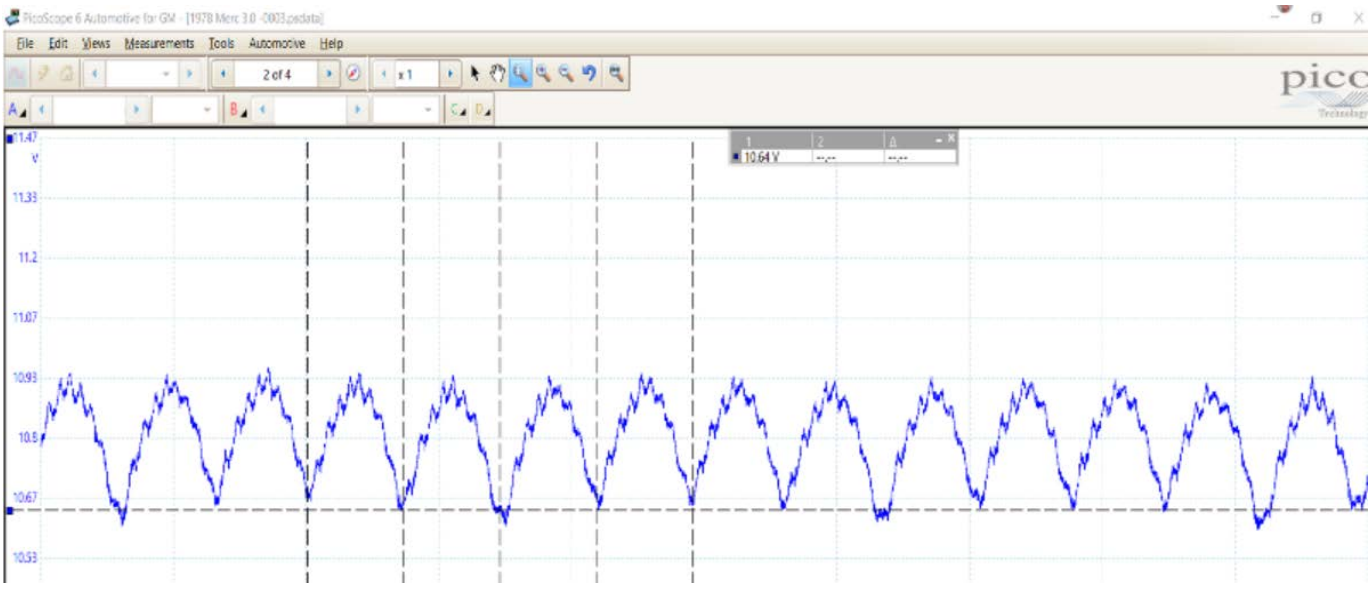
5420027

The graphic above depicts an example of a four-cylinder engine with a bad exhaust cam lobe.

Note that consistently there is one cylinder with an extra-long compression stroke.

– Examination of this engine showed that cylinder number four had a worn down cam lobe.

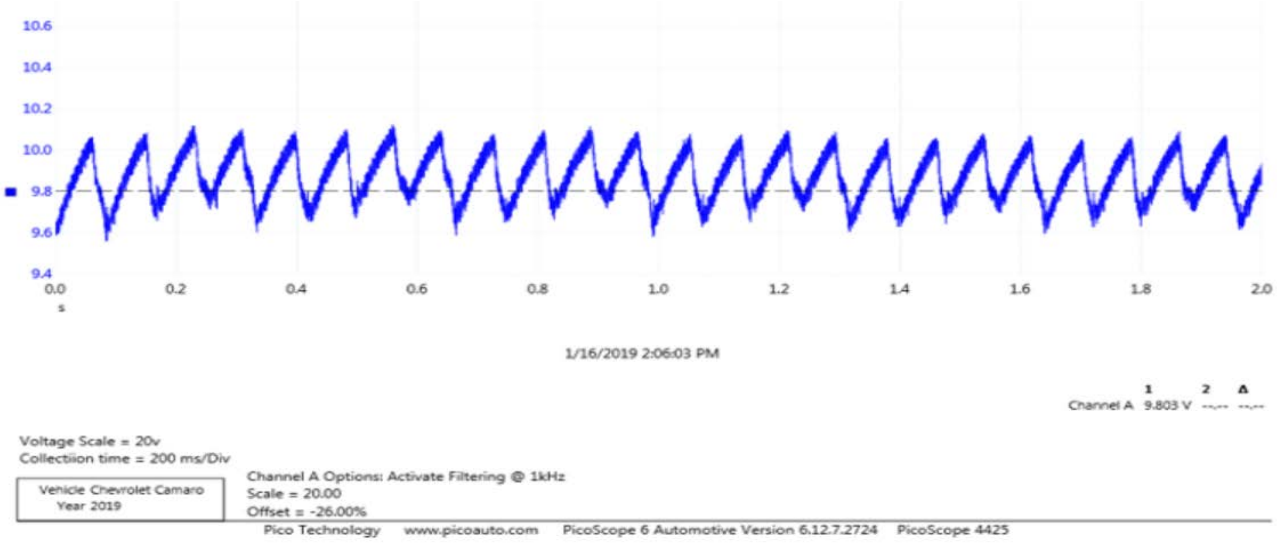
5420028

This is a four-cylinder engine with a 20 PSI loss in one cylinder

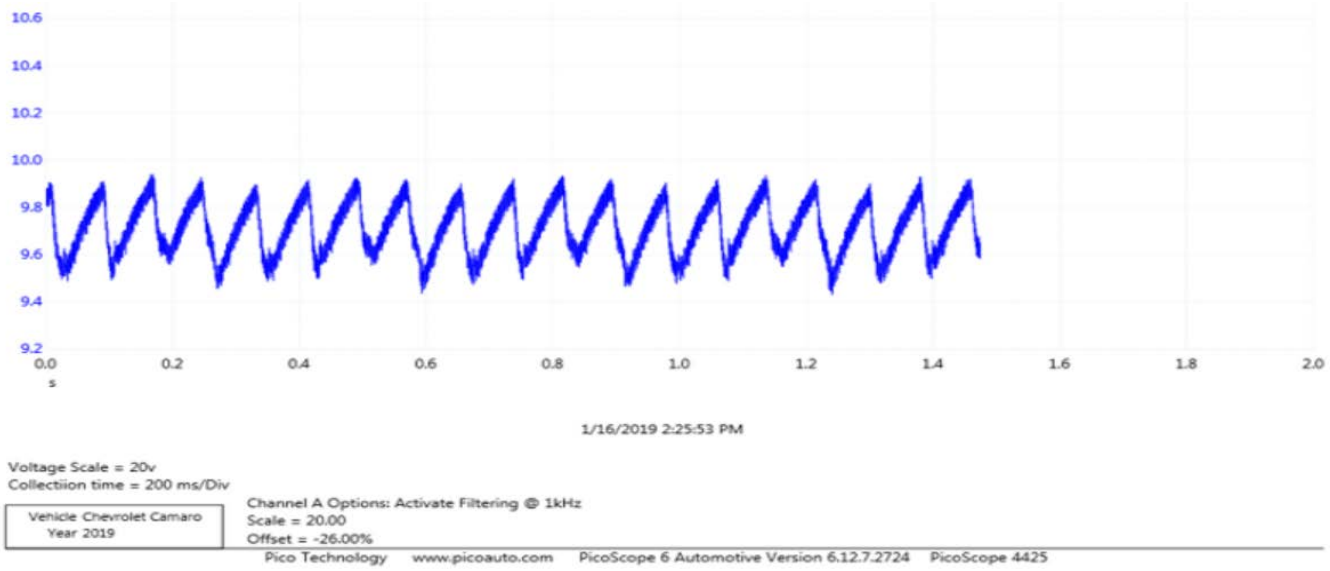
5420034

This is a four-cylinder engine with a 40 PSI loss in one cylinder.

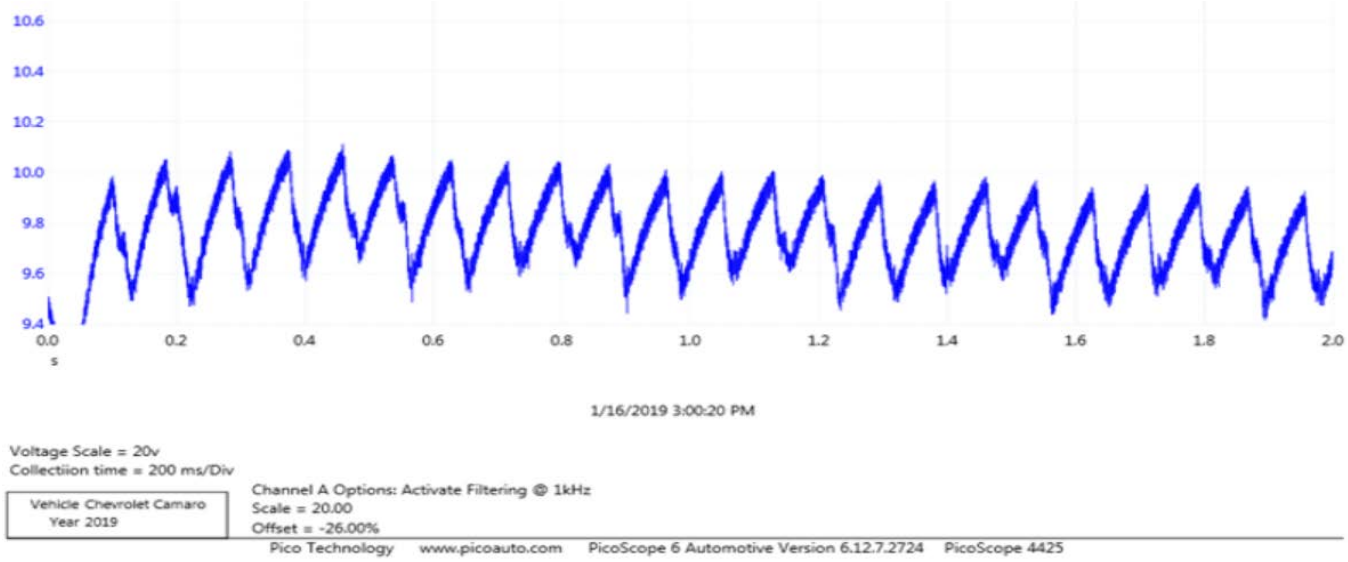
5420040

This is a four-cylinder engine with a 60 PSI loss in one cylinder.
