| **Technical Service Bulletin**: TSB220021 | **Released Date**: 07-Feb-2022 |

# Mislabeled Thermal Management System Harness

- BES CM0904 EV104B

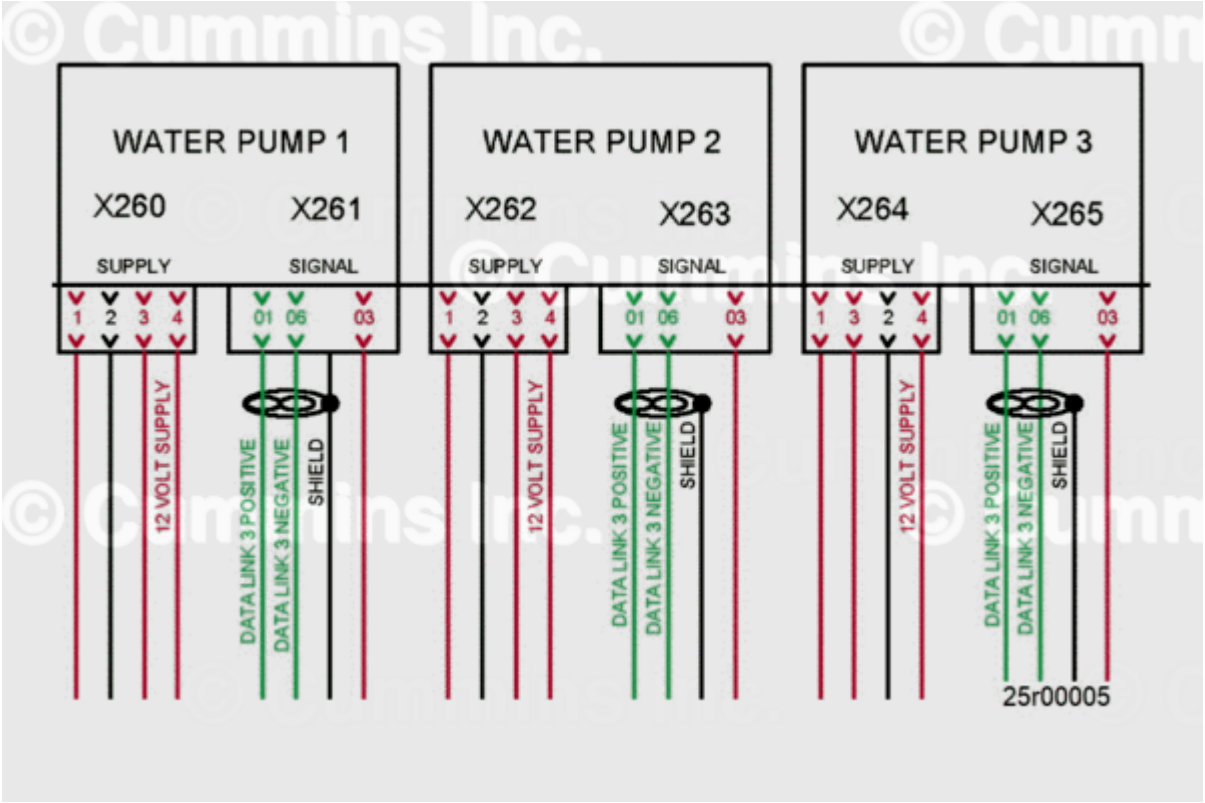
The existing thermal management system harness is labeled incorrectly. See Table 1 for correct labeling.

Figure 1, Thermal Management System Harness Schematic (Pump-side).

Figure 2, Example of Mislabeled Power Connector as x265 Which Should Be x264.
