TECHNICAL INSTRUCTIONS

LIMITED SERVICE CAMPAIGN 22LD01

OPTIONAL BODY-COLORED REAR SPOILER DESIGNED FOR:

CERTAIN 2021 MODEL YEAR IS 300 VEHICLES

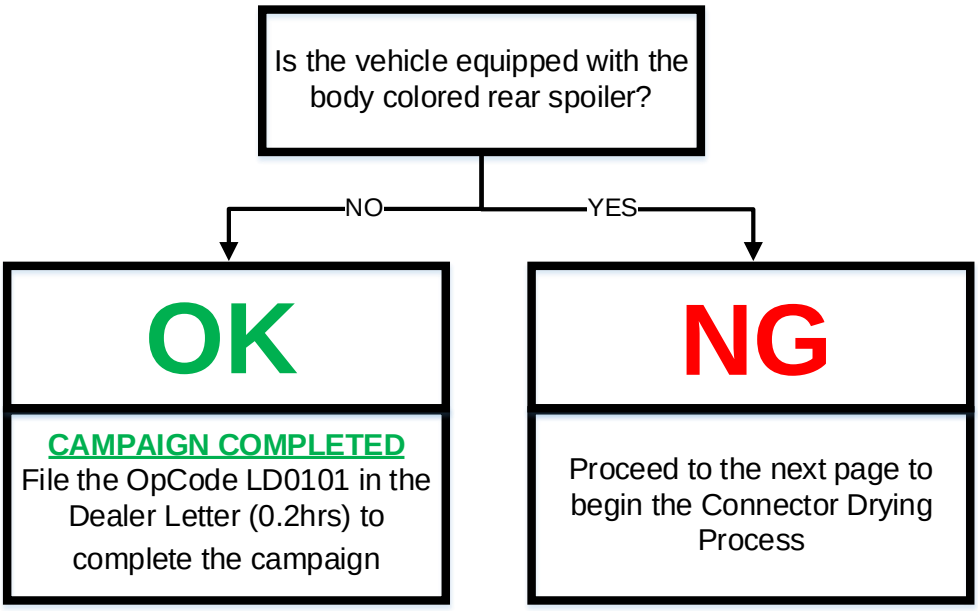
a. Look at the exterior aft edge of the deck lid (trunk) to determine if the vehicle is equipped with the affected body-colored rear spoiler covered by this Limited Service Campaign.

NG	GOOD		
AFFECTED	**NOT AFFECTED - CAMPAIGN COMPLETED**		
Lexus Body-Colored Spoiler	**Lexus Carbon Fiber Spoiler**	**Lexus Factory-Black Spoiler**	**No Spoiler Installed**

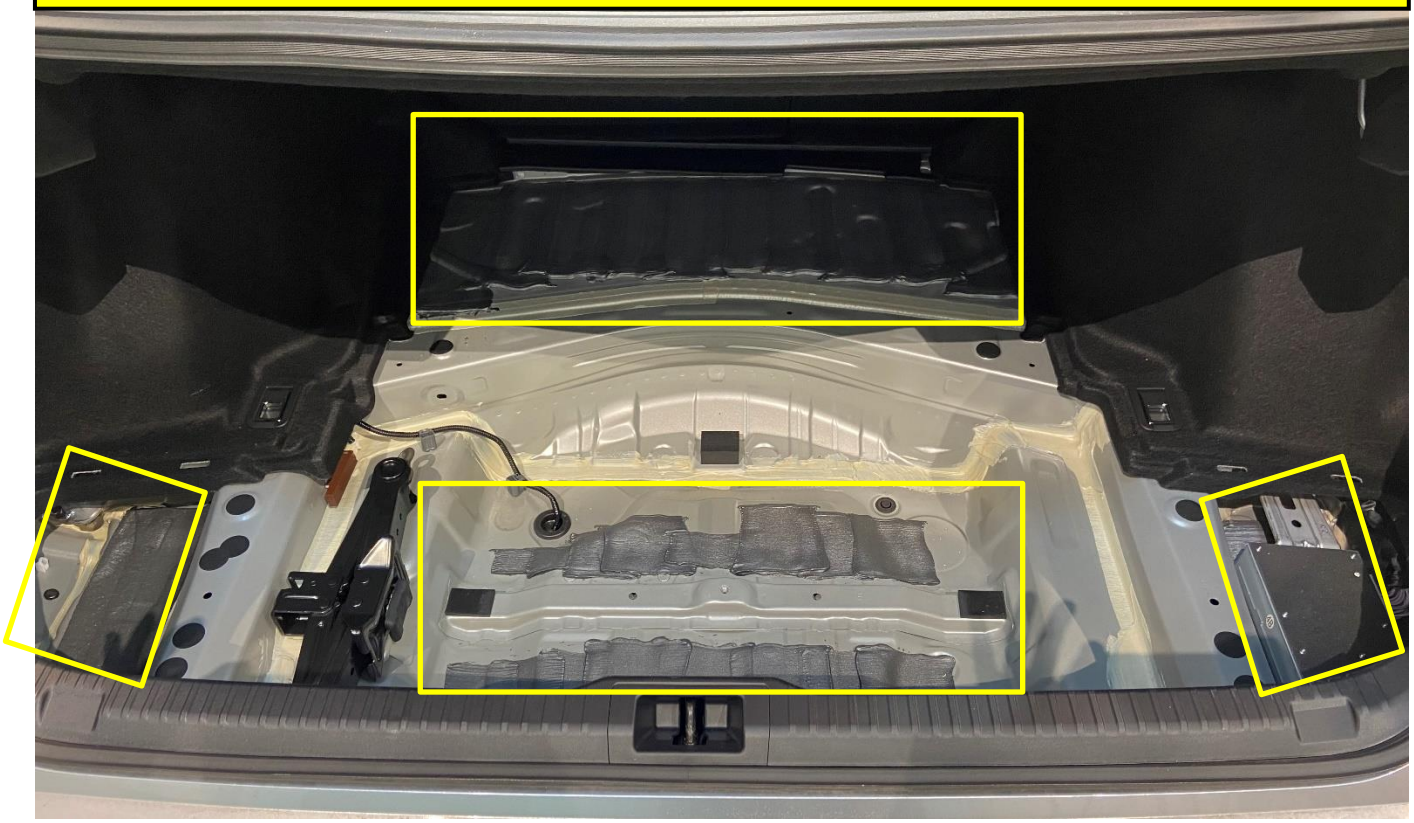
10. VISUALLY INSPECT THE TRUNK FOR ORGANIC GROWTH

a) Visually inspect the areas, shown below, for signs of organic growth caused by water intrusion.

NOTE: The areas shown immediately below are the most prone to organic growth because they are coated in factory applied LASD (liquid applied sound deadening).

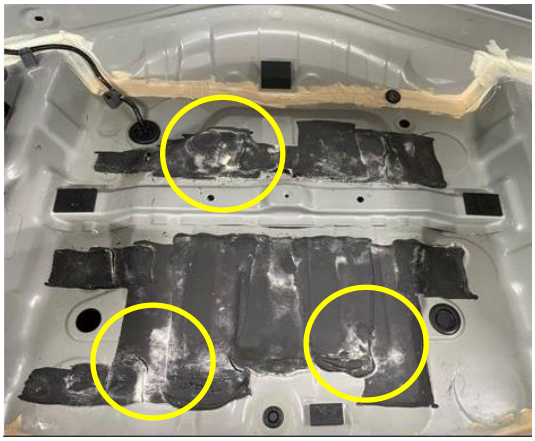
Examples of Organic Growth

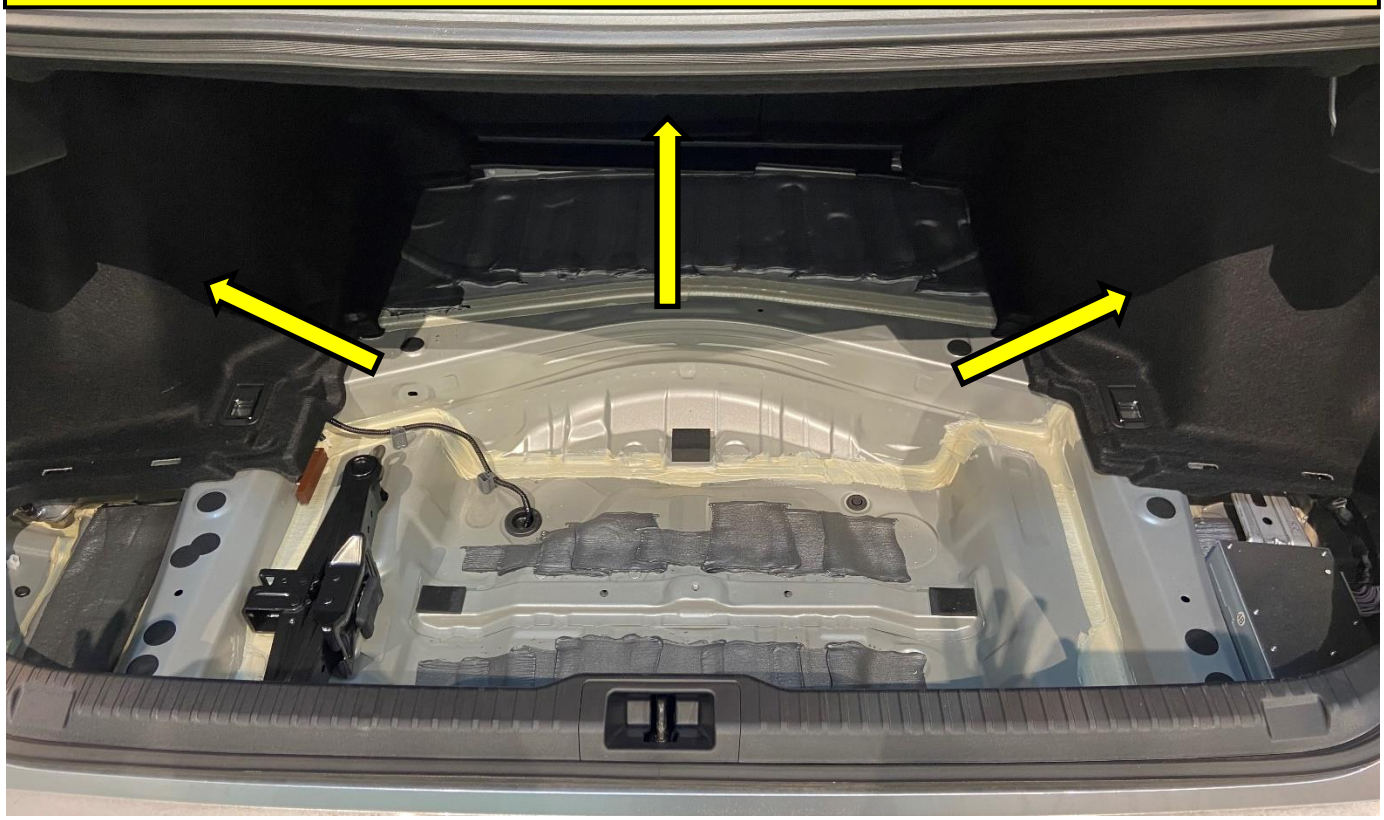
Organic Growth Inspection Areas

11. VISUALLY INSPECT TRUNK FABRIC LINER COMPONENTS FOR ORGANIC GROWTH

a) Visually inspect the fabric liners, shown below, for signs of organic growth caused by water intrusion.

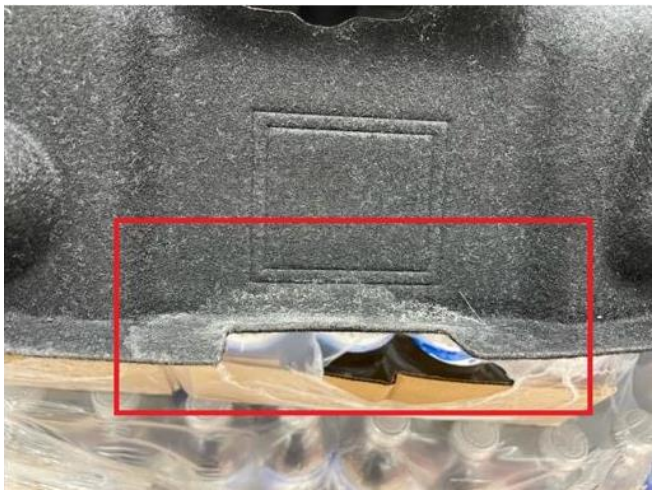
Examples of Organic growth

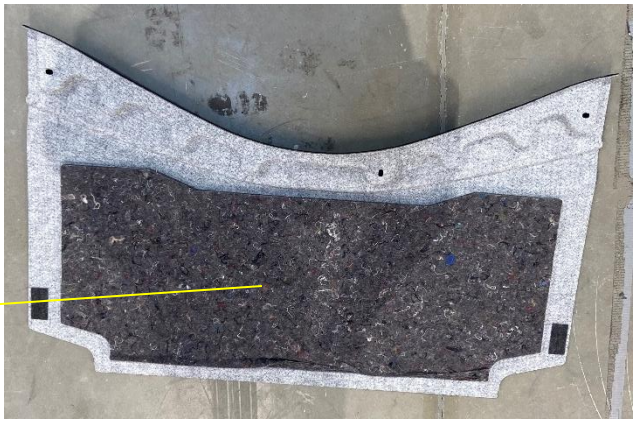
b) Organic growth is <u>most commonly</u> found on the jute padding. But you should inspect both sides of the panel

Organic growth is most commonly found on the jute padding

Examples of organic growth

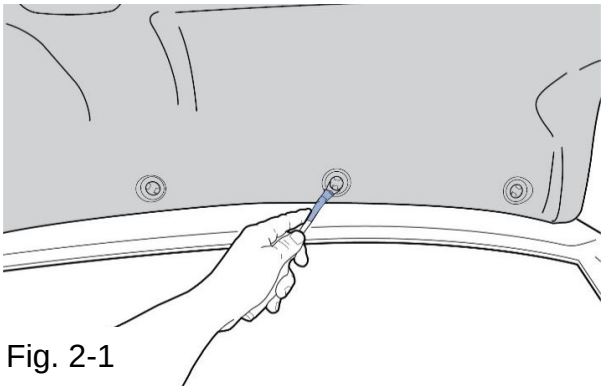
Fig. 2-1

a) The deck lid liner panel should already be removed from the connector drying process. However, if the panel is still installed, use a trim removal tool to disengage and remove the 11 clips from the interior decklid panel. (Fig. 2-1).

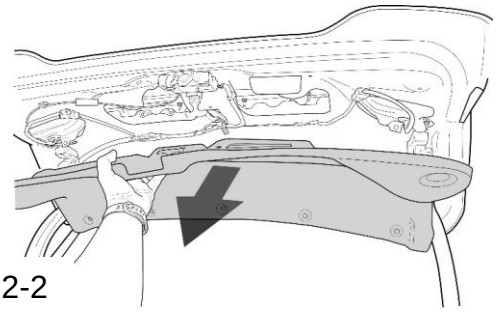
Fig. 2-2

b) Remove the interior decklid panel to expose the inside area of the decklid (Fig. 2-2).

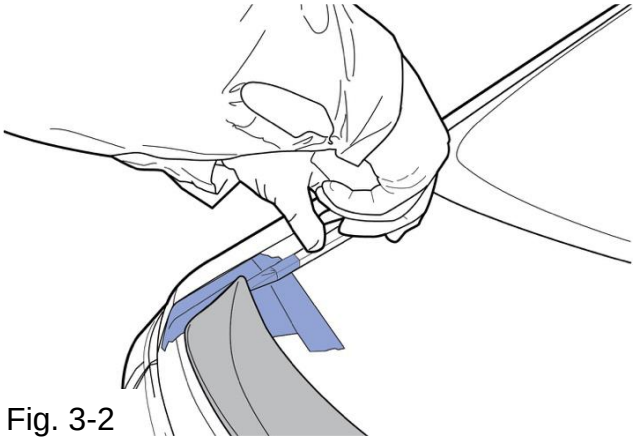
Fig. 3-2

c) Starting on outside corner, use a plastic pry tool to remove the exiting spoiler and any tape adhering to the surface (Fig. 3-2).

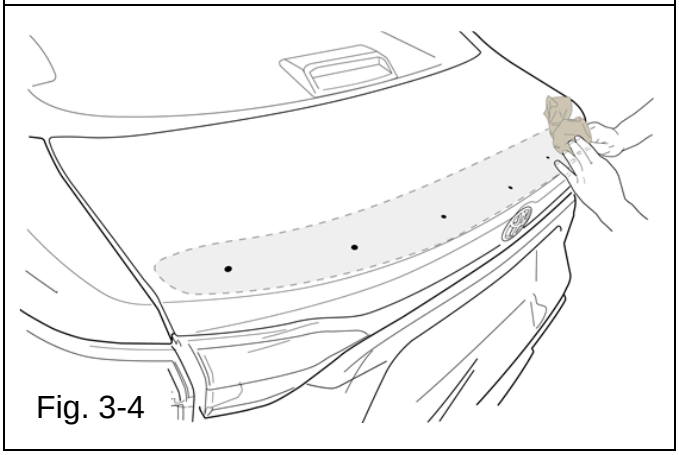
Fig. 3-4

b) Using surface cleaner, remove any adhesive residue and thoroughly clean the entire surface of any dirt and debris to maximum adhesion for the new spoiler. Wipe dry. (Fig. 3-4).

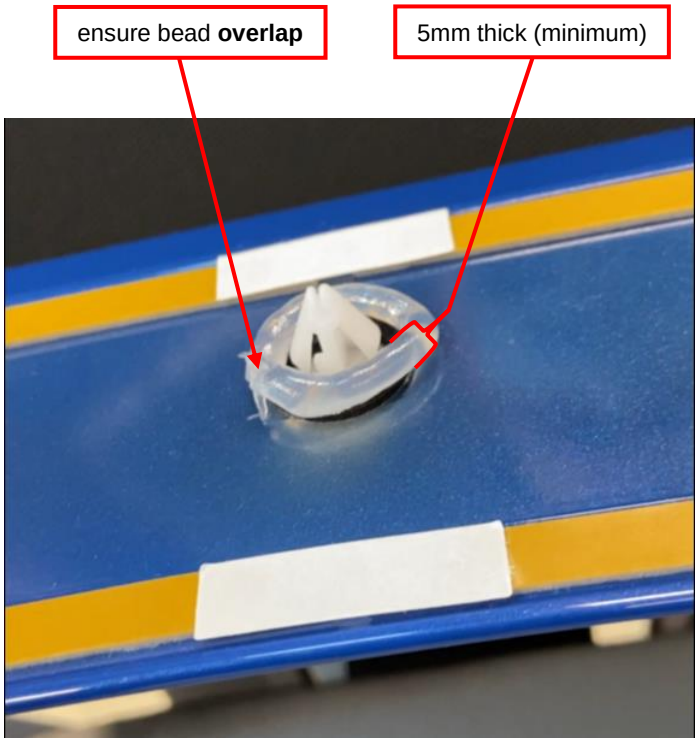
Proper Sealant Application

b) **Apply auto body sealant to <u>DECK LID</u>:** Apply a 5mm thick (minimum) continuous bead of auto body sealant to the perimeter of the holes in the deck lid indicated in the picture below.

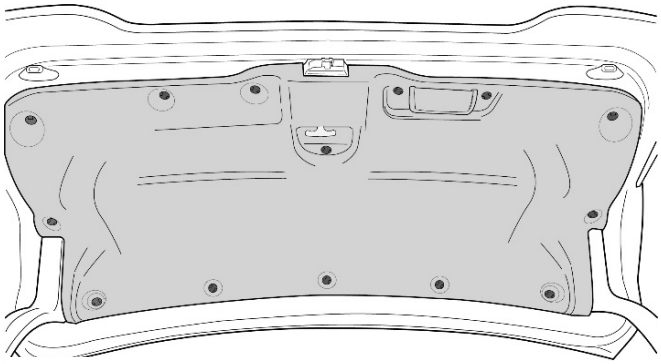
Fig. 7-1

a) Align the decklid interior panel and reinstall by firmly pressing the 11 clips back into place (Fig. 7-1).
