# Volvo Chassis - DTC U012100 - Lost Communication With Anti-Lock Brake System (ABS) Control Module, No Additional Information

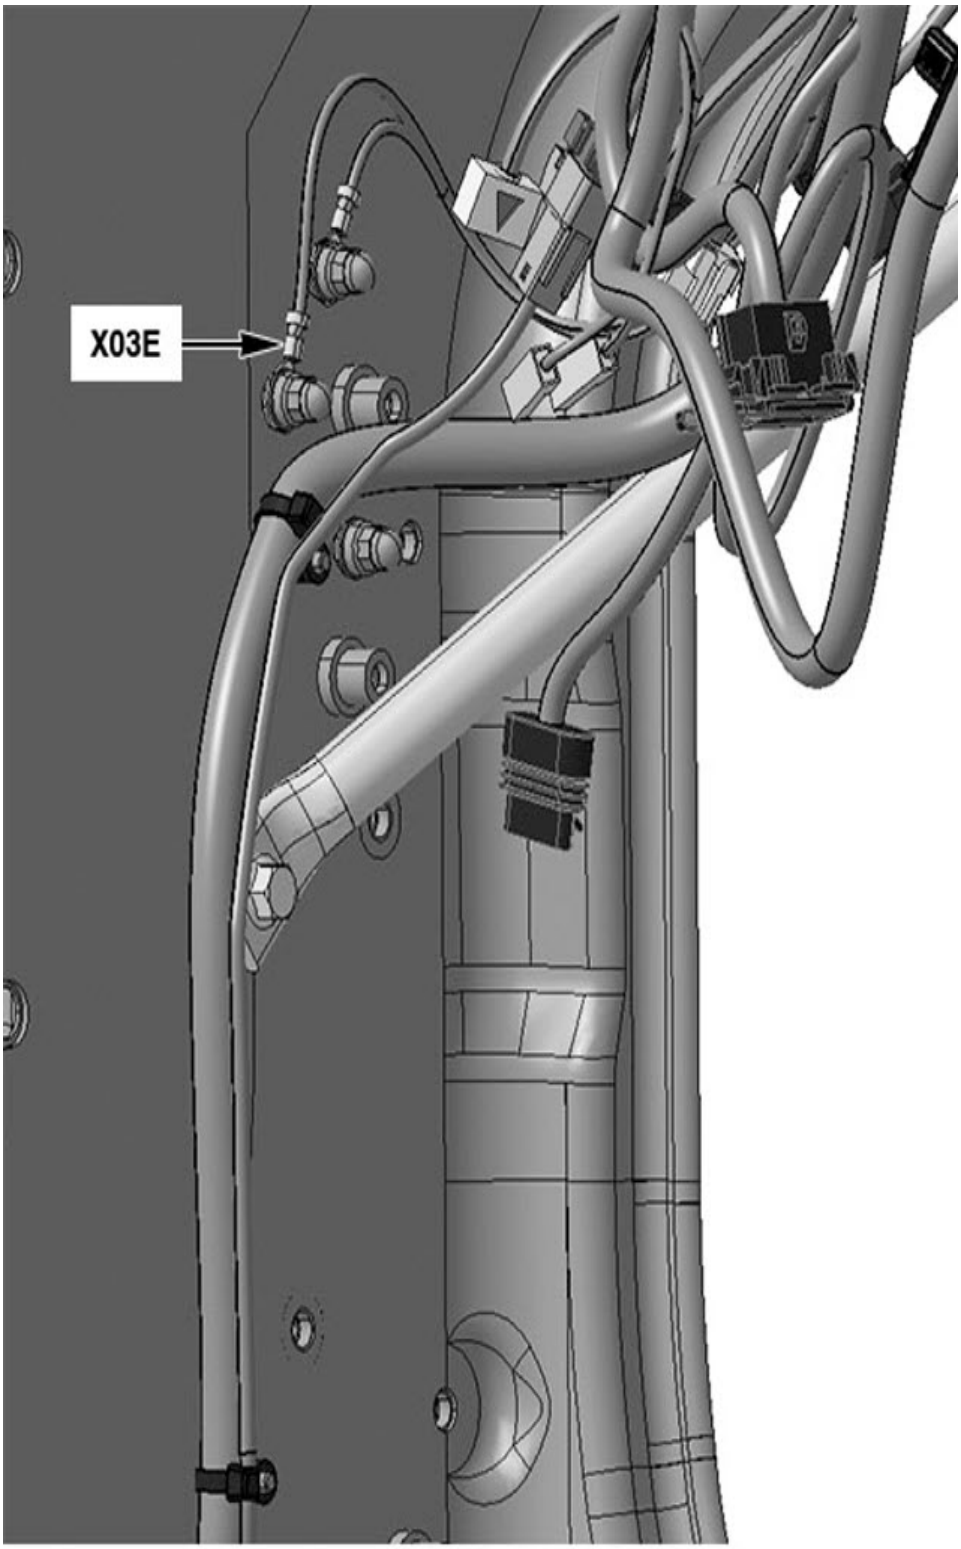
LEFT SIDE OF DASH UNDER CLUSTER

Fault Code U012100 may be caused by caused by poor ground connection.
If DTC is present do the following:

The X03E ground junction is located on the left side of the dash under the cluster. See images below.

1. Disconnect the battery.
2. Remove all exterior Ground conections.
3. Thoroughly clean all surfaces.
4. Reassemble connections.
5. Apply protective coating.

Clear faults and verify the repair. If the fault returns continue with Guided Diagnostics.
