Rear Corner Molding Sealant

Bulletin Type:	TSB	**Publication Date:**	August 2022
Bulletin #(s):	22-072	**Make(s):**	Jayco
Job Code(s):	9801579	**Model(s):**	North Point (382FLRB) North Point (377RLBH)
Flat Rate(s):	.10 Inspection .50 Inspection and Repair	**Model Year(s):**	2022-2023

Incident:	**Missing sealant on rear corner moldings**
Affected Units:	**2022-2023 Jayco North Point**
Parts Kit: None	Parts Kit #: None
Misc. Tools & Supplies:	Caulk Gun Soapy Water Sealant, Geocell 2300 VBS (Jayco Part #0327810) (Purchase Locally)
Parts Return Information:	N/A

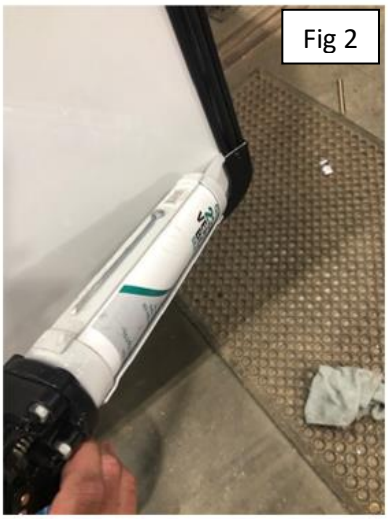
Fig 1

- Determine whether rear corner moldings and rear corner caps for door side and off-door side have been sealed. Please follow the repair below if the corner caps and corner moldings have not been sealed.

1. Begin by sealing the door side and off-door side moldings on both sides from the top corner cap to the bottom corner cap. The corner caps should already be sealed. The green arrows shown in Figures 1 and 4 show the sides on the unit that need to be sealed.
