Dealer Service Bulletin

NO.: 7SB005-23-01A
SECTION: Plumbing
DATE: September 19, 2022

MODELS AFFECTED: All Models

SUBJECT: Shower Surround Sealant

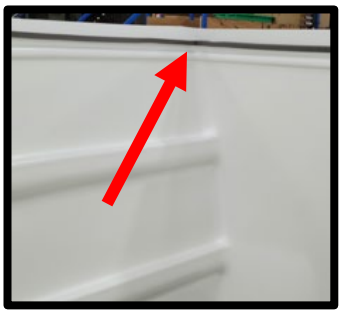
Figure 1

Please be sure to pass this along to your staff so they are aware that the shower is not missing sealant. Reference photos below. Figures 1 and 2 indicate the new foam, Figure 3 shows the surround with no sealant.

This bulletin is to advise you of a change to the shower surround sealant process. We have eliminated caulk-type sealant between the surround and the shower pan in favor of a closed-cell foam installed behind the shower surround. This will prevent moisture from getting behind the surround and eliminates the need for visible, caulk-type sealant.
