Bulletin #: C32-0223-0611	☐ Take Note ☒ Take Action
☐ Retail Operator ☐ Sales Pre-Owned	☐ Business Manager ☒ Parts & Accessories
☐ General Manager ☐ Sales New Car	☐ Service ☐ Administration
Name: Kenny Inoa	Phone Number: 201-571-5623
Title: Material Flow & Inventory Integrity	Source: Parts Logistics
Date: February 8, 2023	Supersedes:

BMW PARTS BULLETIN

TEC509 RIGHT SIDE OUTER WEATHERSTRIP RETURN

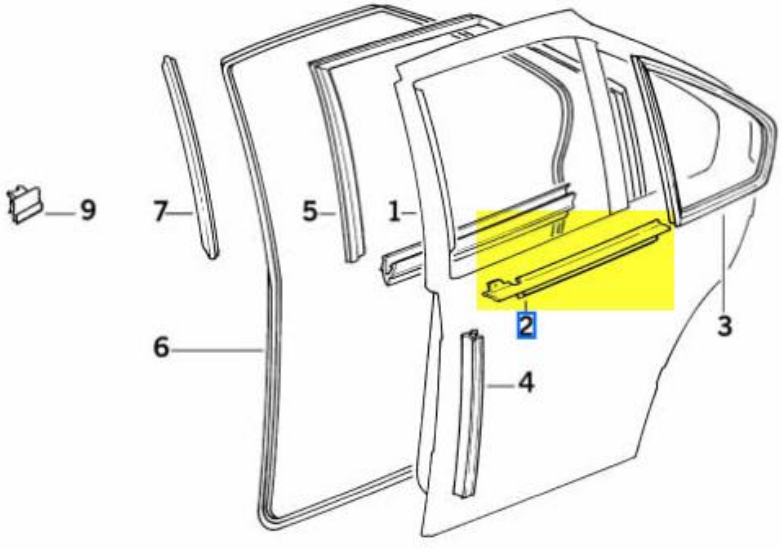
51 22 1 960 848

Concerned are all parts shipped and delivered so far with incorrect length (example 835mm). Correct part must have a length of 593mm (+1,5mm;-0,5mm) and pn 1960848 is printed on the part.

Affected inventory must not be sold or installed on any vehicle.

Please return all affected part(s) to your facing Regional Distribution Center (RDC). Submit for return using a YR26 damage claim with order reason BM2. A valid BMW delivery and delivery item number must be entered, and TEC509 must appear in the text of your TEC claim. If you cannot locate the delivery number, please submit an IDS ticket to Parts Logistics>Returns>Claims>Quality>Claims for assistance.
