SS 3119-FTL 2023 P4 New Cascadia PTO Grinding

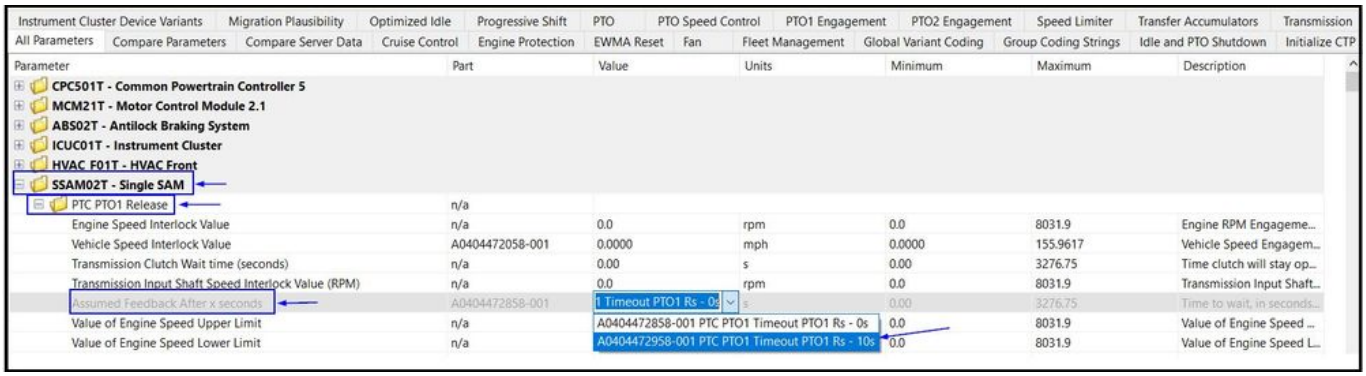
When vehicle is in PTO operation, a parameter (emergency mode) may be incorrectly set allowing the PTO to try to re-engage while in operation.

If encountering PTO grinding during operation, check the sSAM for the PTO position (screen print example will be for PTO1) programming for Assumed Feedback After x seconds. The parameter should be set to 10s. Make sure the setting applies to the PTO being programmed PTO1, PTO2 or PTO3.
