Technical product information

Topic	New Continental GT and GTC - Window drop glass operation
Market area	Australia E04 Bentley rest Asia and Australia (6E04),China 796 VW Import Comp. Ltd (Vico), Beijing (6796),Germany E02 Bentley rest Europe (6E02),Japan E03 Bentley Japan (6E03),Korea, (South) E08 Bentley South Korea (6E08),United Arab Emirates E06 Bentley Middle East and Africa (6E06),United Kingdom E01 Bentley UK (6E01),United States E05 Bentley USA and rest America (6E05)
Brand	Bentley
Transaction No.	2070497/3
Level	EH
Status	Approval
Release date

New Continental GT and GTC

Retailer glass reset procedure for GT/GTC

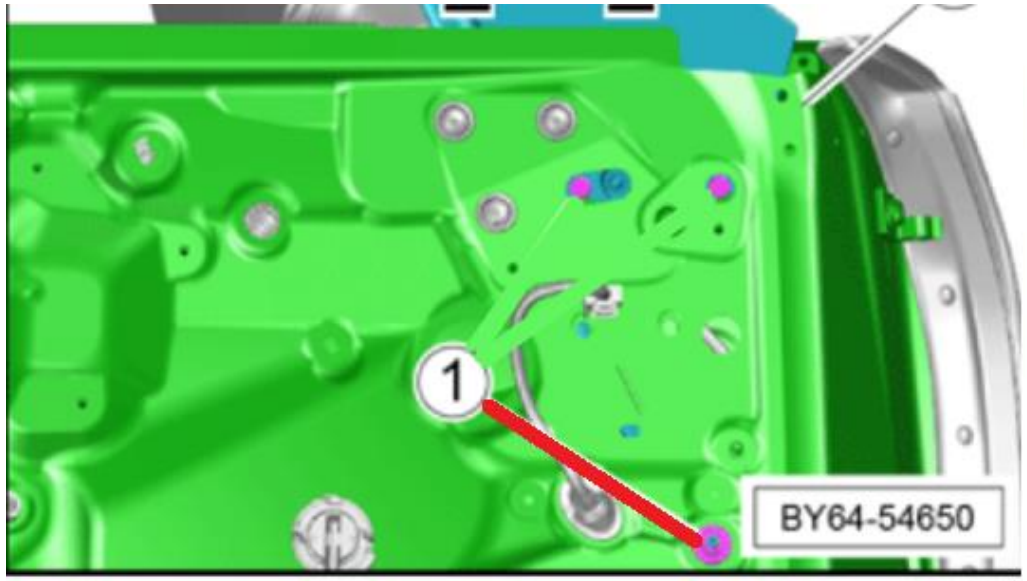
Front Quarter glass adjuster Item 1
Measurement between bottom of mounting washer and division bar frame, is 12.5mm.
To reset this adjuster without removing the quarter glass, loosen the lock nut, screw the adjuster all the way in clockwise until it bottoms out on the frame, then unscrew anti clockwise 4 complete turns then set height and profile to ELSA specification before moving on to the next step.

Image for reference, glass does not require removal from vehicle

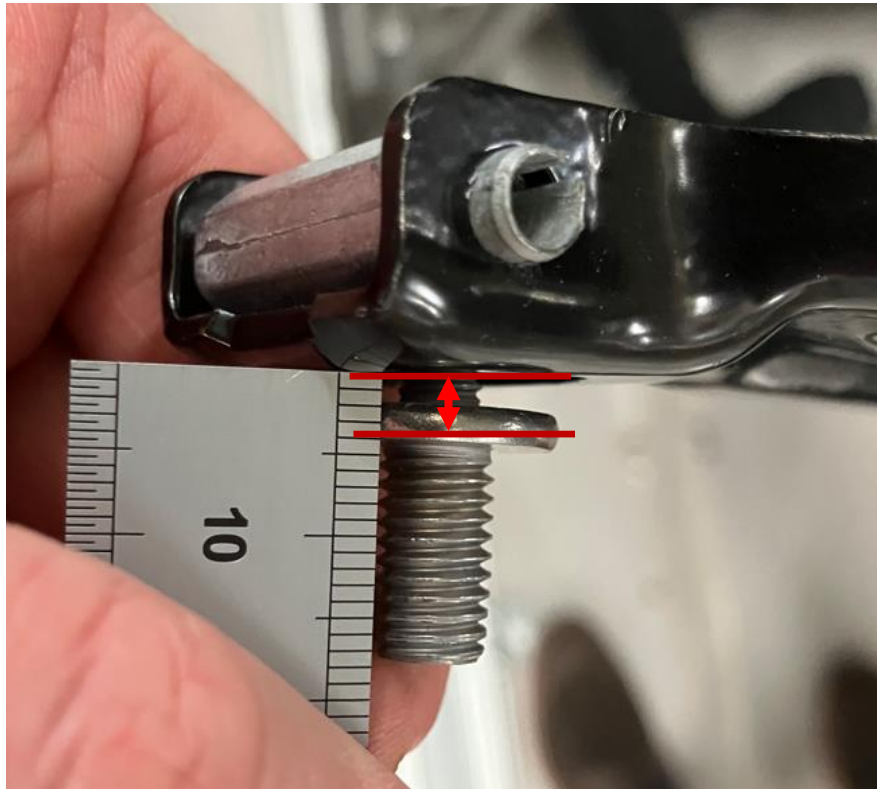
Regulator adjusters X1 X2

Measure from top of mounting washer to frame
X1 = 4mm, To reset this adjuster without removing the regulator fully screw in clockwise until hard stop, then unscrew 4 turns anticlockwise

X2 = 4.5mm, To reset this adjuster without removing the regulator fully screw in clockwise until hard stop, then unscrew 4 turns anticlockwise

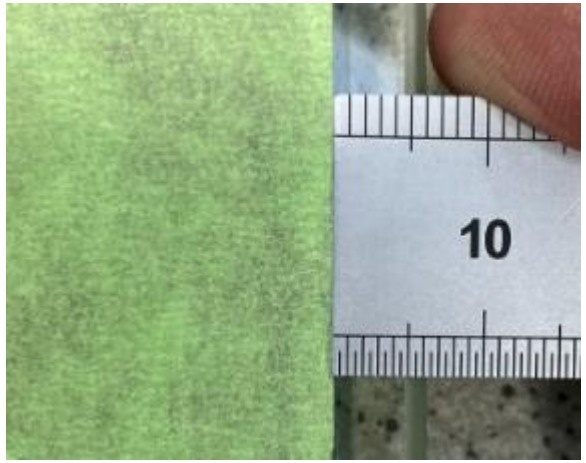
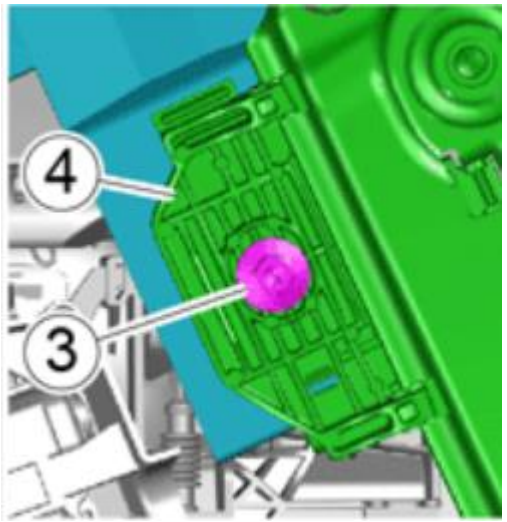
- **Measuring front glass intrusion into front division bar**

Example of incorrect fitment:
10mm intrusion into division bar seal not achieved. Only 6mm seen, front and rear side glasses will be too far rearwards, potentially clash condition between rear of rear glass and cant rail/roof seals

When reinstalling front drop glass ensure tape is applied at 10mm from front edge and align this with the previously set quarter glass division bar.

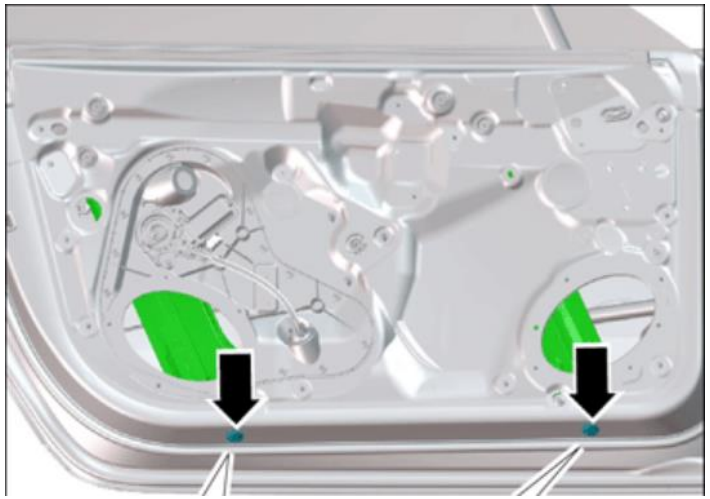
- Z Axis height adjustment on front drop glass

Example: Front drop glass Z axis not adjusted correctly. Bottom of tape was level with waist rail seal, after slackening pinch bolt (3 in bottom left image) front drop glass lowered 14mm to where pen marked line is.
Z-axis adjusters (bottom middle and right images) had not been used, pinch bolt had been slacked and glass lifted out of the regulator to achieve specification. This has a knock on effect of altering the 10mm division bar intrusion seen in previous slide as glass is loose and can be accidentally moved in X-axis.
This also creates a risk that the window will bottom out on the cant rail seals rather than the regulator bump stops meaning that the glass can raise further as the seals soften over time and affect end stop learning.

Z-Axis height should only be adjusted by the 4mm Allen key adjusters as per ELSAPRO

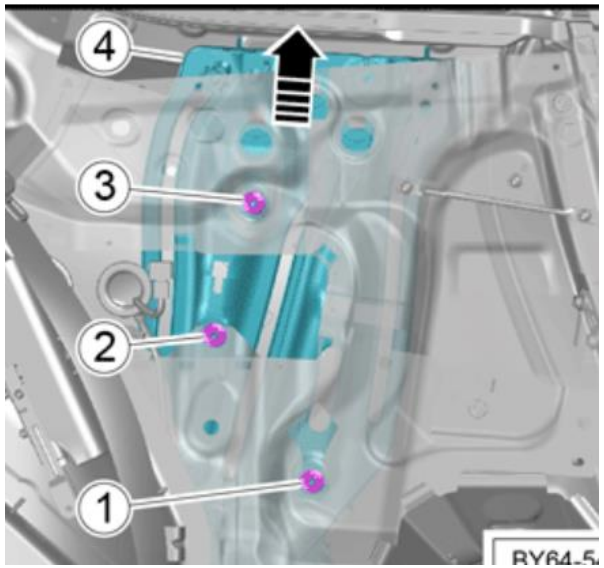
Before resetting adjusters remove the 3 13mm lock nuts (1-3 in image) to allow adjusters to be fully screwed in without damaging the regulator, Also ensure black closing panel (see page 12) is not stopping the regulator from moving when performing these adjustments.

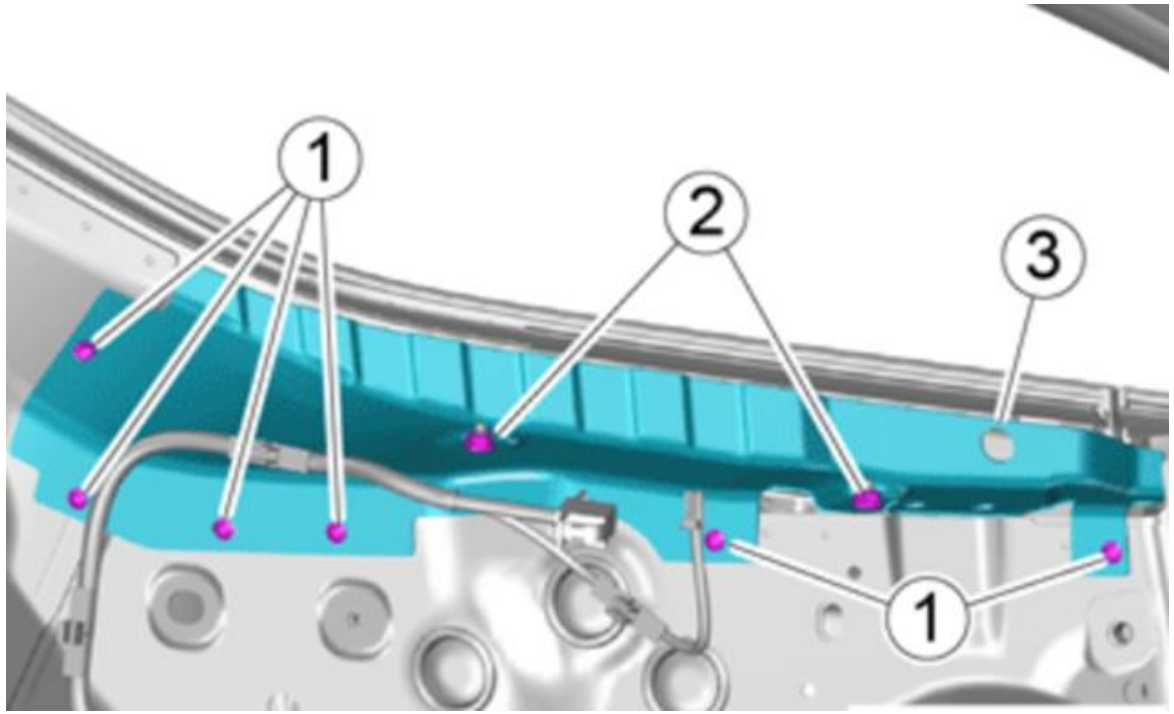
- Rear quarter regulator adjuster reset

After resetting all 3 adjusters leave the locking nuts loose to allow vertical movement.
Ensure closing panel (item 3) is installed and 10mm nuts (item 2) are tightened to set regulator height before tightening adjuster locking nuts (item 1-3 in image on page 10). Ensure regulator is bottoming out on bump stops when measuring/setting glass height in Z-axis

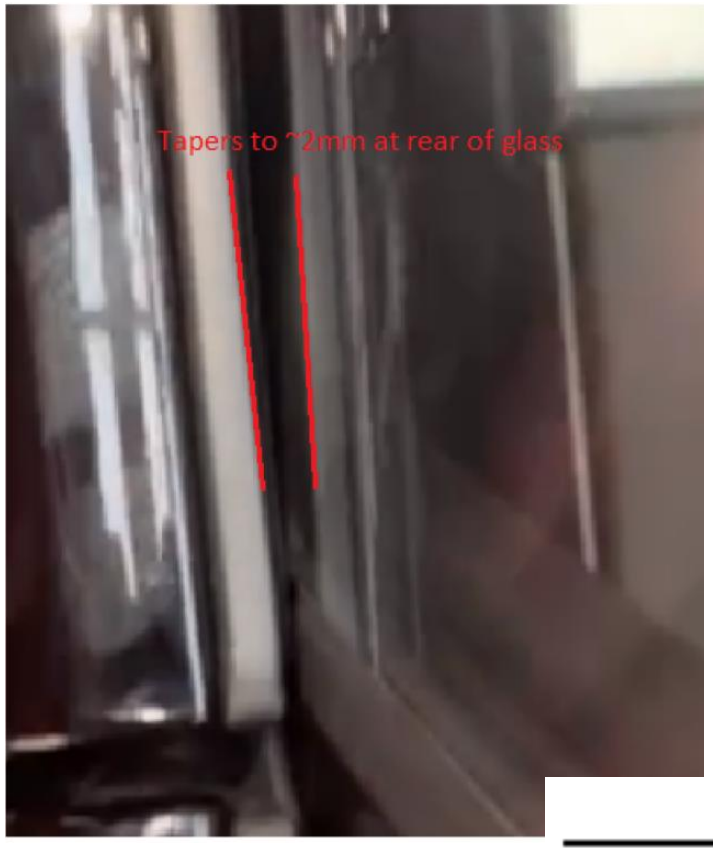
- **Waistrail measurement checking/resetting**

Images show a poor setting.
Circa 6mm at front edge (near wing mirror) closing up to 2mm at the rear edge.

2mm at rear edge would have been set to achieve specified flush/2mm underflush profile condition between front and rear glasses, the rear quarter glass mirrors this taper condition. This potentially increases the risk of false anti trap as rear window/seal does not engage with front window at the correct angle.
Suggested to set to specification on problem vehicles as per next slide. If both windows are set between 4-6mm then the flush/2mm underflush profile can be easily achieved.

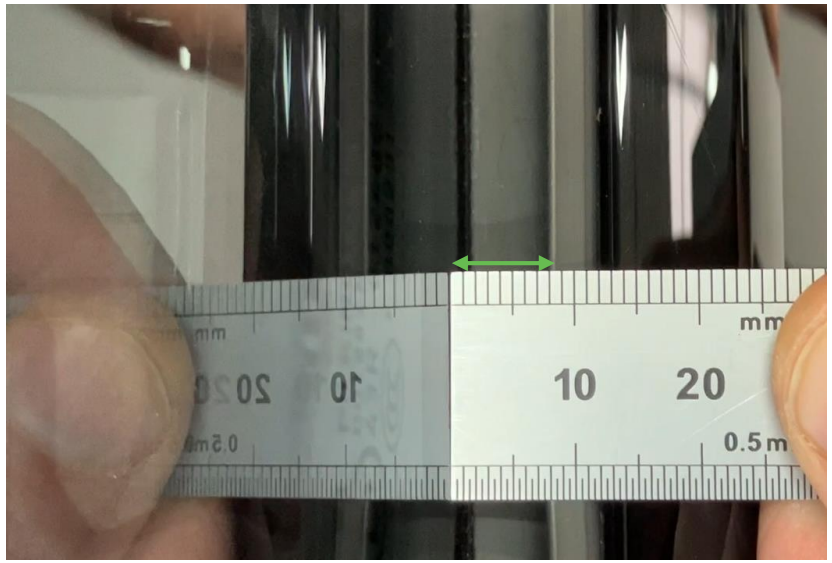
RHF window, front window closed, rear window open. Note gap

When setting front to rear window profile and waist rail measurements ensure that the front window does not move outboard excessively when the rear window closes as this will increase current draw on the rear motor during the period where it is monitoring for it's end stop, excess current draw in this zone can cause a false anti-trap scenario.
There does need to be some tension between the front and rear glass to seal against the drop glass seal, zero mm of movement is best.
If more tension is required to resolve a wind noise or water ingress then aim for no more than 0.25mm of outboard movement.

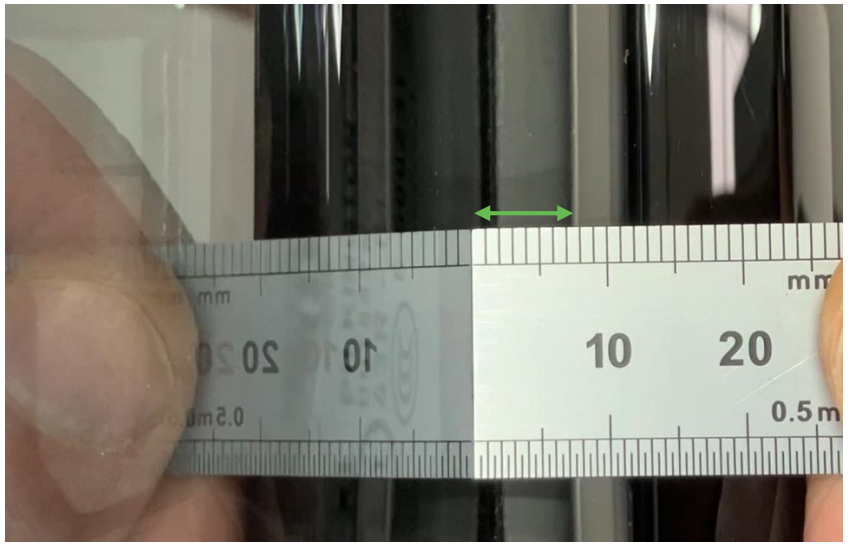
RHF window, front window closed, rear window closed. Note gap, over 0.25mm outboard movement, this is incorrect

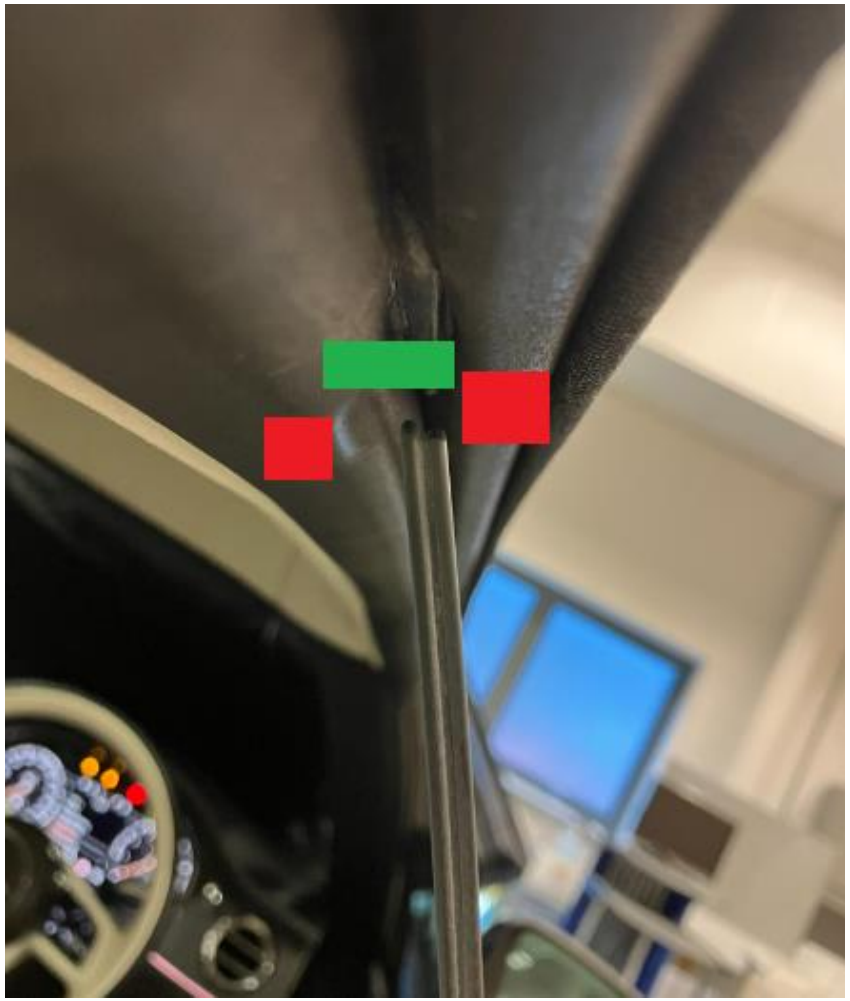
Window entry into cant rail/convertible roof seal

Front window examples showing correct operation

Windows should enter cant rail seal smoothly, making contact with inboard edge first and then be pushed outboard (green square).
Too far inboard increases the risk of the cant rail seal pinching, too far outboard will clash with cant rail brightware (red squares)
For front door, poor door profile is a major contributing factor here and should be checked/adjusted if window found to be entering seal incorrectly
