BEZEL - INSTRUMENT CLUSTER

Quality Inspection Request

Part Number : 6PM54TX7AB

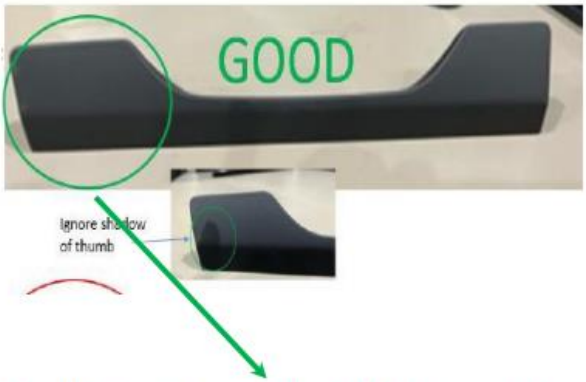
Correct Part	Suspect Part

Good Parts : Parts without Missing paint on the parts/shiny surface are good parts.	**Suspect Parts : Parts with Missing paint on the parts/shiny surface are suspect parts.**

Please check and return suspect stock of part number **6PM54TX7AB.** Please refer QIR attachment.

Please return all parts back to your facing depot using **Return Code 02**, before 7th September 2023.
