Technical product information

Topic	New Continental GT/GTC and New Flying Spur - V8 Kovomo - Fuel Pressure Regulation - Numerous DTC's
Market area	Australia E04 Bentley rest Asia and Australia (6E04),China 723 Volkswagen (Anhui) Automotive CO (6723),China 796 VW Import Comp. Ltd (Vico), Beijing (6796),Germany E02 Bentley rest Europe (6E02),Japan E03 Bentley Japan (6E03),Korea, (South) E08 Bentley South Korea (6E08),United Arab Emirates E06 Bentley Middle East and Africa (6E06),United Kingdom E01 Bentley UK (6E01),United States E05 Bentley USA and rest America (6E05)
Brand	Bentley
Transaction No.	2061171/12
Level	EH
Status	Approval
Release date

New Continental GT/GTC and New Flying Spur - V8 Kovomo

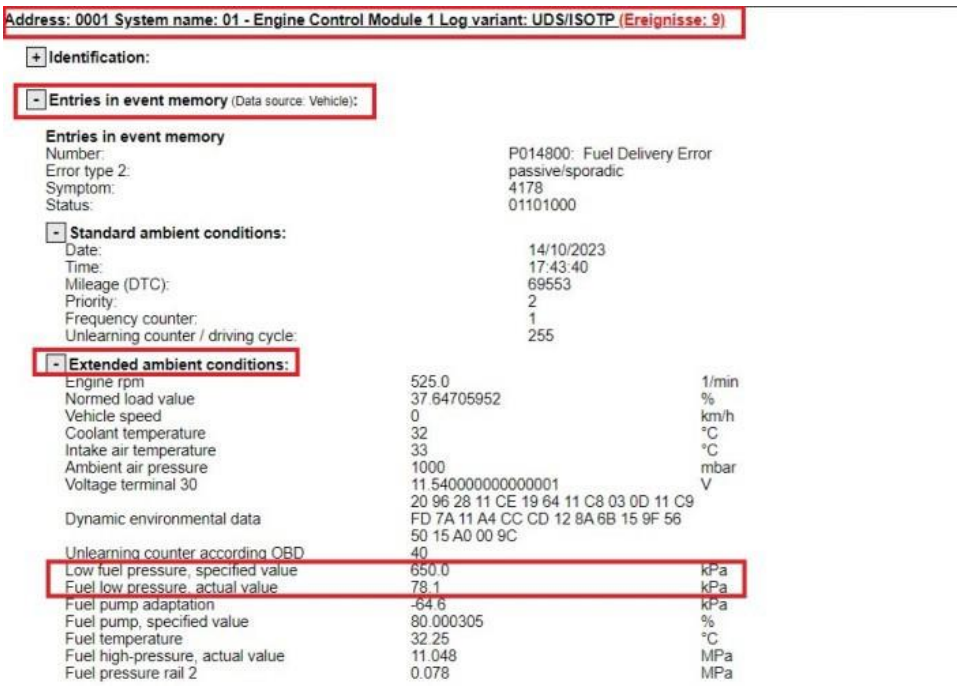
2) Check ***"Low fuel pressure, specified value"*** and ***"Fuel low pressure, actual value"*** within the fault memory, refer to ECU "***01 – Engine Control Module 1"*** - From "***Extended ambient conditions"*** note the values of the ***"Low fuel pressure, specified value"*** **and** ***"Fuel low pressure, actual value "*** - Figure 1 and Figure 2 depending on the DTC P310B00 and/or P014800

Engine rpm	525.0	1/min
Normed load value	37.64705952	%
Vehicle speed	0	km/h
Coolant temperature	32	°C
Intake air temperature	33	°C
Ambient air pressure	1000	mbar
Voltage terminal 30	11.540000000000001	V
Dynamic environmental data	20 96 28 11 CE 19 64 11 C8 03 0D 11 C9 FD 7A 11 A4 CC CD 12 8A 6B 15 9F 56 50 15 A0 00 9C	
Unlearning counter according OBD	40	
Low fuel pressure, specified value	650.0	kPa
Fuel low pressure, actual value	78.1	kPa
Fuel pump adaptation	-64.6	kPa
Fuel pump, specified value	80.000305	%
Fuel temperature	32.25	°C
Fuel high-pressure, actual value	11.048	MPa
Fuel pressure rail 2	0.078	MPa

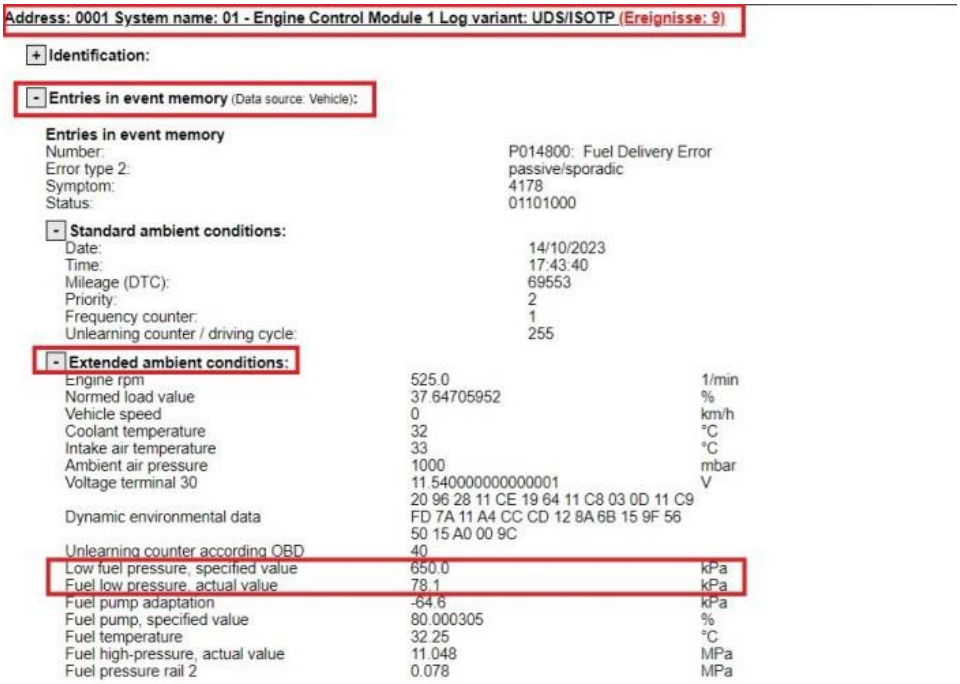
Figure 2

Engine rpm	525.0	1/min
Normed load value	37.64705952	%
Vehicle speed	0	km/h
Coolant temperature	32	°C
Intake air temperature	33	°C
Ambient air pressure	1000	mbar
Voltage terminal 30	11.540000000000001	V
Dynamic environmental data	20 96 28 11 CE 19 64 11 C8 03 0D 11 C9 FD 7A 11 A4 CC CD 12 8A 6B 15 9F 56 50 15 A0 00 9C	
Unlearning counter according OBD	40	
Low fuel pressure, specified value	650.0	kPa
Fuel low pressure, actual value	78.1	kPa
Fuel pump adaptation	-64.6	kPa
Fuel pump, specified value	80.000305	%
Fuel temperature	32.25	°C
Fuel high-pressure, actual value	11.048	MPa
Fuel pressure rail 2	0.078	MPa
