Service Bulletin

Bulletin No.: 24-NA-214
Date: October, 2024

Subject: Medium Duty L5D Trucks Setting DTC P2959

Brand:	Model:	Model Year:		VIN:		Engine:	Transmission:
		from	to	from	to		
Chevrolet	Silverado MD 4500 HD, 5500 HD, 6500 HD	2024	2024			L5D

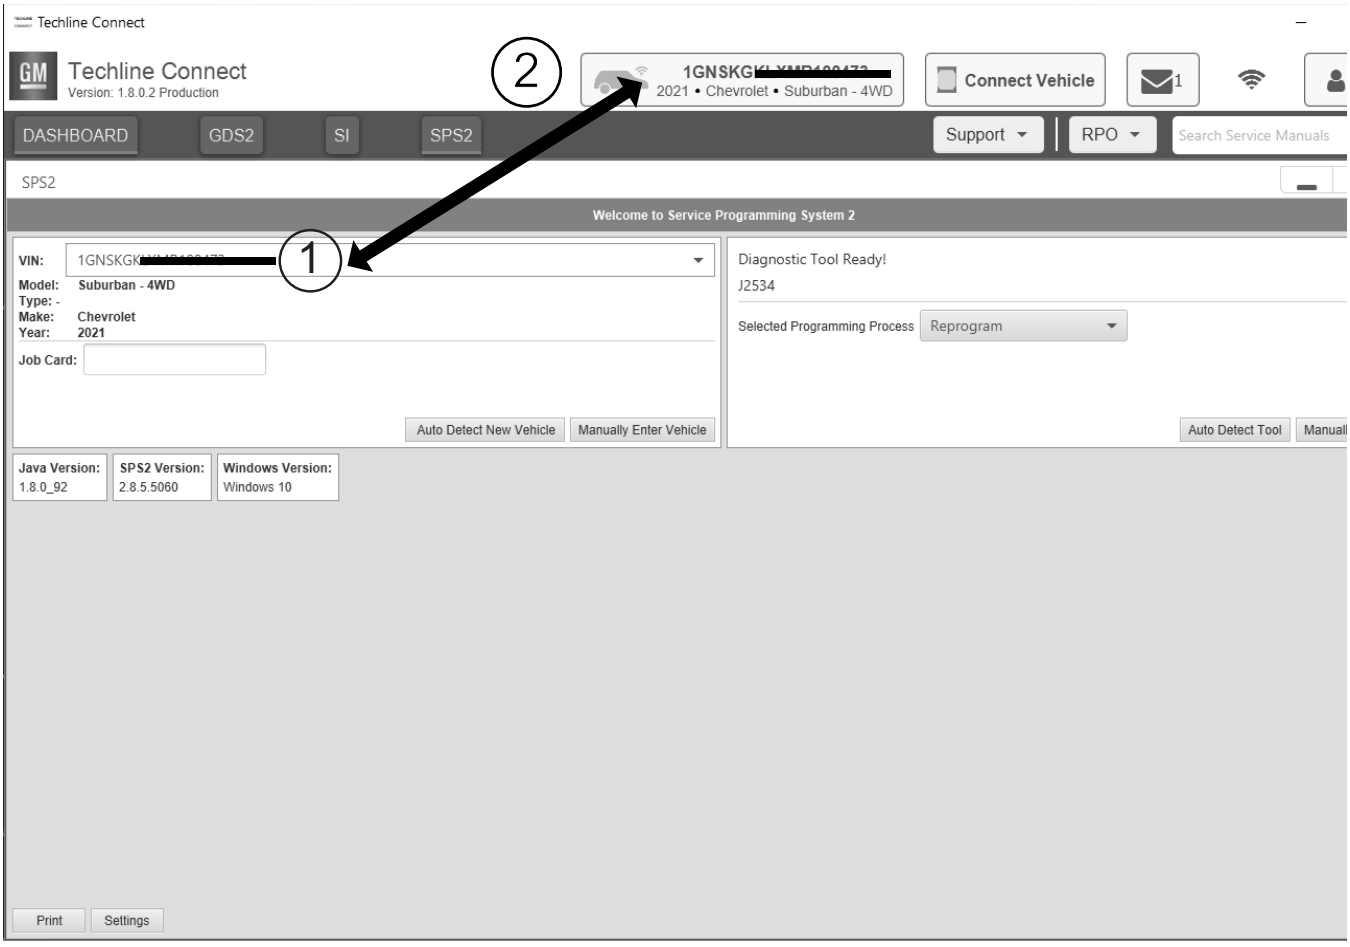
Caution: Be sure the VIN selected in the drop down menu (1) is the same as the vehicle connected (2) before beginning programming.

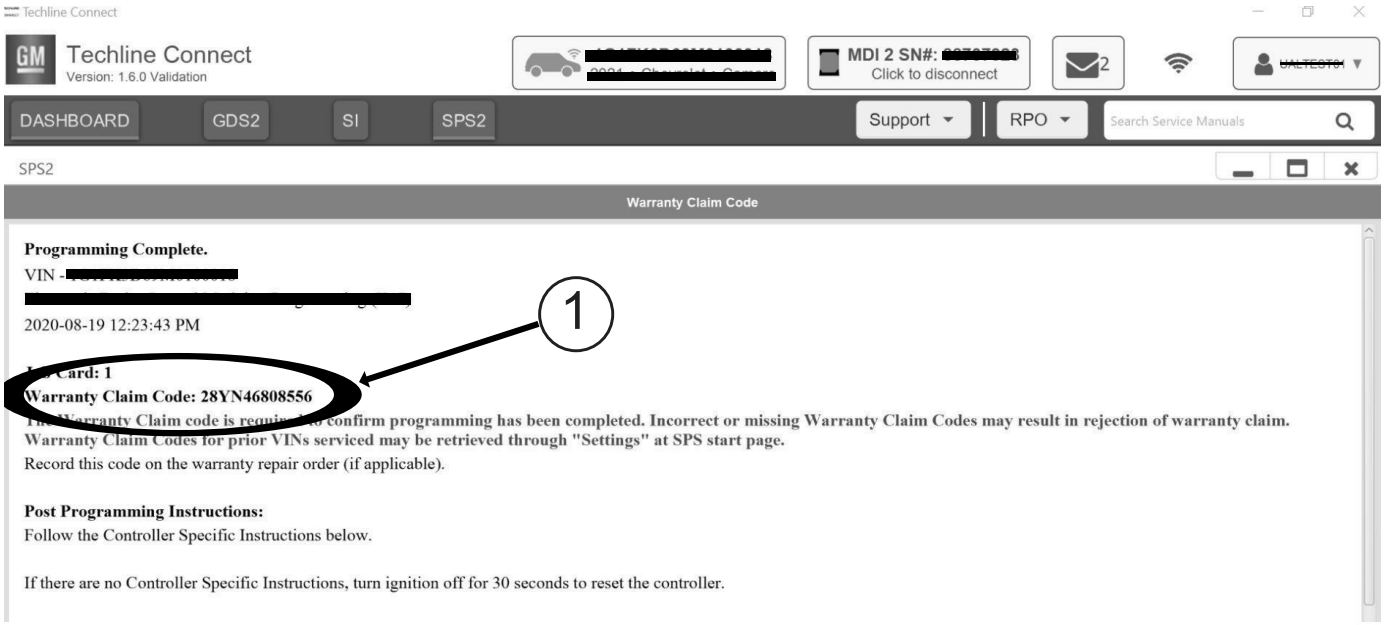
5644478

Note: The screenshot above is an example of module programming and may not be indicative of the specific module that is being programmed. Module selection and VIN information have been blacked out.

1. Reprogram the Engine Control Module. Refer to *K20 Engine Control Module: Programming and Setup*.
