Authored Date	19/11/2024	
Doc No.	IATSB003072v2	
Title	Split Door Seal - Replace	
Affected Vehicle(s)	Grenadier	RF019106 - RF019516
This Technical Service Bulletin (TSB) should only apply to vehicles that demonstrate the described issue below.

Split Door Seal - Replace

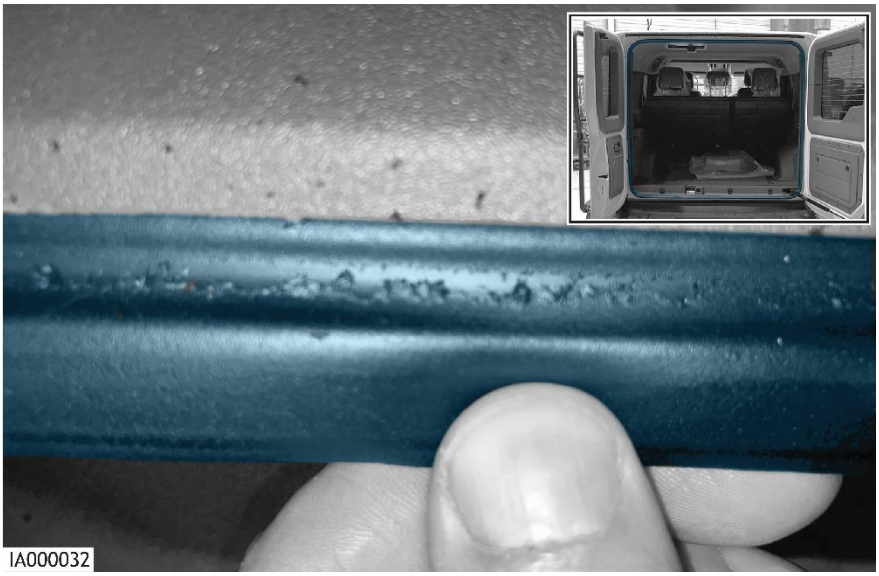
Issue: An issue has been identified on a small percentage of the affected vehicles where the Split Door Seal may have perished (See image below).

Cause: Manufacturing Issue.

1	Remove the Loading Space Entrance Trim. **Refer to: TOPIC_0000002691 Loadspace Entrance Trim (Remove for access and install)**
2	Note: Leave the arrester attached to the door, rest the end that was disconnected on the floor  Using a suitable tool, release the door arrester.
3	 Remove and discard the Split Door Seal.

4	Note: Make the surface is clean and free of any foreign objects Note: Do not stretch or compress the new door seal when installing. Install the new Split Door Seal.
5	Install the door arrester into its original position.
6	Install the Loading Space Entrance Trim. **Refer to: TOPIC_0000002691 Loadspace Entrance Trim (Remove for access and install)**
7	Release the vehicle.
