## M2 Plus Crew Cab Dome Light Not Activating With Rear Doors

***Field Service Solution SS 3153-FTL***

***Published Date: 09/13/24***

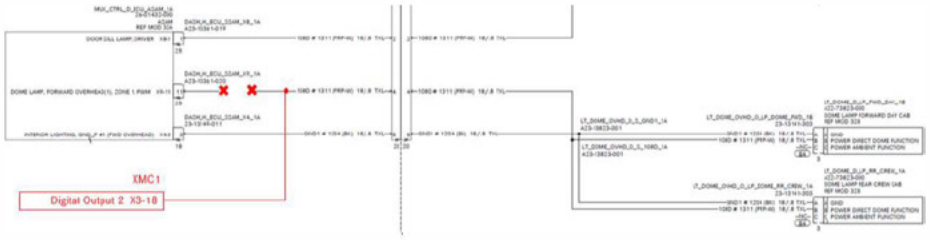
### Dash Wiring Changes

- The dome light in the cab does activate if either of the front doors are opened. The issue is only with the M2 Plus Crew Cab and the rear doors not activating the dome lamp when opened. This service solution **SS 3153-FTL** provides a fix using an XMC1 to route the signal to the dome lamp.

- Feature requirement not delivered/assigned to Body Controllers team for development. Not included in PVE test case.

**Reference:** G66-15211-001 (harness A66-15212)

**Note:** It should be OK to splice 108D circuit into existing TEM dome light output if XMC pin already populated for TEM connector. This output pin can supply enough current for multiple loads (20A) .
If a terminal is not present at X3-18 then use terminal P/N AI 1 968849 1 (23-13209-202) that will fit an 18 GA TXL wire. If for some reason a larger wire is used such as a 14 or 16 GA TXL wire, then use terminal P/N AI 1 968873 1 (23-13209-200).

- Published Service Solution **SS 3153-FTL** on **9/13/24** that provides technician guidance for modifying the wiring and adding programming to the XMC1 that corrects for the issue.
