STELLANTIS
PARTS & SERVICES

Technical Service Bulletin (TSB)

Flash: Electronic Vehicle Control Unit (EVCU) Updates 11A2

CAUSE:	**EVCU software update**

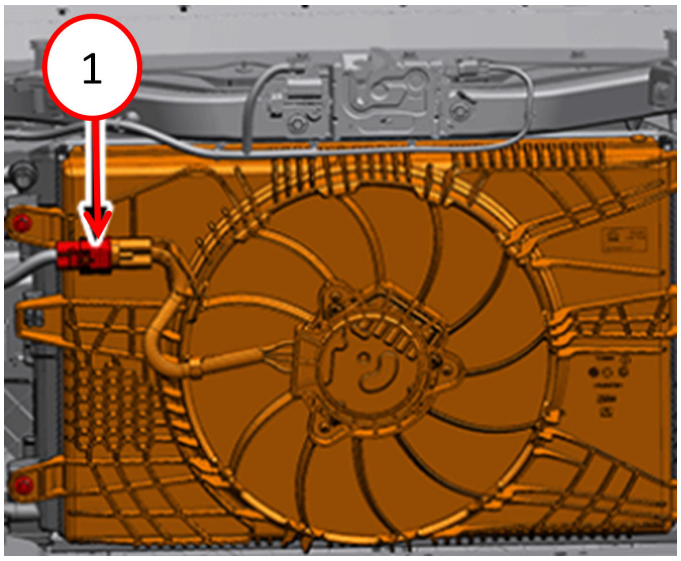
Fig. 1
Cooling Fan Assembly

NOTE: The cooling fan must be disconnected to prevent it from powering on, which may interrupt/ abort the flash process.

4. Disconnect the cooling fan wire harness connector Fig. 1.**

1 - Wire Harness To Disconnect/Connect

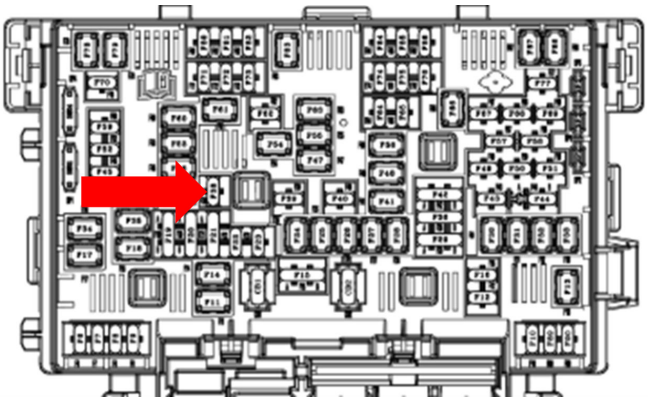
Fig. 3
#38 AGSM Fuse Location

CAUTION!
Failure to remove the #38 AGSM fuse will result in damage to the shifter.

6. Remove the PDC cover, locate and remove the #38 AGSM fuse Fig. 3.

NOTE: If the Wheel End Disconnect Position Learn routine is not successful, roll the vehicle slightly forward so that the wheel end disconnect actuators can align on the spline before attempting to perform the routine again.
16. Install the #38 AGSM fuse Fig. 3 and the PDC cover Fig. 2.
17. Position the rear carpet in place.
18. **Connect the cooling fan wire harness connector Fig. 1.
19. Install the front storage bin. Refer to the detailed service procedures available in DealerCONNECT/ ServiceLibrary under: Service Info> 23 - Body / Exterior / Bin, Storage / Installation.**
