SERVICE BULLETIN

L1025 2026-02-25

L1025: PRODUCT PROGRAM 1902 S2 ABS/EHCU MODULE CORRECTION

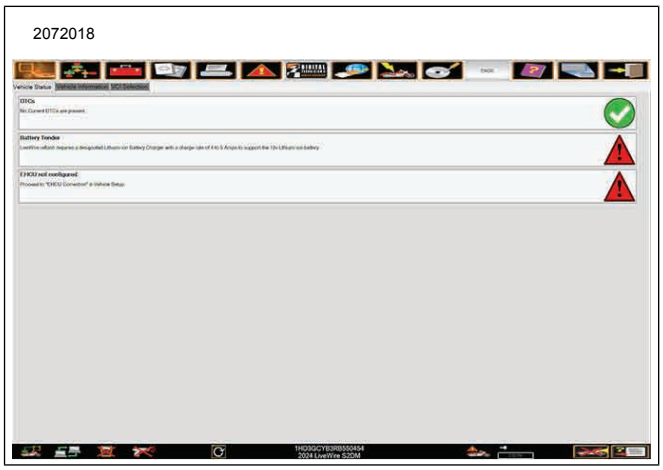
Figure 1. Not Configured

This bulletin informs dealers that the Anti-lock Braking System / Electro-Hydraulic Control Unit (ABS EHCU) module on some S2 Del Mar and Mulholland vehicles have a software configuration that prevents them from being unlocked. This prevents the ability to perform an ABS service bleed and software updates. It does not affect the operation of Anti-lock Braking System (ABS).

2. Connect DT II to the vehicle. The Vehicle Status screen will display that the EHCU is not configured. See Figure 1.

3. **Navigate:** Toolbox > Vehicle Setup.

a. Select ABS EHCU Correction.

b. Follow on screen instructions.
