HUSQVARNA TECHNICAL BULLETIN HTB2603 – USA

APRIL 2, 2026

RECALL - REMEDY NOTICE

E-THROTTLE ASSEMBLY REPLACEMENT

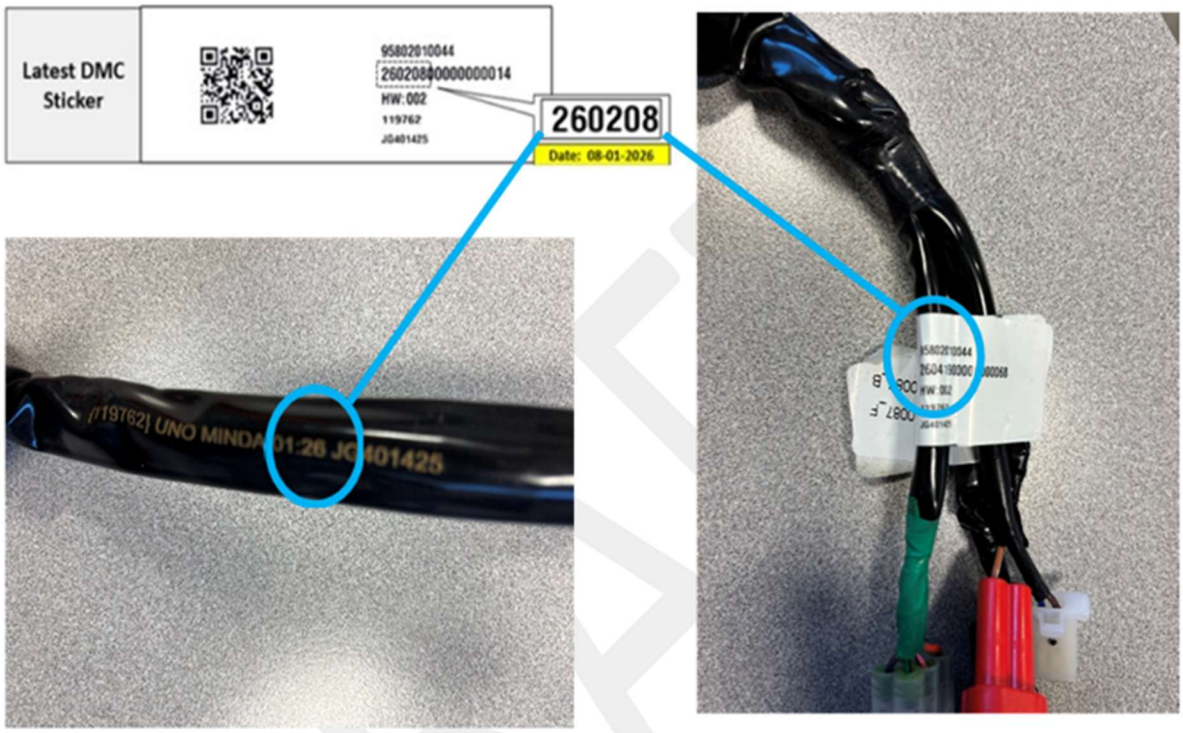
Figure 1 – DMC label on e-throttle wiring

Destroy the old part by cutting off the connector, attach a photo of the destroyed part to the warranty claim. Improved parts can be recognized at the label attached or printed to the wiring of the part (see fig.1). Use only parts with production date starting with 26 (see example in fig.1).
