STAR ONLINE PUBLICATION

Case Number: S2623000037

Symptom/Vehicle Issue: Condensation Or Water Infiltration In Headlights, Daytime Running Lights (DRL), Turn Signals, Fog Lights, Taillights.

2017-2026 Alfa Romeo Giulia (GA) 2018-2026 Alfa Romeo Stelvio (GU)

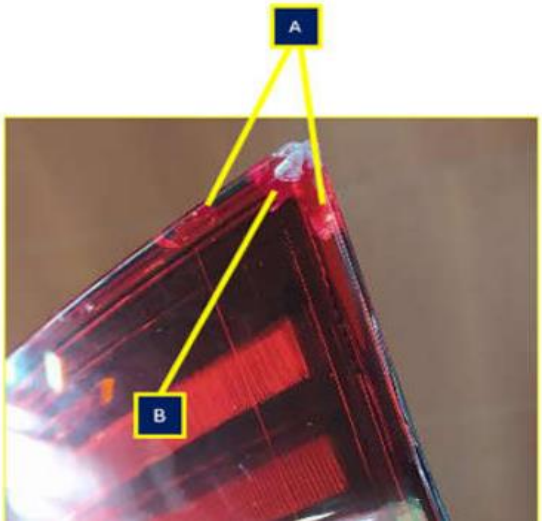
• The device must be examined beforehand for cracks on the outer surface of the lens and on the mating surface between the outer lens and the housing (welds) or cracks on the housing (black part).

If the cracks or breakages are due to external impact damage, the repair cannot be covered under warranty.

A - Cracked Welding Line
B - Impact in the corner

Fig. 1
Impact Damage To The Taillight

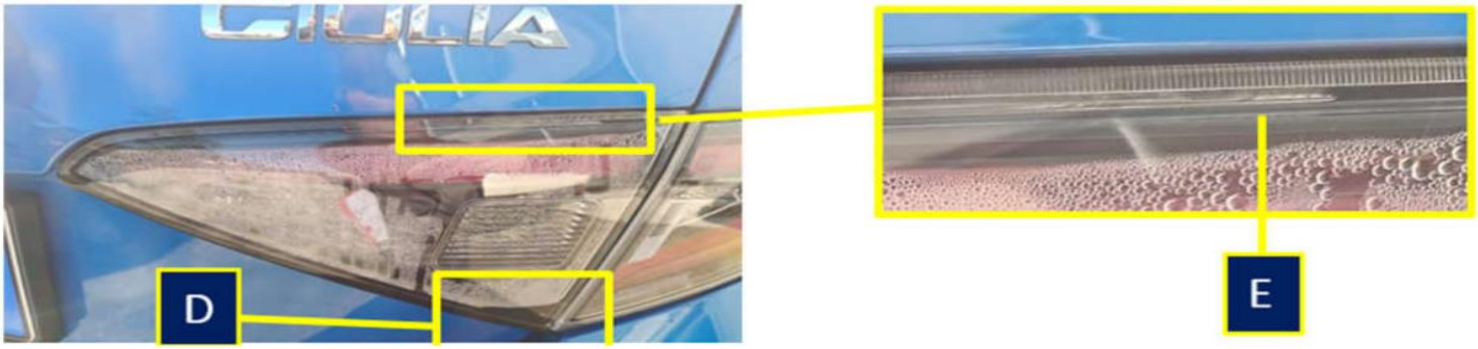
• The lamp assemblies are made of Acrylic. They are highly sensitive to the combined action of heat (intense solar radiation) and aggressive cleaning products used to clean the surface. Cleaning these components (especially when hot) with aggressive liquids can break the weld line between the lens and the lamp body, causing leaks and water ingress (see below for a description of this type of problem). Owner's manual provides guidance for care of exterior items (Fig. 2).

Fig. 3 - Water inlet due to breakage of the welding line. No signs of impact. “D” shows water puddling inside the lamp. “E” shows the root cause- cracked weld like. The welding line is black in color; once broken it becomes shiny / transparent
