MAS005253 RU 26-16

Rapid Update 833
Grecale – Fuel Vapor Filter Inspection

DATE: July 24, 2026

VEHICLES INVOLVED: (M182) Grecale MY26

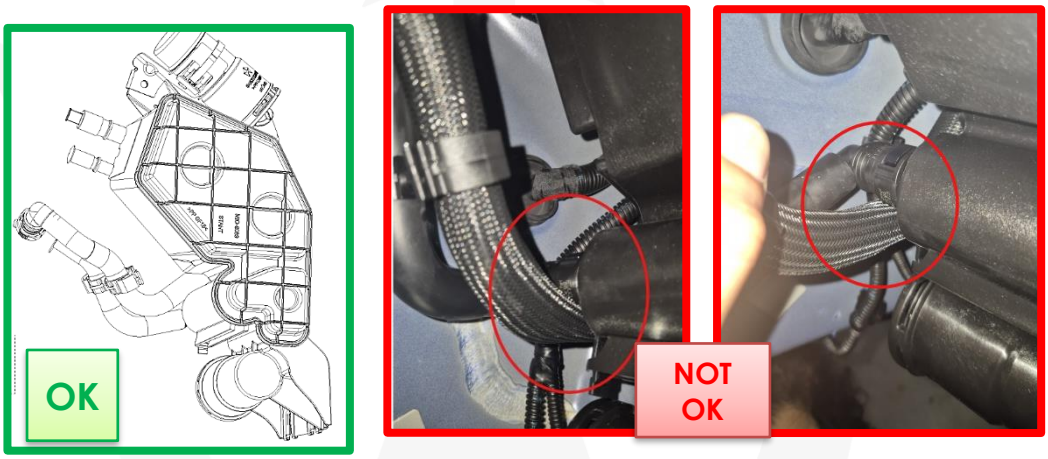
Description
On some vehicles, the fuel vapor filter may be positioned outside the specified routing, which may result in incorrect pipe orientation. If present, this condition may cause the pipes to become pinched and affect component operation. This preventive action is intended to verify the installation and, if necessary, restore the correct routing to help ensure proper system performance.

2. Locate the fuel vapor filter pipes and verify that they are correctly routed.

3. If any **non-compliance** is found, **restore** the correct pipe routing.

4. Remove the fuel vapor filter according to the Workshop Manual instructions.

5. Inspect the pipes for damage and **refit the same component** by reversing the removal sequence.
