STELLANTIS
PARTS & SERVICES

Technical Service Bulletin (TSB)

Incorrect Fuel Tank Installed

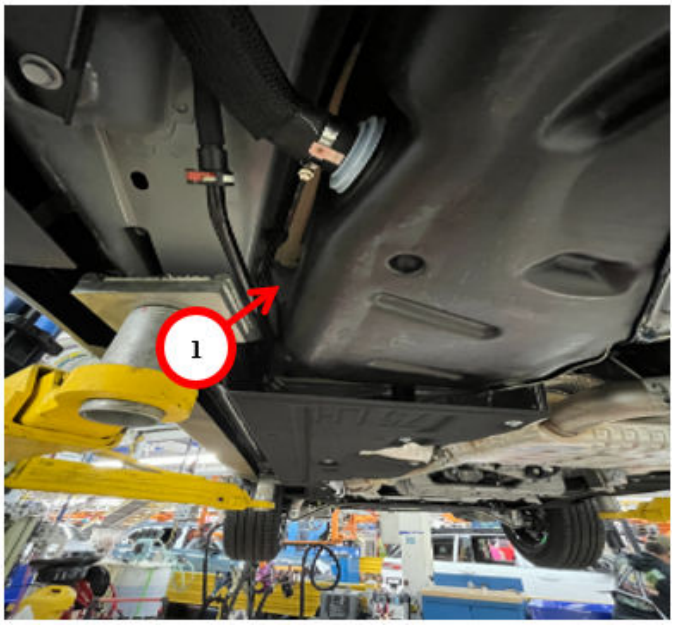
Fig. 2
Mirror Insertion Location For Inspection

3. Use a small inspection mirror to place above the left most end of the fuel tank Fig. 2 Fig. 3.

1 - Inspection Location

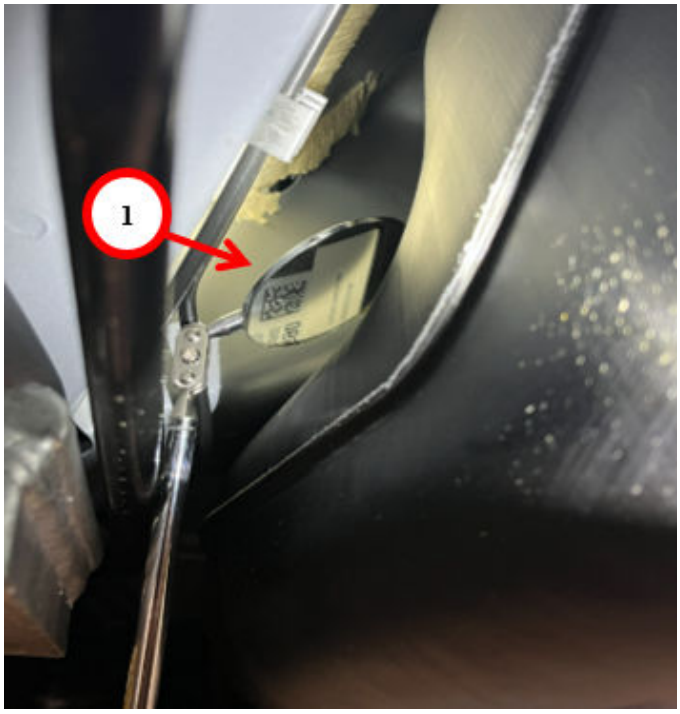
Fig. 3
Mirror Capturing Parts Label On Fuel Tank

1 - Parts Label Location

4. Use adequate lighting and take photo of the mirrored label (two people required) Fig. 3.
5. Check the photo taken for clarity and flip photo to correct the label direction Fig. 4.

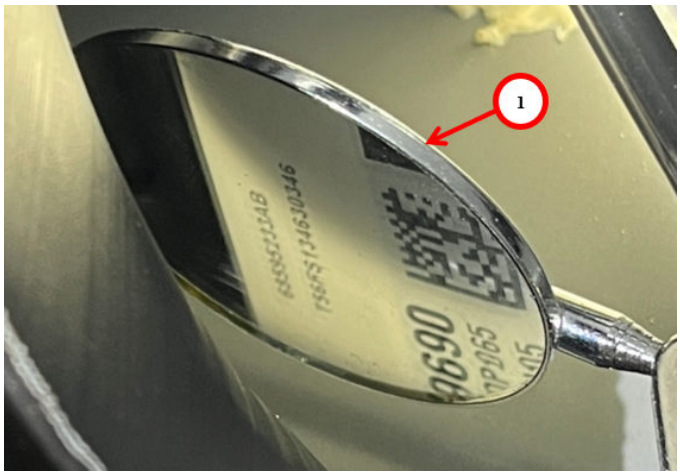
Fig. 4
Camera Image Flipped

1 - Part Label Image Capture

6. Is the fuel tank part number 68595233AA or 68595233AB?
   - YES>>> This bulletin has been completed. Use Inspection LOP (14-50-01-92) to close the active RSU.
   - NO>>> Proceed to Step 7.
7. Replace the fuel pump. Refer to the detailed service procedures available in DealerCONNECT/Service Library under: Service Info> 09 - Engine, 2.0L / Fuel System / Modules / Removal and Installation.
8. Clear DTCs.
