Technical Service Bulletin Transaction No.: **2082144/3**

90 Panoramic display: MMI display shows vertical lines Release date: Sep 2, 2026

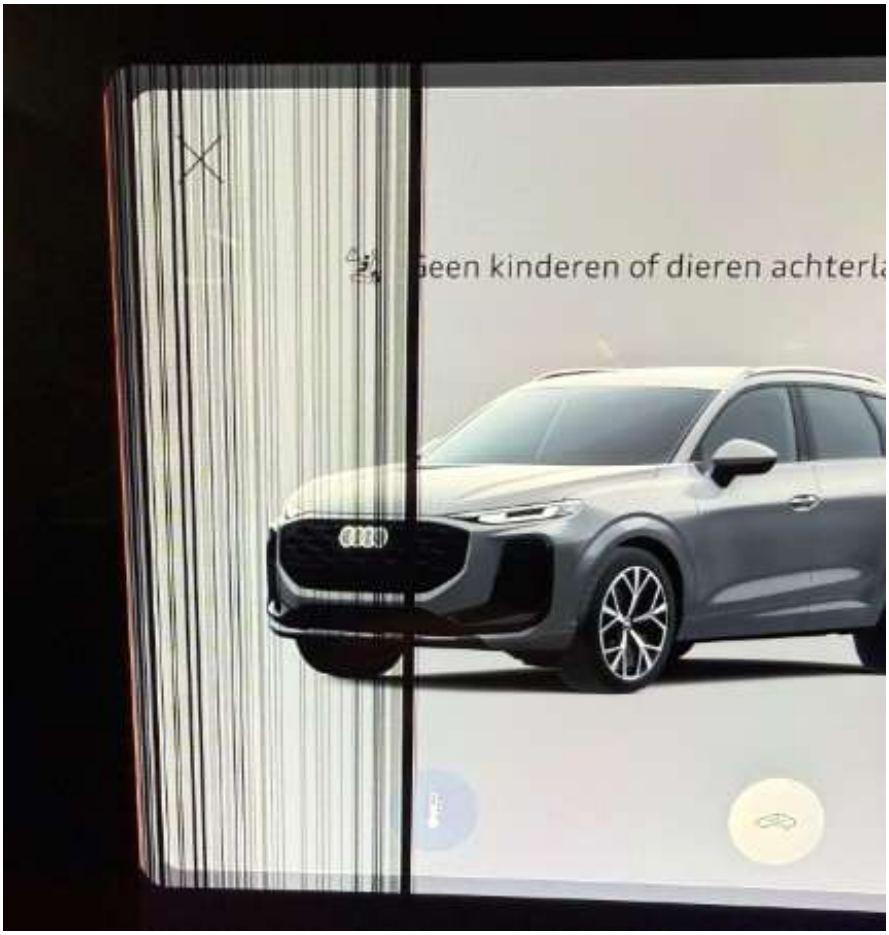
The panoramic display shows vertical lines on the central MMI display (this is the display on the right on left-hand-drive vehicles).

Figure 1. *Example of complaint.*

Figure 2. *Example of complaint.*

Figure 3. *Example of complaint.*

Hardware issue in the panoramic display.

If the production date read out is **BEFORE** 07/22/2026, this TSB applies and the panoramic display must be replaced.
