STELLANTIS
PARTS & SERVICES

Technical Service Bulletin (TSB)

Coolant Leak From Obstructed Reservoir Duct

REFERENCE:	**TSB:** 07-008-26 **GROUP:** 07 - Cooling	Date:	October 22, 2026	REVISION:	—

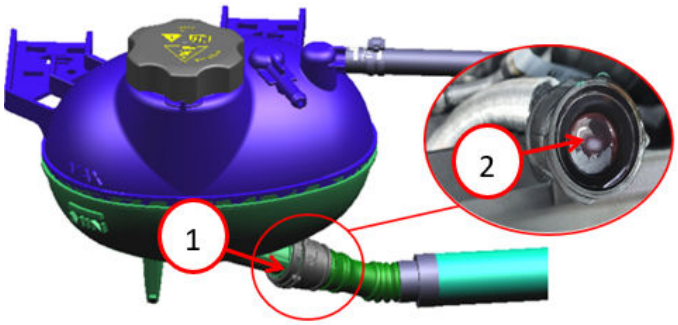
Fig. 4
Protective Plug

CUSTOMER SYMPTOM:	**Customers may experience one or more of the following:** • Coolant is leaking. • Vehicle is overheating.
CAUSE:	**The protective plug on the primary tank duct was not removed during the assembly process, blocking coolant flow**

6. Using special tool **Snap-on Vacuum Device (EQ-10353145)**, remove the coolant from the coolant recovery bottle.
7. Disconnect the quick connector from the coolant recovery bottle and remove the protective plug Fig. 4.

8. Connect the quick connector to the coolant recovery bottle.
9. Fill the coolant recovery bottle as required.
10. Install the coolant recovery bottle cap.
11. Close the hood.
