Technical product information

Topic	A Post Tweeter Vibration
Market area	Bentley: worldwide (2WBE),China 796 VW Import Comp. Ltd (Vico), Beijing (6796)
Brand	Bentley
Transaction No.	2083504/1
Level	EH
Status	Approval
Release date

Continental GT/C & Flying Spur | 20-27MY

A Post Tweeter Vibration

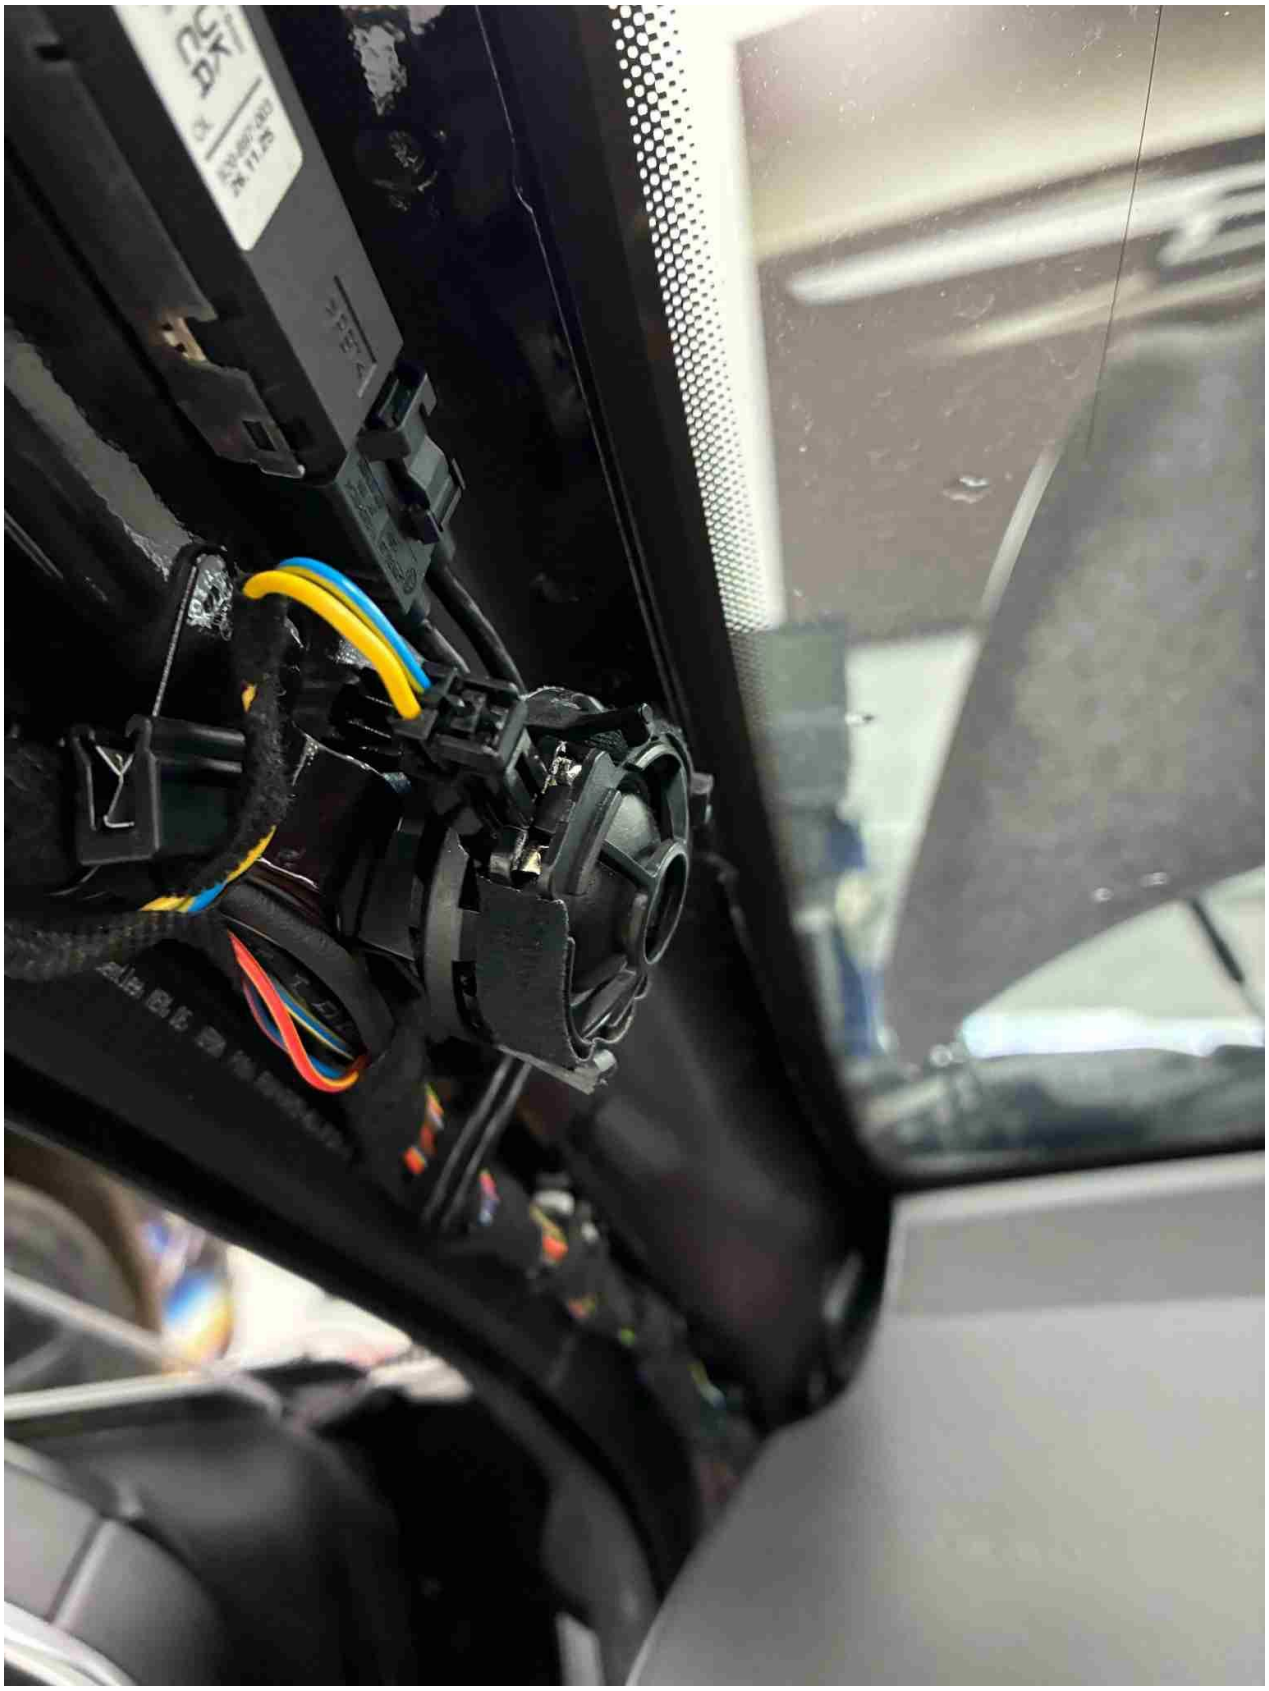
Some Continental GT/C & Flying Spur vehicles fitted with the Naim speaker audio system may exhibit vibrations in the speaker/s located in the A-post/s.

This is due speaker vibrating off the bracket securing it within the A-post.

4. Apply anti-creak tape around the outer shell of the speaker, as shown below:

5. Refit the speaker into the A-post, ensuring the connector and the speaker is secured. Shown below:
