Topic	Software Update | Window Short Drop Deletion | Continental GTC | 27MY (SC26/18)
Market area	Australia E04 Bentley rest Asia and Australia (6E04),China 796 VW Import Comp. Ltd (Vico), Beijing (6796),Germany E02 Bentley rest Europe (6E02),India 938 Indien; SKODA AUTO Volkswagen India (6938),Japan E03 Bentley Japan (6E03),United Arab Emirates E06 Bentley Middle East and Africa (6E06),United Kingdom E01 Bentley UK (6E01),United States E05 Bentley USA and rest America (6E05)
Brand	Bentley
Transaction No.	2082801/8
Campaign number	ED97
Note	
Type	
US code

Software Update | Window Short Drop Deletion | Continental GTC | 27MY (SC26 /18)

ED97
Retailer Glass Measurement Procedure for GTC
BY635

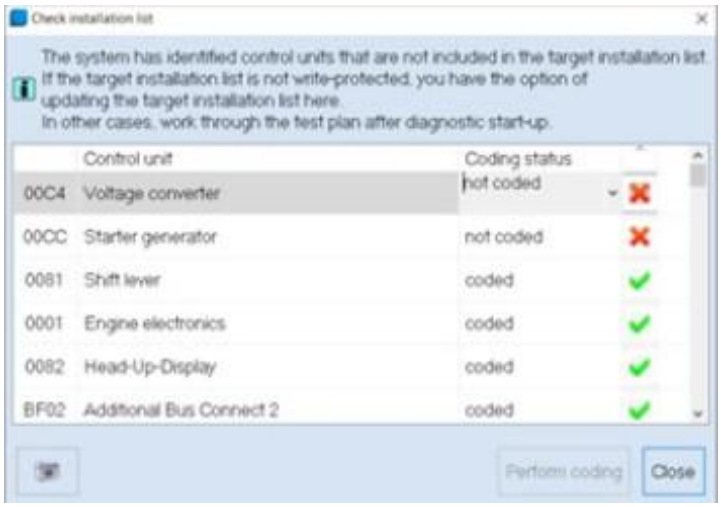
Figure 1

If a ‘Check installation list’ pop-up appears, select ‘close’ (Figure 1)

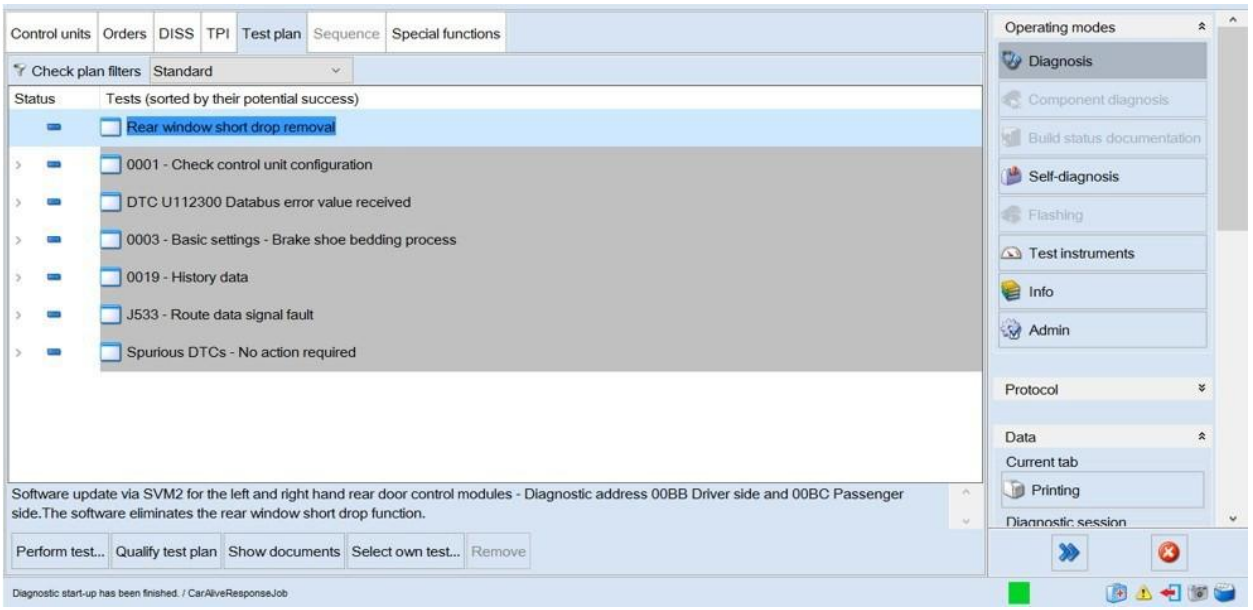
Figure 2

If the short drop function is still active on the vehicle a test plan called 'Rear Window Short Drop Removal' will automatically be generated within test plan.

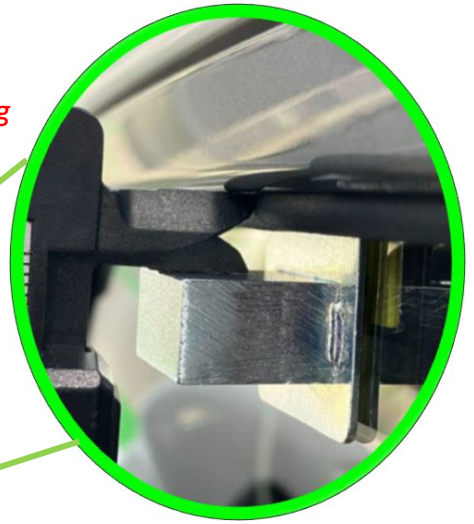
INTERLOCK POINT 1

Place block 50mm in front of front div bar

Record measurement for all interlock points

From block to bright ware for all interlock points

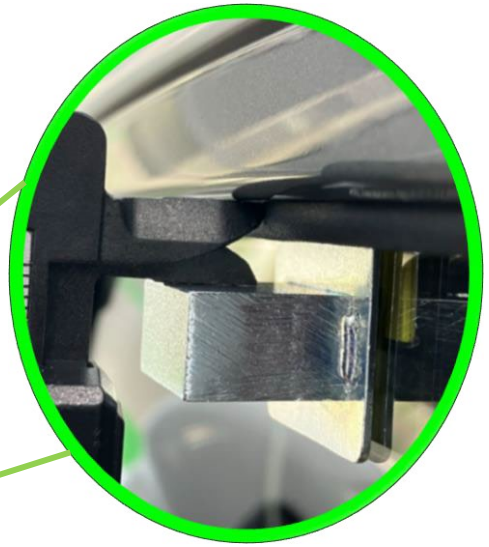
INTERLOCK POINT 2

Place block 100mm behind front div bar

Record measurement for all interlock points

From block to bright ware for all interlock points

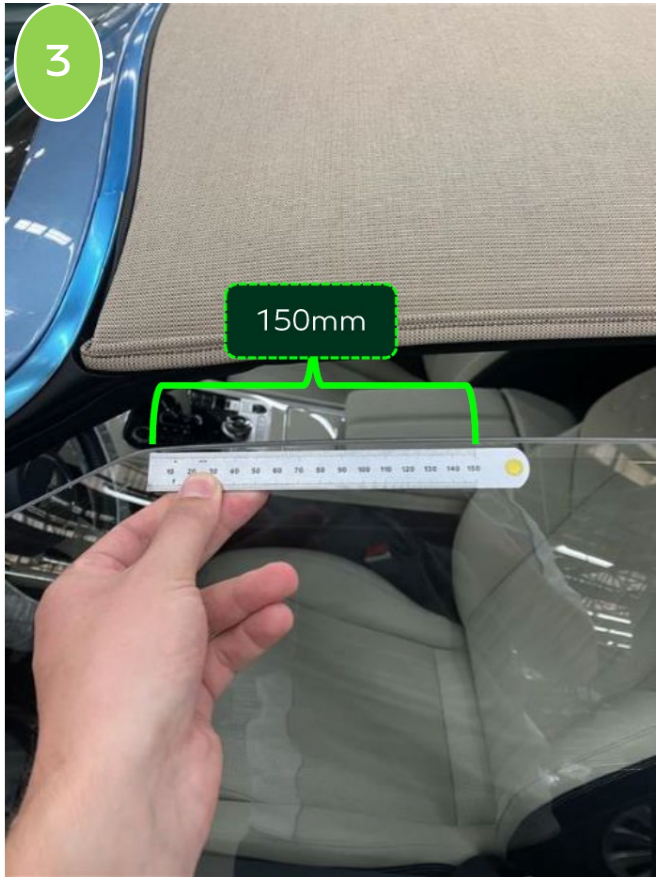
INTERLOCK POINT 3

150mm from front corner of window glass as shown

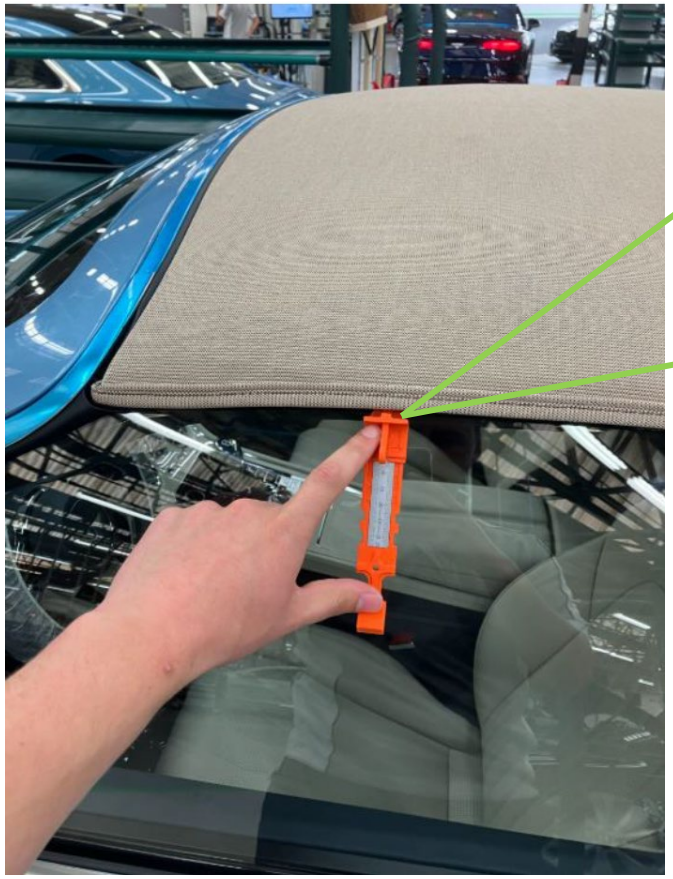
1. Hook onto glass with door open at measured point
2. Close door and allow glass to close
3. Lightly push gauge to top and take measurement at indicated point. Do not deform the seal.

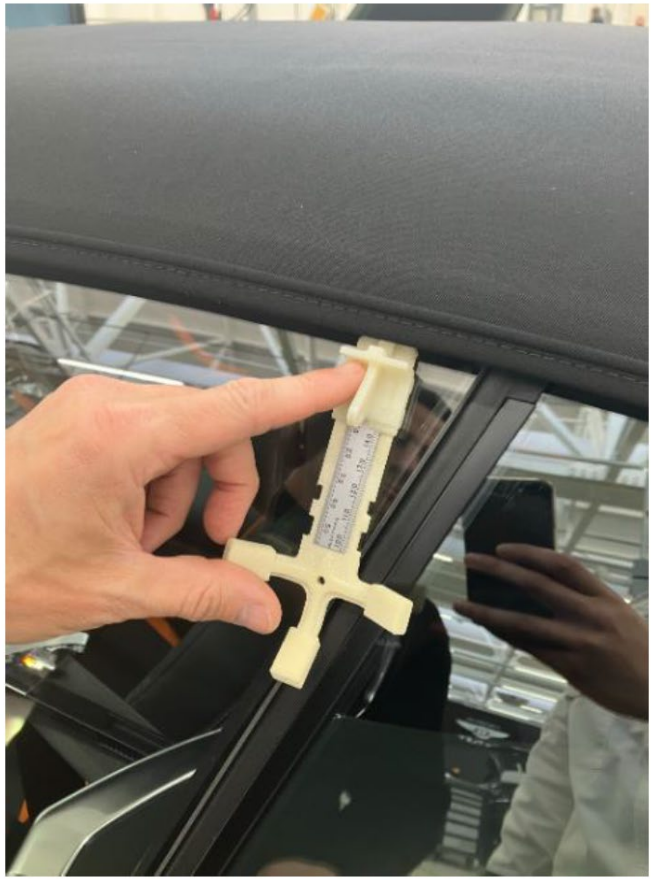
INTERLOCK POINT 4

50mm from rear edge of the front door glass as shown

1. Hook onto glass with door open at measured point
2. Close door and allow glass to close
3. Lightly push gauge to top and take measurement at indicated point. Do not deform the seal.

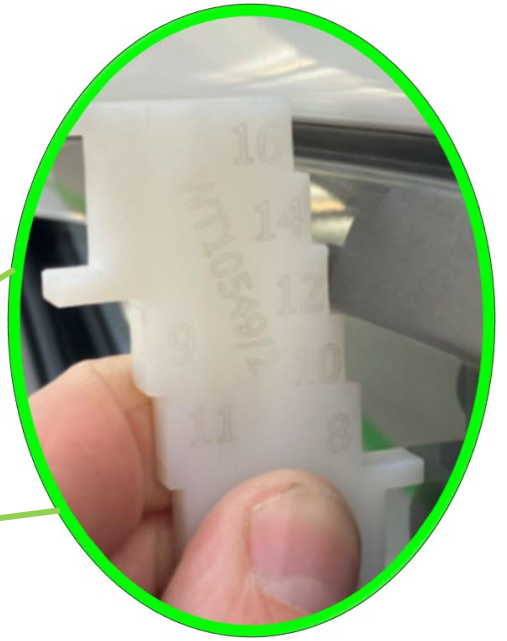
PROFILE POINT 1

50mm in front of front div bar

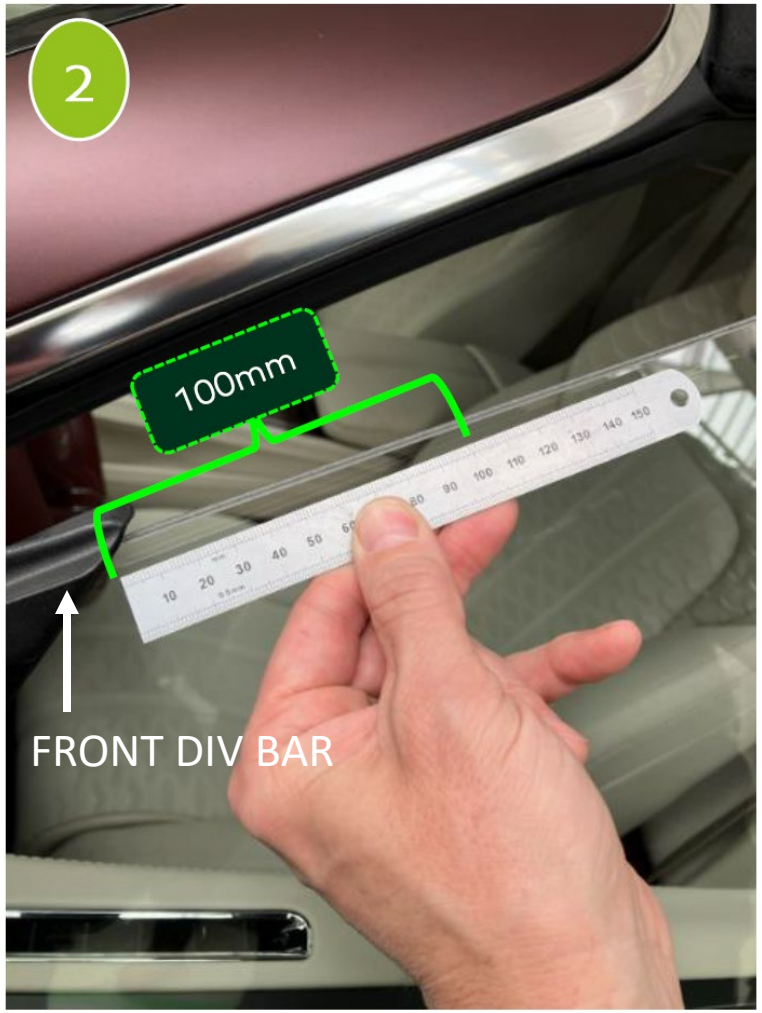
PROFILE POINT 2

Place block 100mm in front of front div bar
