DOT Auto Safety Hotline  
**Vehicle Owner's Questionnaire**  
To Report Vehicle Safety Defects  
1-888-DASH-2-DOT  
(1-888-327-4236)  
INTERNET: www.nhtsa.dot.gov/hotline

17 digit Vehicle Identification Number (located in front of windshield on driver's side) **1J4GW58S0AC723830** Make **JEEP** Model **GRAND CHEROKEE** Model Year **1999**  
Date Purchased **10/2000** Dealer's Name and Telephone Number **Ed Schmidt 419-874-4331** Engine: **4.0** Fuel Type: **Unleaded**  
Original Owner  Dealer's City **Perrysburg** State **OH** Zip Code **43051** No. Cylinders  
Transmission Type **Automatic**  Anti-lock Brakes Powertrain  Cruise Control Vehicle Component Code **063200 ENGINE AND ENGINE COOLING:EXHAUST SYSTEM:MANIFOLD**  
Multiple Failure: 1

RE: Complaint letter sent to Daimler Chrysler  
(Revised letter-original dated February 24, 2003)

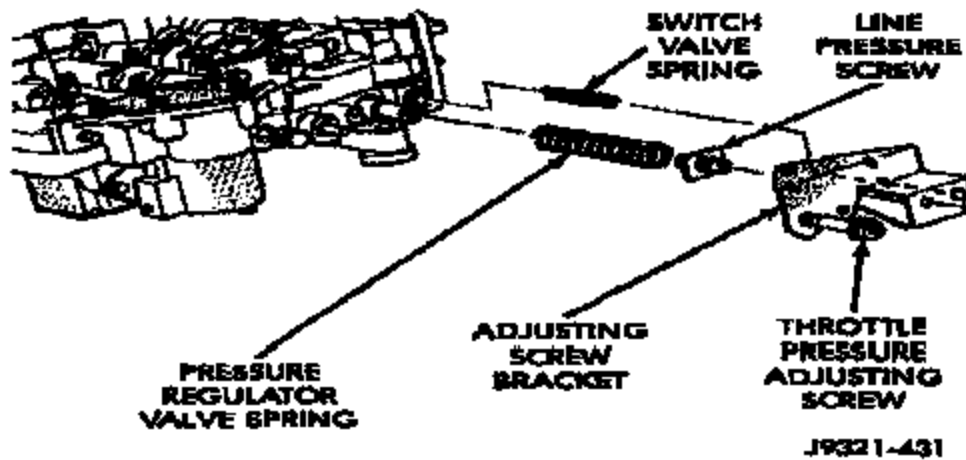
**FIGURE 1**

If a buzz/roaring/whirring like noise is present, perform the Repair Procedure.

1. Remove the screws holding the adjusting screw bracket and replace the regulator valve with p/n 04130169 (Figure 1). Install the adjusting screw bracket.

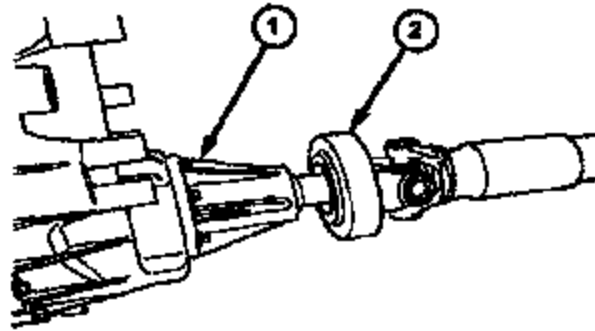
**Fig. 1 DAMPER LOCATION**

SYMPTOM/CONDITION:  
Customer may complain of a high-pitched sound coming from the rear of the vehicle between 55 and 70 MPH (88 - 112 KPH)

DIAGNOSIS:  
If the customer complains of the condition, and the damper is not present, perform the repair.

**NOTE: 52099485AF IS TO BE USED EXCLUSIVELY FOR THIS SERVICE BULLETIN (WITH NV247 w/M35 REAR AXLE). USE 52099485AE FOR ALL OTHER PROPELLER SHAFT REPAIRS NOT RELATED TO THIS BULLETIN (WITH NV247 w/M35 REAR AXLE).**
