DOT Auto Safety Hotline  
**Vehicle Owner's Questionnaire**  
To Report Vehicle Safety Defects  
1-888-DASH-2-DOT  
(1-888-327-4236)  
INTERNET: www.nhtsa.dot.gov/hotline

CONSUMER STATED BRAKING SYSTEM OPERATED POORLY. HAD VEHICLE INSPECTED, AND DISCOVERED THAT ALL FOUR REAR WHEELS BRAKE ASSEMBLY WAS CRACKED. ELEVEN FAILURES WERE REPORTED WITH DEALER WITHIN 22 MONTHS. \*AK

November 14, 2003

This letter and the attached enclosures augment the Vehicle Owner's Questionnaire from your office to bring attention to the serious problem of defective brake assemblies. Specifically these are the S cam Brake assemblies installed on the tri axle truck of my client; and common to other trucks with the same rear axle assemblies.

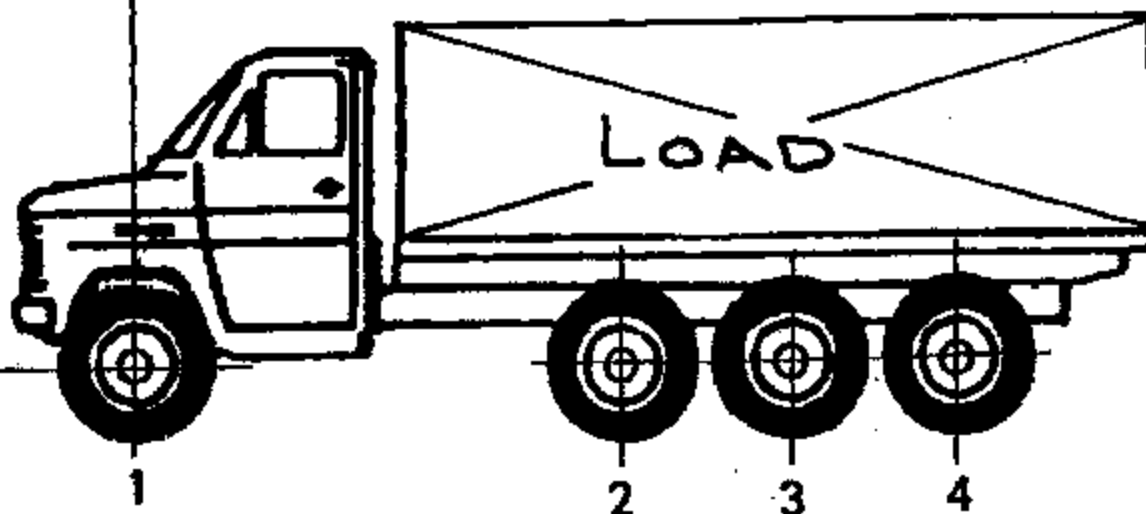
Note braking takes place at the wheels of the dual axles #3 and #4 as is the case for the Wardell Peterbilt 379 model with dump body.

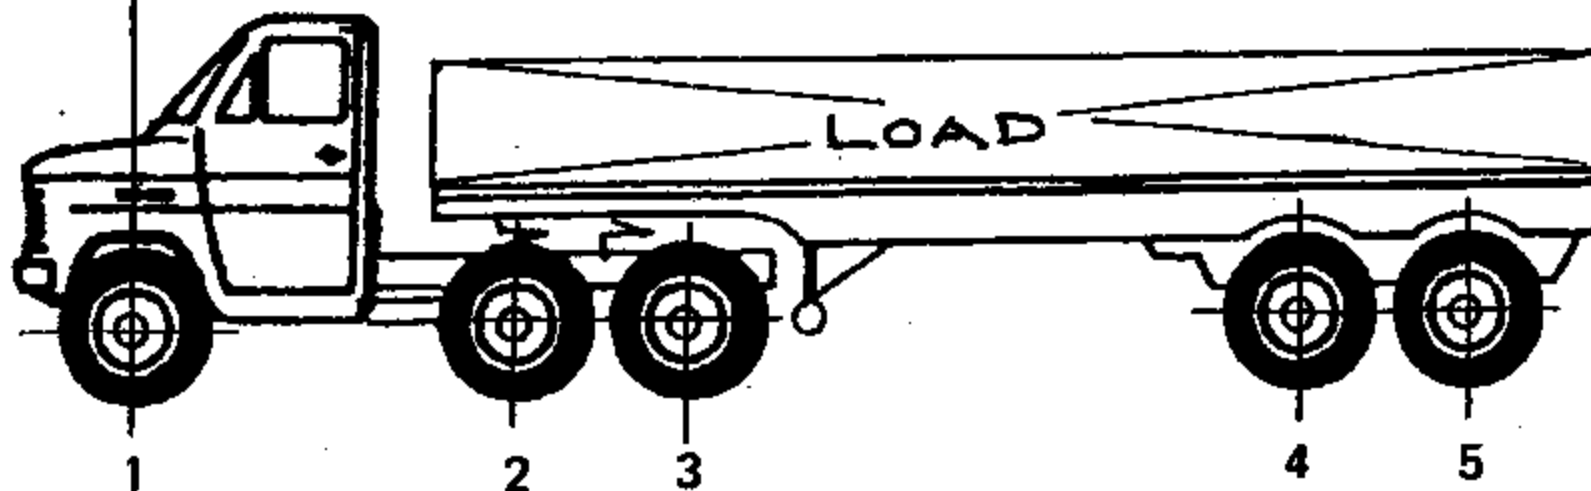
Note braking with same load as the dump truck carries is now taking place over the dual axles #2 and #3 of the truck plus trailer's #4 and #5.

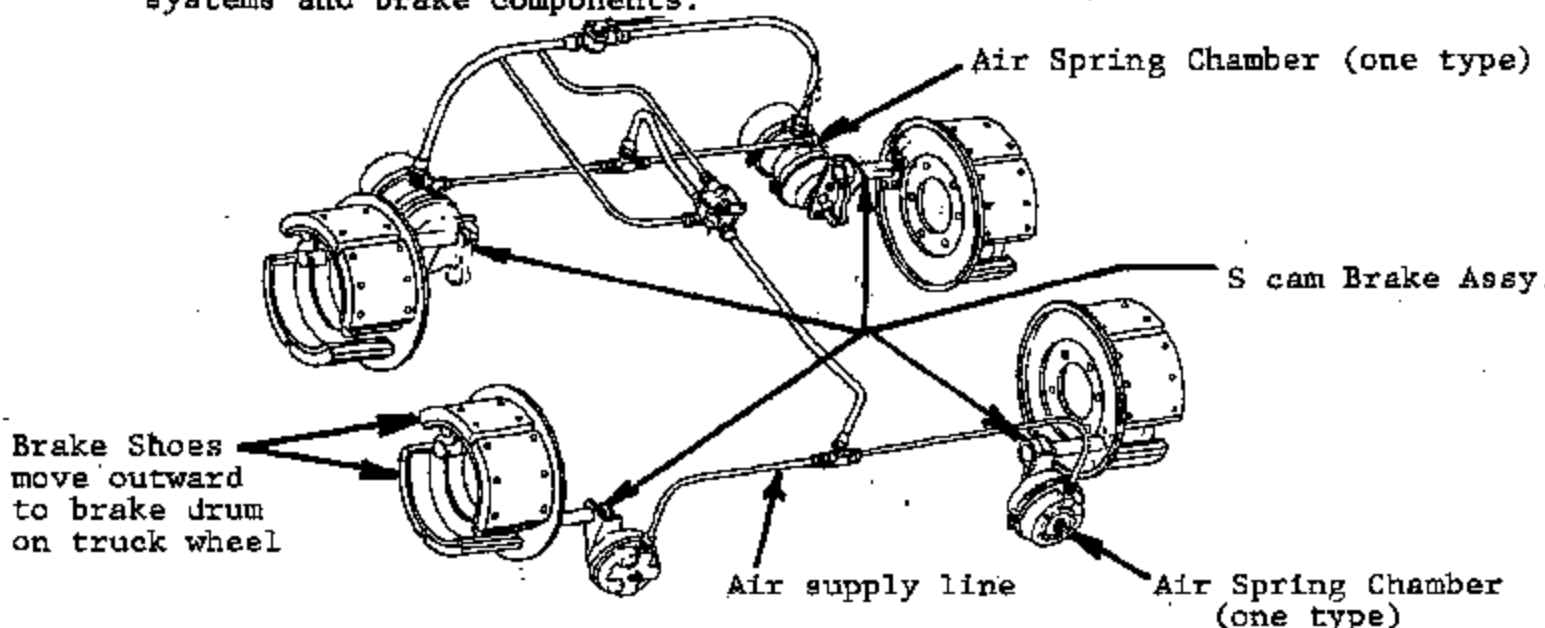
The drawing below was taken out of the sales catalog of Wagner Electric Corp., an original equipment manufacturer of brake systems and brake components.
