## ODI RESUME

INVESTIGATION: EA99-021

SUBJECT: Alleged Parking Brake Malfunction

## ENGINEERING ANALYSIS CLOSING REPORT

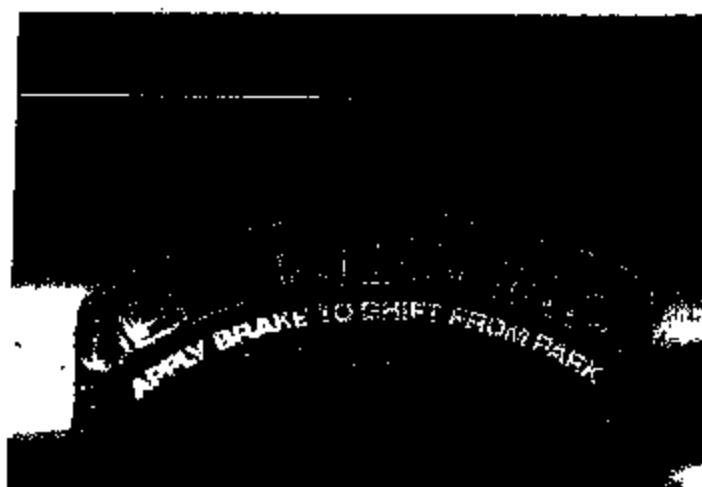
Figure 4

The steering column mounted gear shift lever does have a marked position ("P") for park (Figure 4). When the gear shift lever is moved into this position, as there is no mechanical park pawl in the transmission, the "Auto-Park" system is activated. The Auto-Park system consists of a brake drum that is mounted around the drive-shaft of the vehicle and a set of brake shoes that are held in the applied position by a cable that is pulled by a large spring located inside the brake activator. This "spring brake" system is very similar to the spring brakes used on the trailers of 18 wheel tractor/trailer trucks. Many drivers of motor homes are apparently not familiar with the operation of spring brake systems. Traditional parking brakes on passenger cars require the driver to apply pressure to the hand or foot
