# ODI RESUME

INVESTIGATION: EA99-021  
SUBJECT: Alleged Parking Brake Malfunction  
PROMPTED BY: PE99-006  
PRINCIPAL ENGINEER: June 97- Feb 01, Bob Young; Feb 01 - June 01, S. B. York

## ENGINEERING ANALYSIS CLOSING REPORT

**SUBJECT:** 1995 - 1998 General Motors P-3 Motorhome Chassis with the J71 "Auto-Park"

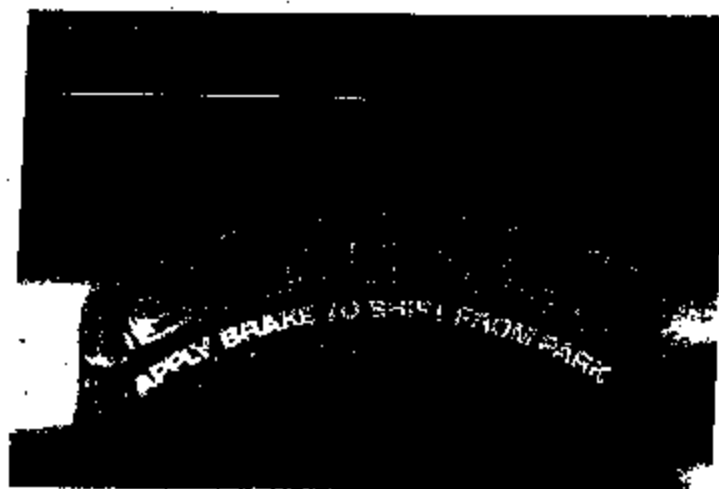
Figure 4

The steering column mounted gear shift lever does have a marked position ("P") for park (Figure 4). When the gear shift lever is moved into this position, as there is no mechanical park pawl in the transmission, the "Auto-Park" system is activated. The Auto-Park system consists of a brake drum that is mounted around the drive-shaft of the vehicle and a set of brake shoes that are held in the applied position by a cable that is pulled by a large spring located inside the brake activator. This "spring brake" system is very similar to the spring brakes used on the trailers of 18 wheel tractor/trailer trucks. Many drivers of motor homes are apparently not familiar with the operation of spring brake systems. Traditional parking brakes on passenger cars require the driver to apply pressure to the hand or foot
