DOT Auto Safety Hotline  
**Vehicle Owner's Questionnaire**  
To Report Vehicle Safety Defects  
1-888-DASH-2-DOT  
(1-888-327-4236)  
INTERNET: www.nhtsa.dot.gov/hotline

JAYCO

DESIGNER

WELD DISCONNECTED FROM THE FRAME OF THE TRAILER WHILE DRIVING. MANUFACTURER WAS CONTACTED. \*AK

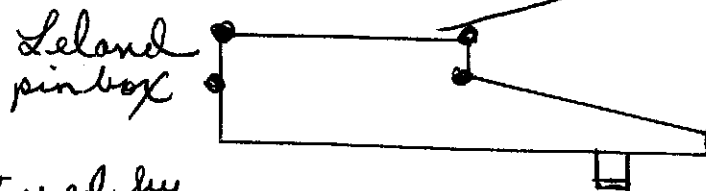
Sketch of Jayco Designer model 3230, year 2000  
5th wheel trailer front frame structure where  
pinbox is welded.

A - This "C" channel beam bent upwards and was replaced with a stronger closed beam by Austin Enterprises

B - This "C" channel beam was re-inforced by Austin Enterprises

C - Right and Left support beams were replaced by Austin Enterprises
