RE: General Motors Corporate

File # 200120385

Bulletin No.: 02-08-61-001

Bulletin No.: 01-02-32-001B

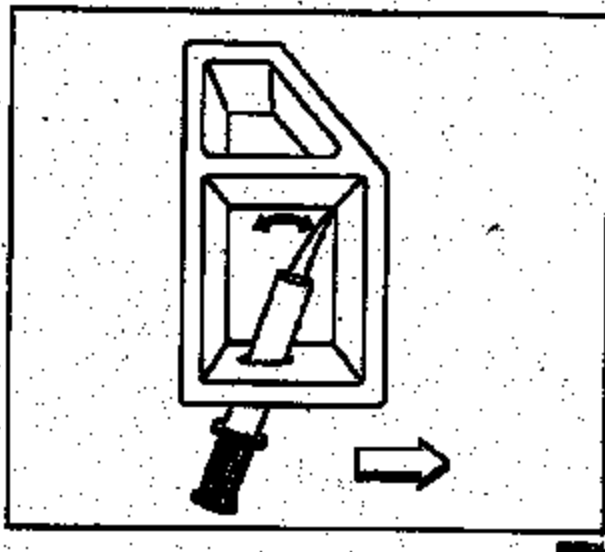
Some owners may comment about a clicking/creaking type noise coming from the front of the vehicle. This noise condition is most apparent during stationary or low speed turning maneuvers and may be audible from outside the vehicle and/or in the vehicle passenger compartment.

This condition maybe the result of small relative movement between the contacting surfaces of various brackets, crossmembers and side rails that are welded together to form the frame/cradle assembly. This slight movement occurs when the assembly is subjected to certain types of load conditions and in some instances may cause a clicking/creaking type noise. The specific areas/contact points on the frame assembly that may cause this condition are indicated below:

- ^ Steering gear brackets to rear crossmember
- ^ Right/left rear body mount bracket to rear crossmember and right/left side rails

Apply penetrating grade threadlocker using the 12 ml syringe applicator as shown provided in J45960, Frame Noise Service Kit, to the locations on the frame assembly and in the manner indicated in the service procedure below. When applying material, it should be flowed onto the designated surfaces or into the designated points in such a manner to ensure adequate and complete coverage. On both horizontal and vertical welds, the threadlocker material should be applied in such a manner that the material flows down over the welds. Care must be taken to ensure that material has been applied to the ends of each of the welds. The technician must ensure that the areas/surfaces indicated are properly covered. To minimize material waste, utilize a small clean container/pan to catch dripping material for reuse. During application

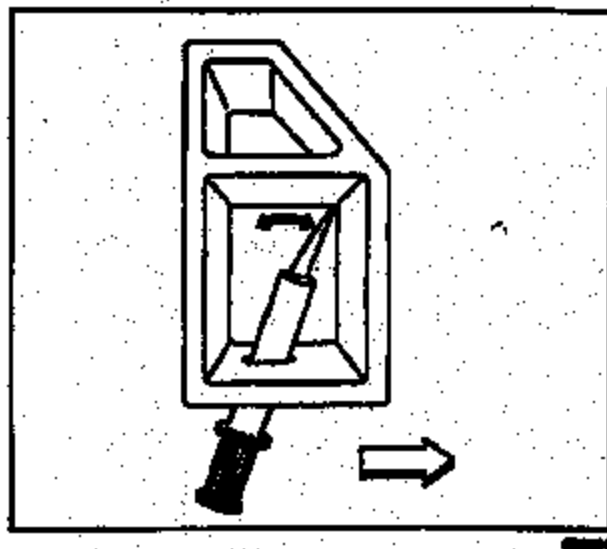
Some owners may comment about a clicking/creaking type noise coming from the front of the vehicle. This noise condition is most apparent during stationary or low speed turning maneuvers and may be audible from outside the vehicle and/or in the vehicle passenger compartment.

This condition maybe the result of small relative movement between the contacting surfaces of various brackets, crossmembers and side rails that are welded together to form the frame/cradle assembly. This slight movement occurs when the assembly is subjected in certain types of load conditions and in some instances may cause a clicking/creaking type noise. The specific areas/contact points on the frame assembly that may cause this condition are indicated below:

- ^ Steering gear brackets to rear crossmember
- ^ Right/left rear body mount bracket to rear crossmember and right/left side rails

Apply penetrating grade threadlocker using the 12 ml syringe applicator as shown provided in J45960, Frame Noise Service Kit, to the locations on the frame assembly and in the manner indicated in the service procedure below. When applying material, it should be flowed onto the designated surfaces or into the designated points in such a manner to ensure adequate and complete coverage. On both horizontal and vertical welds, the threadlocker material should be applied in such a manner that the material flows down over the welds. Care must be taken to ensure that material has been applied to the ends of each of the welds. The technician must ensure that the areas/surfaces indicated are properly covered. To minimize material waste, utilize a small clean container/pan to catch dripping material for reuse. During application

of material, technicians should wear appropriate eye and hand protection.
