### Recall Detail

| Subject: VW/FRONT CONTROL ARM BRACKET | | Remedy Type: | RF Num: | FMVSS Num: |

**Subject: 1998-2000 Model Year Volkswagen Passat Vehicles  
Check/Replace Front Suspension Lower Control Arms**

**Subject: Service Action VM  
1996-2000 Model Year Volkswagen Passat Vehicles  
Check/Replace Front Suspension Lower Control Arms**

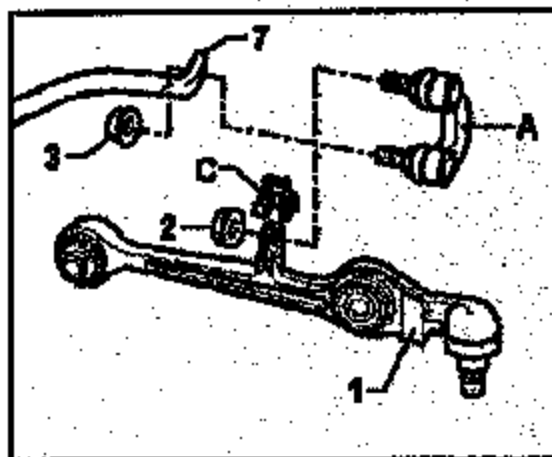
**IMPORTANT!** This illustration shows link -A- with ball joints and is on most vehicles up to vehicle identification number (VIN) 3B\_X\_213726

Clamp -C- must be reinstalled with link that has ball joints

- ⇐ If vehicle has link -A- with ball joints between control arm -1- and stabilizer bar -7-, reinstall link, clamp -C- and new nuts -2- & -3- (N 102 881 02)

- ⇐ Tighten nuts -2- & -3- to 100 Nm (74 ft. lbs.)

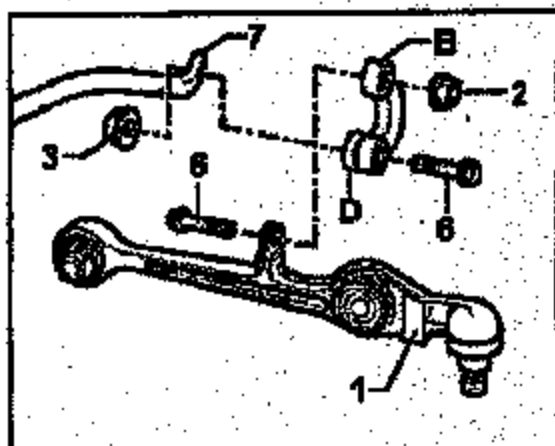
**IMPORTANT!** This illustration shows link -B- with bonded rubber bushings and is on vehicles after VIN 3B\_X\_213720

Clamp -C-, shown in previous illustration, is not used

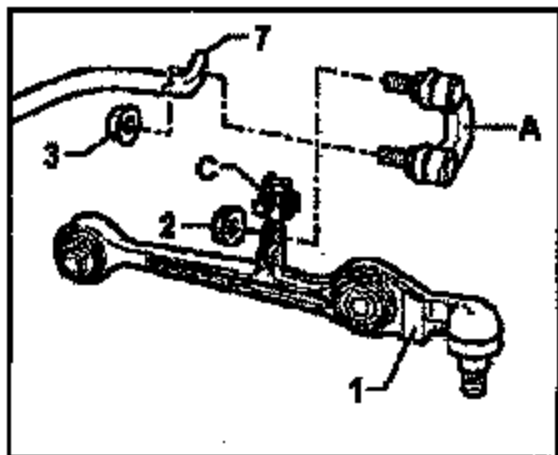
**IMPORTANT!** This illustration shows link -A- with ball joints and is on most vehicles up to vehicle Identification number (VIN) 3B\_X\_213726

Clamp -C- must be reinstalled with link that has ball joints

- ⇐ If vehicle has link -A- with ball joints between control arm -1- and stabilizer bar -7-, reinstall link, clamp -C- and new nuts -2- & -3- (N 102 881 02)
- ⇐ Tighten nuts -2- & -3- to 100 Nm (74 ft. lbs.)

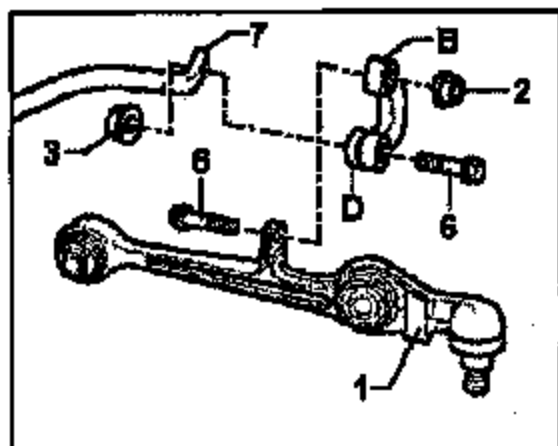
**IMPORTANT!** This illustration shows link -B- with bonded rubber bushings and is on vehicles after VIN 3B\_X\_213726

Clamp -C-, shown in previous illustration, is not used
