# NHTSA Complete Record Information

**Subject: CERTIFIED LTR REQUESTING NHTSA INITIATE A DEFECT INVESTIGATION RE SELECTED FORD MOTOR COMPANY VEHICLES LEFT FRONT INNER BEARINGS FOR ADVANCE FATIGUE CRACKS**

RE: Public safety concern

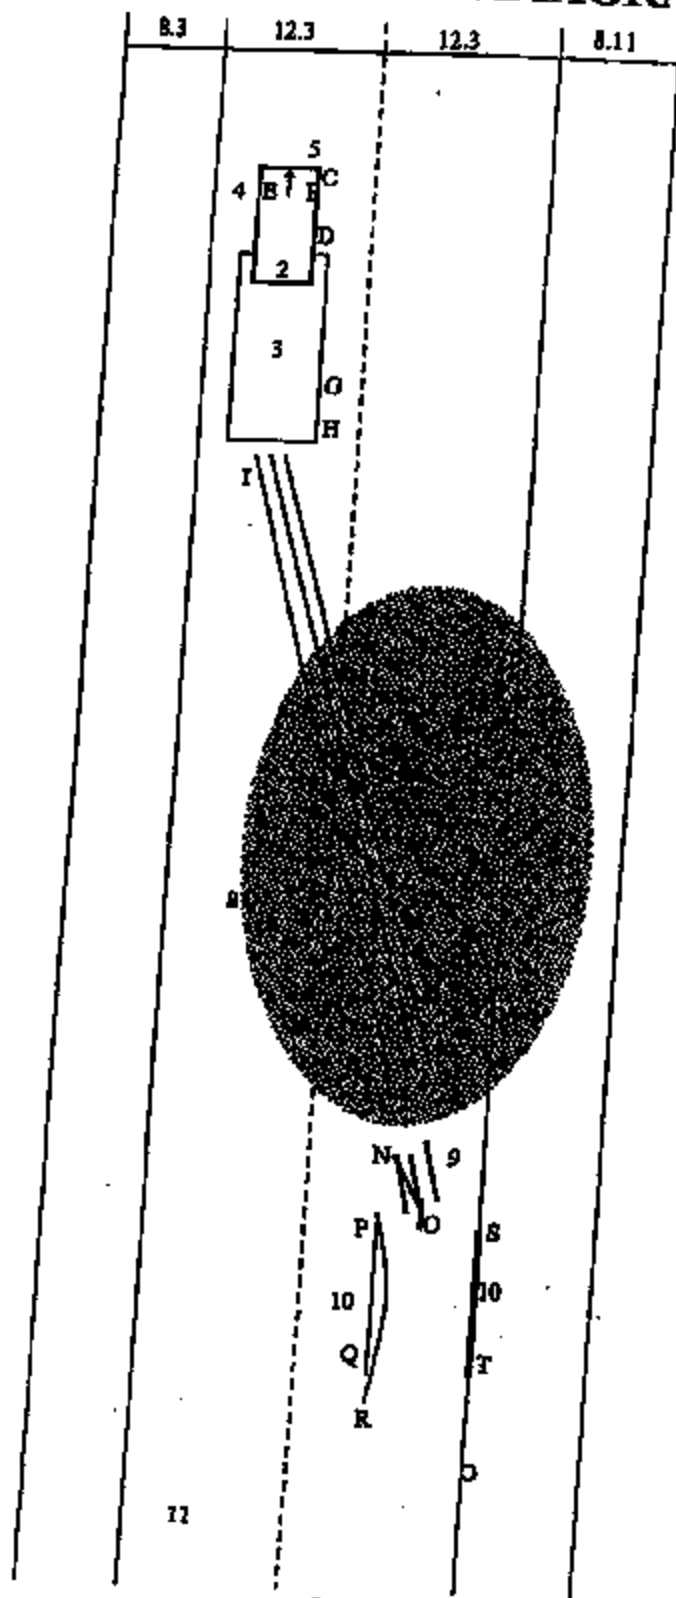
# STATE OF NEW MEXICO SUPPLEMENTAL DIAGRAM/NARRATIVE

My investigation revealed that the crash took place in the eastbound lane. Vehicle #1 was traveling westbound and for an unknown reason entered the eastbound lane of travel. It is my belief that the reason that Vehicle #1 entered the eastbound lane was due to the left front outer wheel bearing nut and center key missing from the wheel assembly. This caused the left front wheel to become very loose and would have made it difficult to control the vehicle causing it to pull to the left.

Vehicle #2 was traveling eastbound at approximately 60 miles per hour and swerved to the right in an attempt to avoid Vehicle #1. As Vehicle #1 entered the eastbound lane it struck Vehicle #2 just right of the front center of the vehicle causing damage to the right front of both vehicles. As Vehicle #1 struck Vehicle #2 it lost control and rolled onto the right side in the unimproved south shoulder. After impact Vehicle #2 entered the westbound lane and ignited causing both the truck and trailer to become fully engulfed in flames. All occupants had to be extracted from both vehicles due to the extensive damage. This officer was unable to determine what caused Vehicle #2 to ignite upon impact with Vehicle #1.

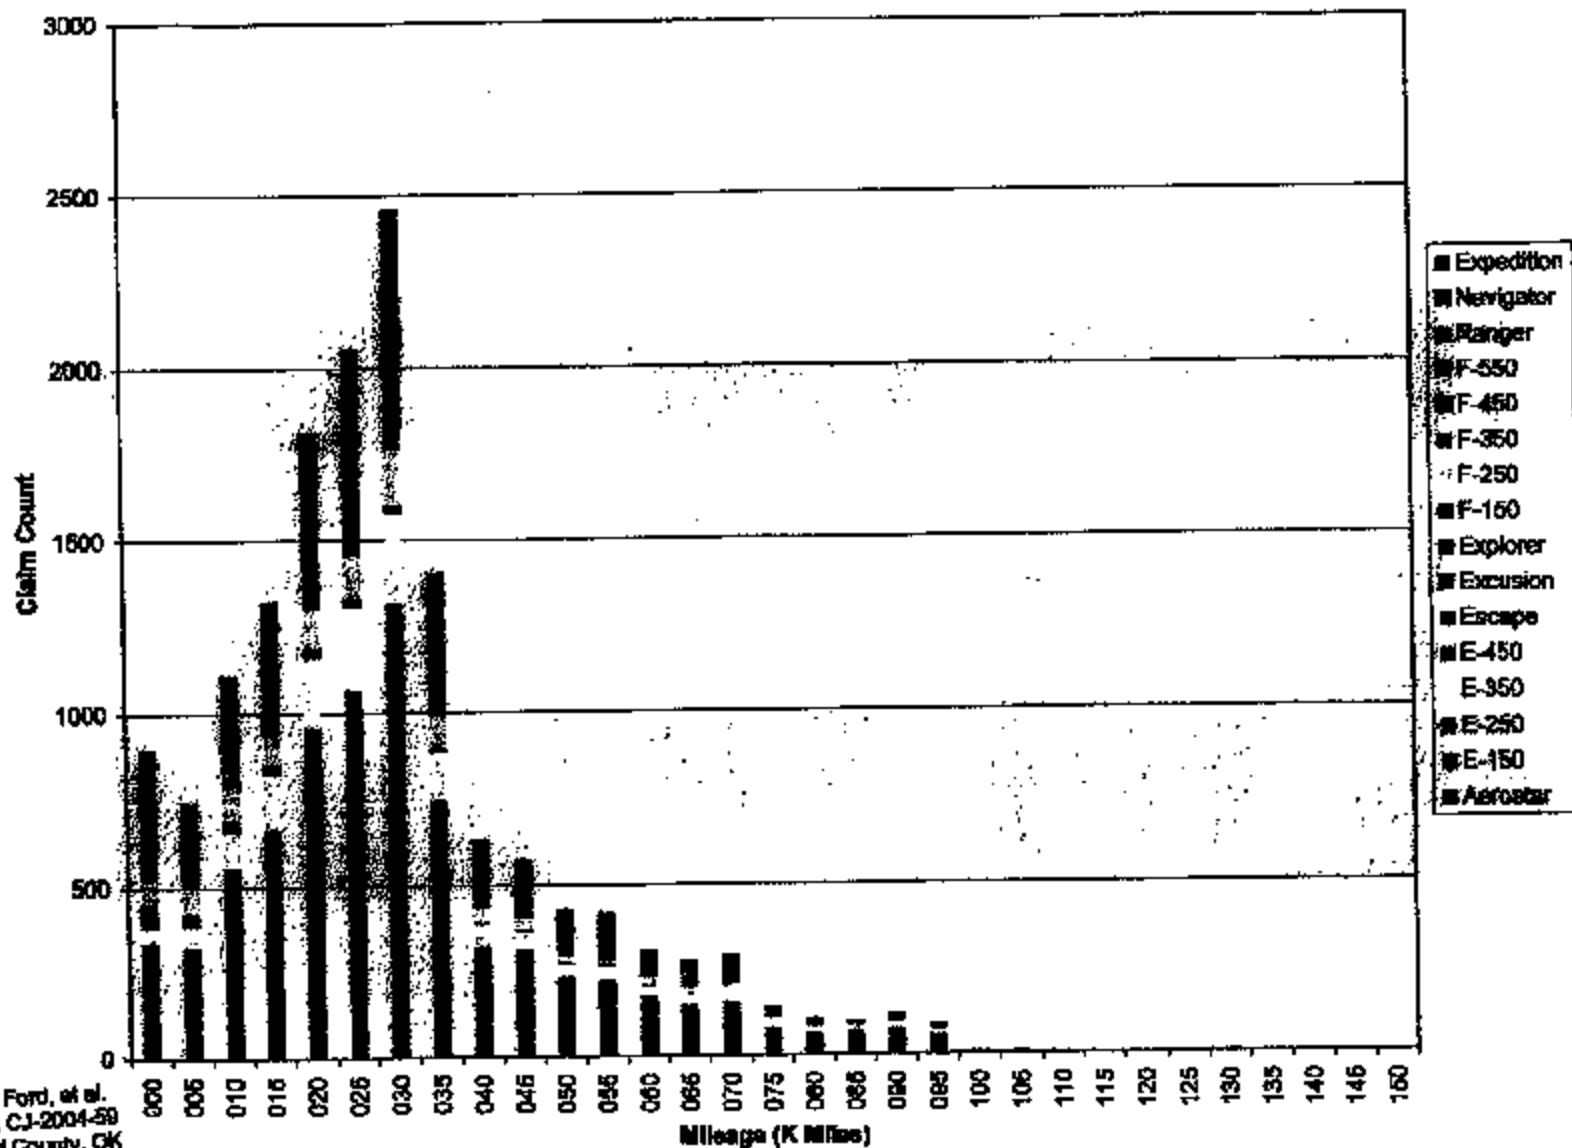
Smith v. Ford, et al.  
Case No. CJ-2004-59  
Cleveland County, OK  
Plaintiff's Exhibit No.

SBA and MDL AWS Data  
ZWD With Markers Q25
