NHTSA Complete Record Information

RE: Public safety concern

We have recently been asked to consult in the matter of a fatal two-vehicle collision. We believe, based upon physical evidence and internal industry documents, that an inherent vehicle defect that is present in selected Ford Motor Company vehicles precipitated the loss of directional control of the striking vehicle. Therefore, we are bringing this matter to your attention as the agency with the authority to investigate and direct national recalls.

ATTACHMENT "A"

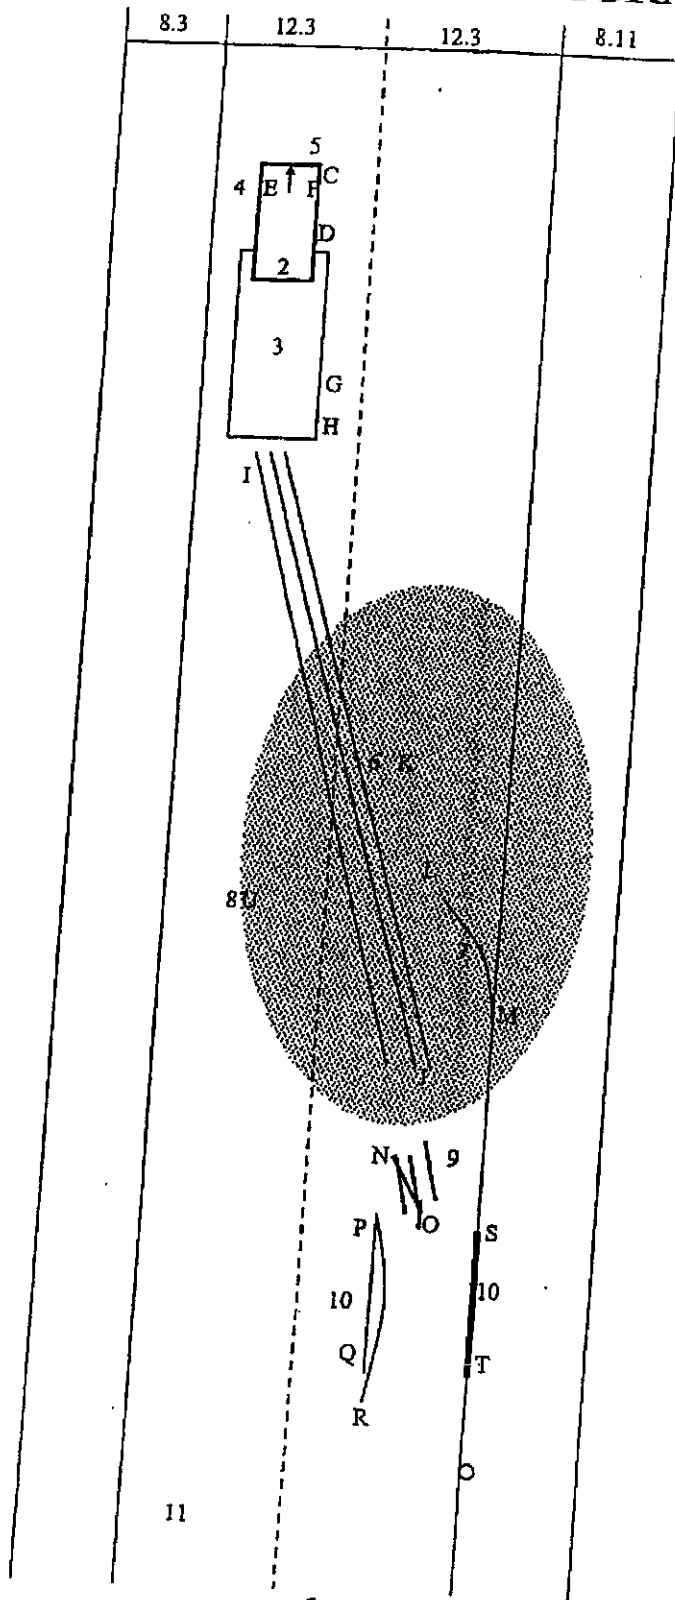
Date	07/26/03	Time	1510	Location	US 64/87	County	COLFAX
Driver No. 1						Sheet	6
Driver No. 2						OF	7

Vehicle positions shown every 10 feet
