CL-10201569

Re: General Motors Corporation
File No.: 07-13717

Re: GM Motor (Class Action Suit)

IM WRITING THIS LETTER CAUSE IM A VICTIM OF A SITUATION THAT GENERAL MOTORS IS VERY WELL AWARE OF UPPER INTAKE MANIFOLD/GASKETS AND COOLANT LEAKS DUE TO APPARENT POOR ENGINEERING. IN MY CASE THE WORST CASE SCENARIO HAPPENED COOLANT MIXED WITH ENGINE OILMAKING THE OIL INEFFECTIVE- AND DAMAGED THE ENGINE. AS PER GM 's INTERNAL SERVICE BULLETIN .I HAD TO REPLACE THE MANIFOLD IN MY 1998 PONTIAC BONNEVILLE SSE "TWICE". ON TOP OF THAT MULITPAL OTHER PROBLEMS ARE OCCURING TO AND ARE VERY FUSTRATING AND EXPENSIVE. TO MY UNDERSTANDING THIS IS NOT DOWN AS MAINTANCE.

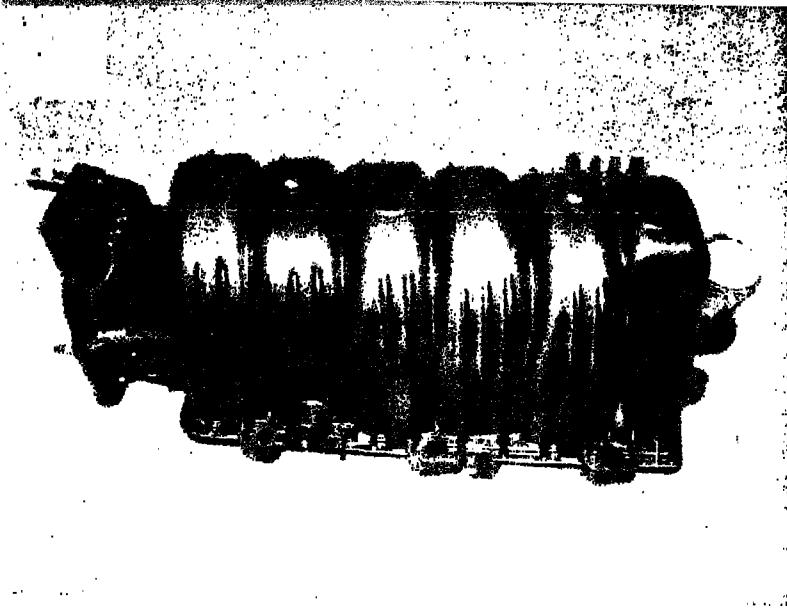
This is Dorman's Replacement Upper Intake (Dorman / Motormite) PN # 615-180.

Dorman markets a replacement UIM kit that includes reduced diameter stovepipes that will directly replace the larger stock one. One of the smaller pipes supplied with the kit is installed in the LIM, the insulating gap between the hot pipe and the plastic manifold is increased to .123". The Dorman upper is a good replacement for the original equipment part, and includes a UIM gasket, throttle body gasket, and other parts, but the EGR passage is not protected with a heat shield. The Dorman kit is available widely and sells for \$100.

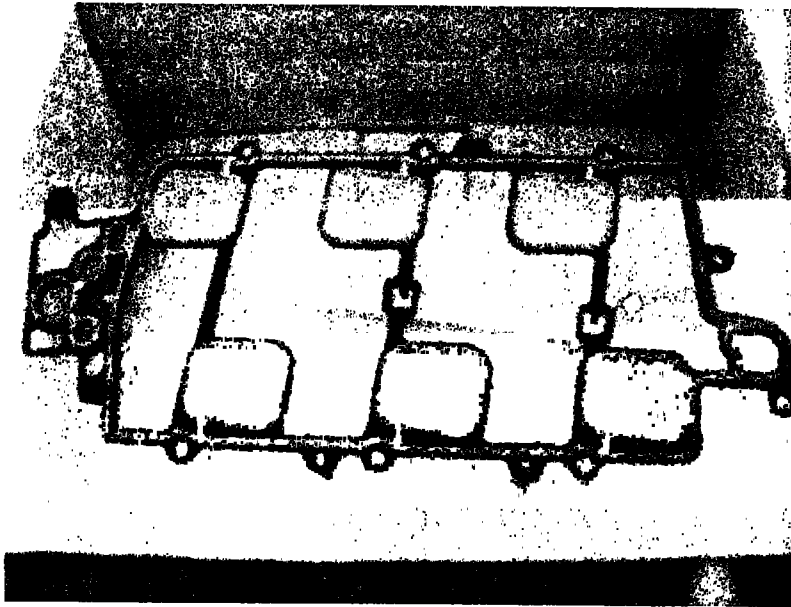
The Dorman kit comes complete with a new upper intake manifold gasket (shown below), throttle body gasket, a new PCV vacuum fitting, and injector o-rings.

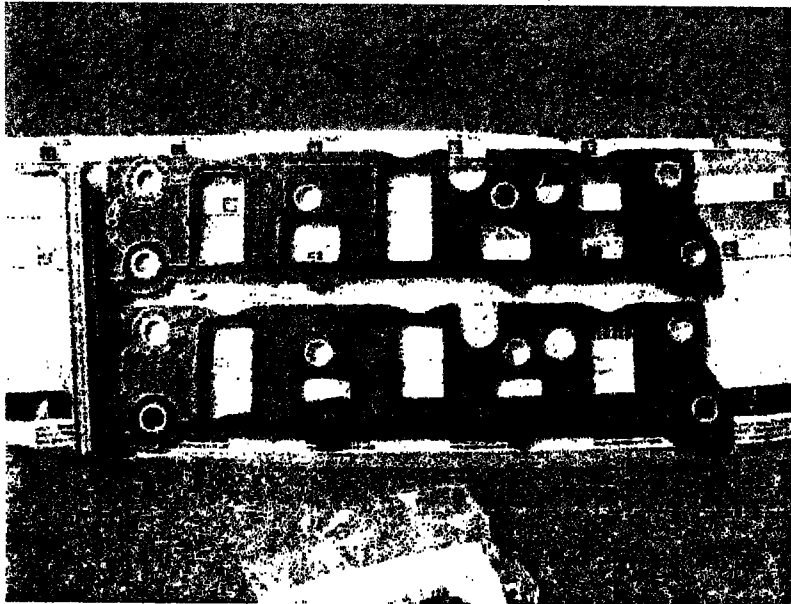
GM Lower Intake Manifold Gaskets (Fel-Pro Similar) Note steel reinforcement rings to prevent overtorque damage to the pl

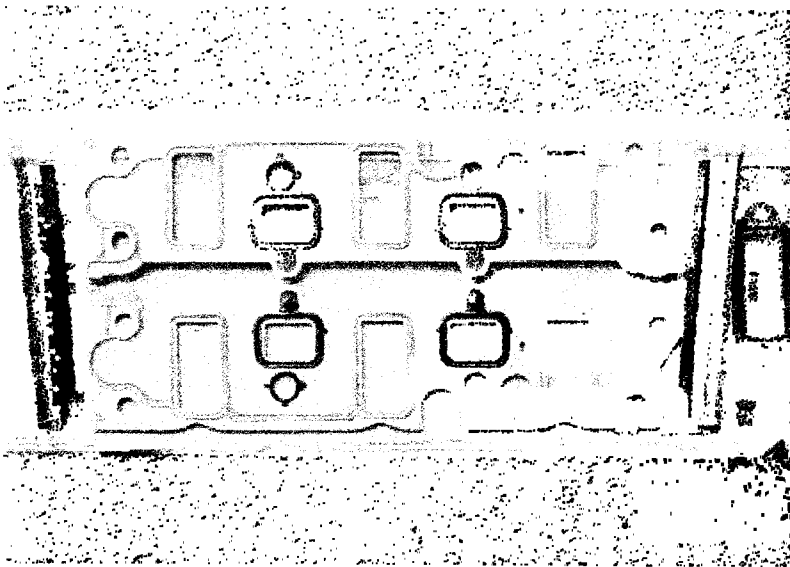
GM Aluminum Frame Lower Intake Manifold Gaskets. We hope that this newest design will provide the best LIM gasket fix March, 2006, these are available at the dealer for [REDACTED]
