DOT Auto Safety Hotline
Vehicle Owner's Questionnaire
To Report Vehicle Safety Defects
1-888-DASH-2-DOT
(1-888-327-4236)
INTERNET:www.nhtsa.dot.gov/hotline

Ocean County Sherriff's Dept. Office of the Fire Marshal
P.O. Box 2191, Toms River, NJ 08754-2191
Phone: 732-341-3451/1-800-331-8152 Fax: 732-341-3154
Fire Investigation Report (Privileged and Confidential)

HARD FACTS™

In accordance with your request, this organization conducted a forensic automotive engineering examination that focused upon the recovered remains of the [REDACTED] vehicle on May 18, 2007. The subject vehicle was examined at Insurance Auto Auctions in Morganville, New Jersey where it was staged under stock number 3105780.

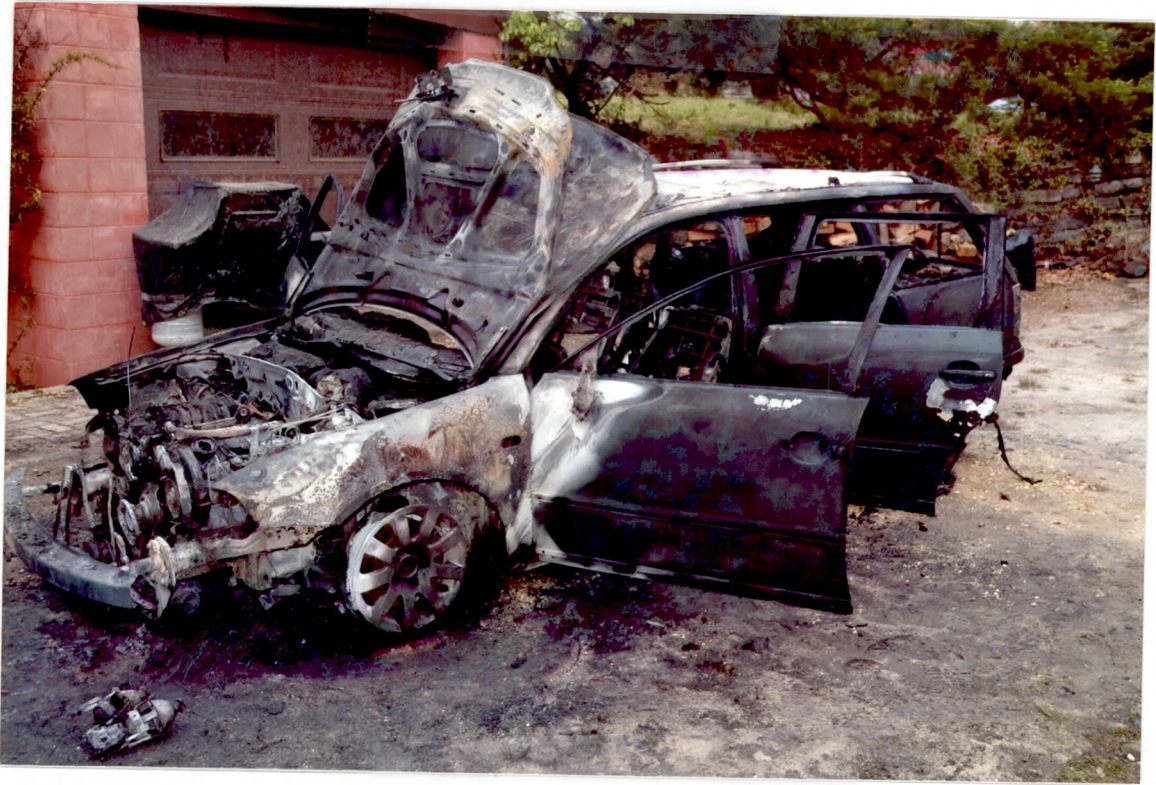
Examination of the power plant compartment revealed evidence of severe fire damage.

All components and assemblies are either partially or fully consumed by fire damage.

1. Based upon the physical evidence, the fire loss is a result of an electrical short circuit of an electrical harness near the front left fender headlamp area. This area had been historically repaired subsequent to a collision event.
