CL-10210570-2355

November 20, 2007

Department of Transport  
National Highway Traffic Safety Administration  
Office of Defect Investigation  
1200 New Jersey Ave. S.E.  
West Building  
Washington, DC 20590

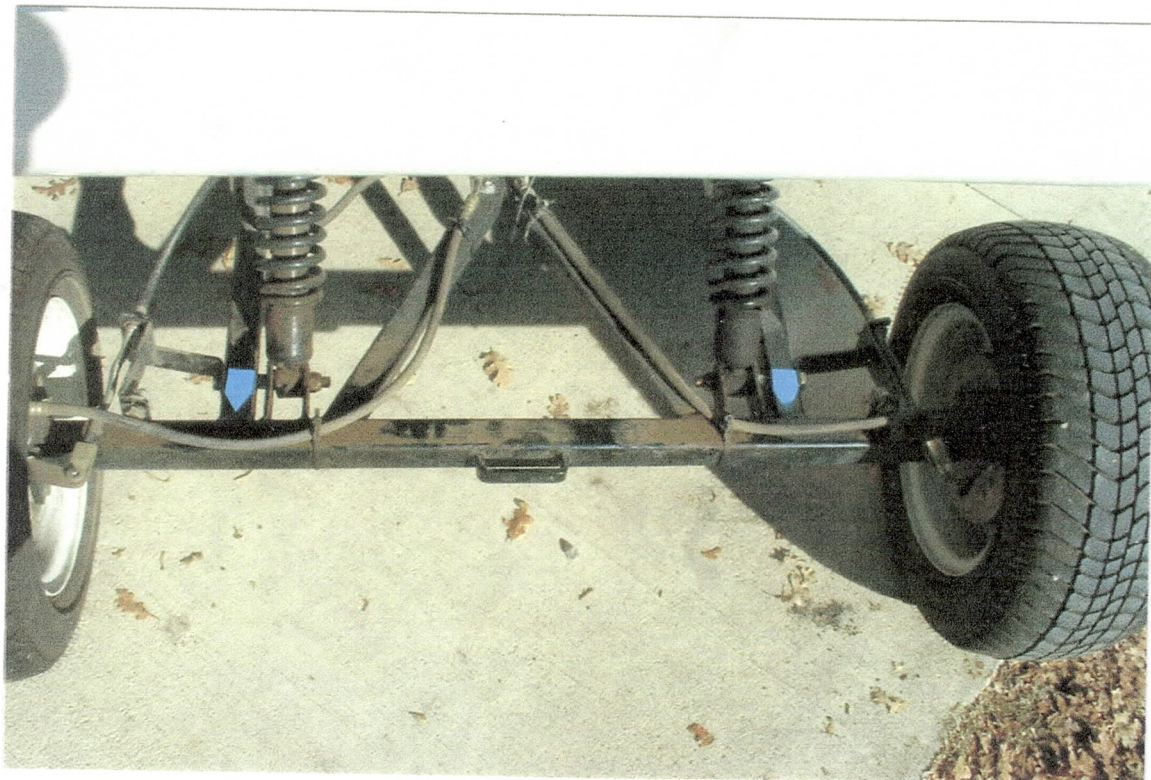
I have discovered an extremely hazardous design flaw in my vehicle which is a 2002 Global Electric Motorcar (GEM) VIN# 5ASAG27482F [REDACTED]. I feel an immediate SAFETY RECALL is necessary. I have made contact with one other owner of this type of GEM and have discovered the same problems in his GEM. The frame supporting the rear axle has already broken in two places as shown in picture #1 by the two blue arrows leaving only the center wishbone holding the rear axle in place. Picture #2 shows the cracks in the rear fender assembly and pictures #7 and #8 show the broken brackets which support the rear fender assembly - all of which were caused by the breaking of the frame which supports the rear axle.
