Secretary of Transportation  
Raymond LaHood  
U.S. Department of Transportation  
1200 New Jersey Ave, SE  
Washington, DC 20590

November 6, 2010

It wasn't until later that we found out about the defect known to Chrysler and the National Highway Traffic Safety Administration (NHTSA) as "park-to reverse, false park or inadvertent rearward movement." In a vehicle with the park-to-reverse defect, an operator of the vehicle in normal use can inadvertently place the shift selector (also referred to as the "Rooster Comb") between the intended park and reverse gear positions. The shift selector will remain for a period of time between the intended gear position and from this position it may (or may not) have a delayed engagement of powered reverse. Upon having an engineer inspect and test our mother's Chrysler Town & Country Mini-Van, he indicated the van did in fact have the defect. The vehicle would go into false park (the cues indicate that the van is in park but seconds later it will self-shift into reverse,) four out of ten times when tested.

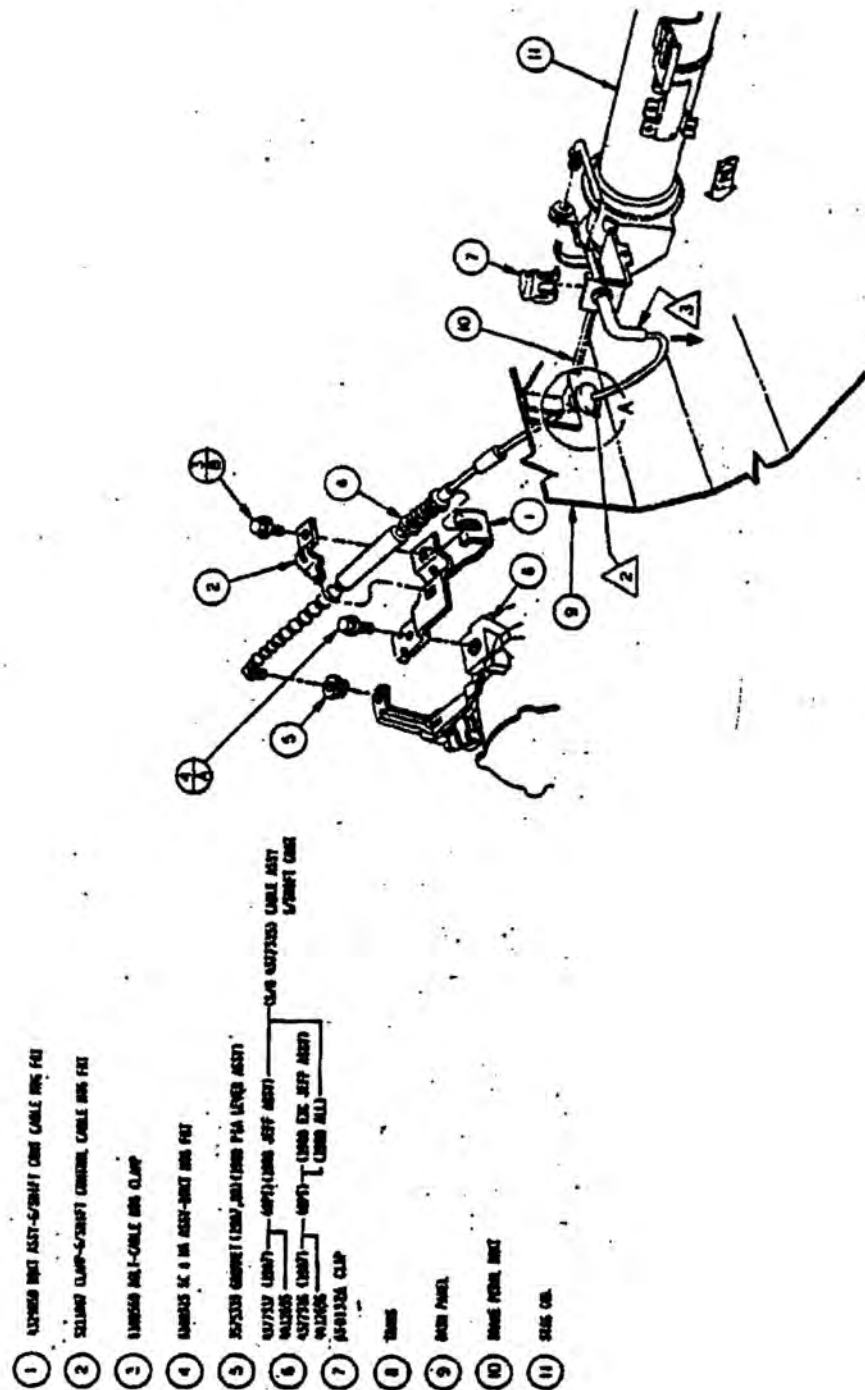
Figure 1. Components of Gear Selector Mechanism

Details of the gear selector mechanism installed in the subject vehicles are shown in Figures 1 through 3. When the vehicle operator shifts to a selected gear, tactile feedback is provided by a combination of component loads and frictional forces within the shift mechanism. When any gear position is selected, the shift lever slides over a gearshift lever gate located inside the steering column housing. For each transmission gear position there is a corresponding position on the gate. The gate is designed so that in order to shift from Reverse to Park, the vehicle operator must first pull the shift lever toward the steering wheel, then apply a counterclockwise force to the shift lever, i.e., push the lever upward toward the windshield. The limit of rotational movement of the shift lever is established by a hard stop on the shift gate. The gear selector indicator provides visual validation of the selected gear position.

The rotational shift input force by the vehicle operator (and the gear selection) is transmitted to the transmission as a linear displacement via a cable which extends from the base of the steering column to a bellcrank which is attached to the manual lever of the transmission (Figure 1). Linear movement of the cable is converted to a rotational

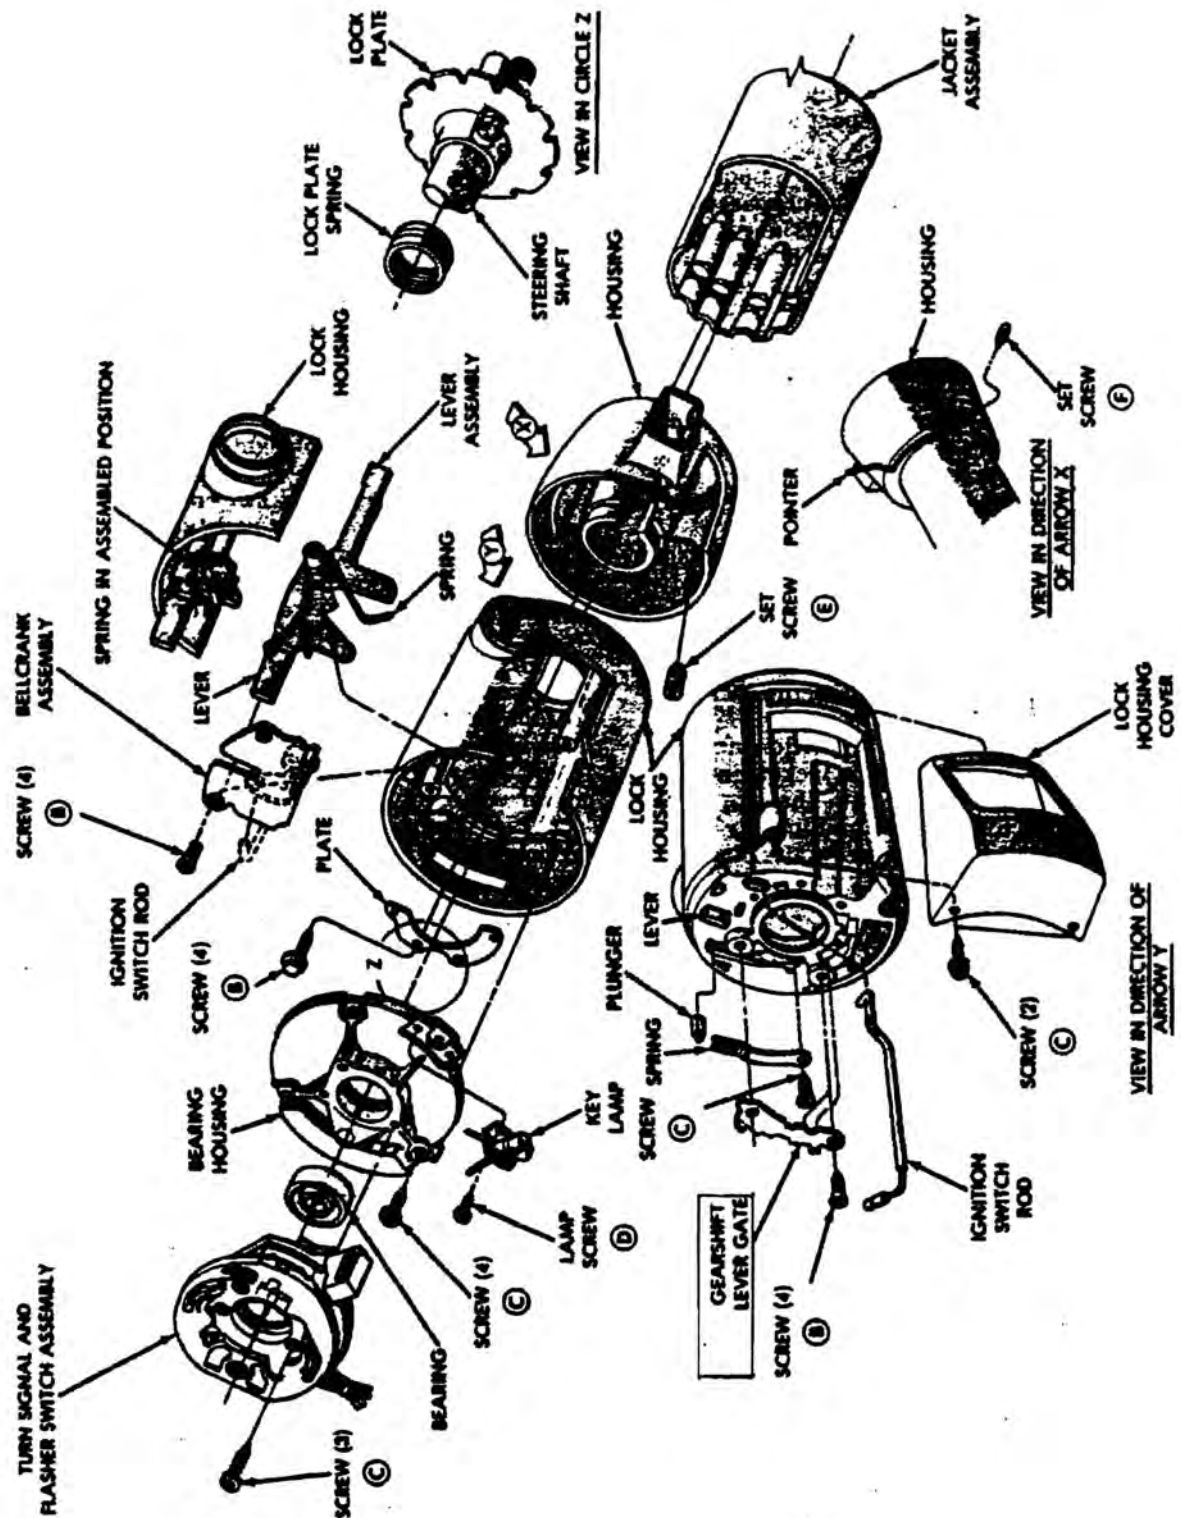
Figure 2. Steering column upper end showing installation of shift lever gate

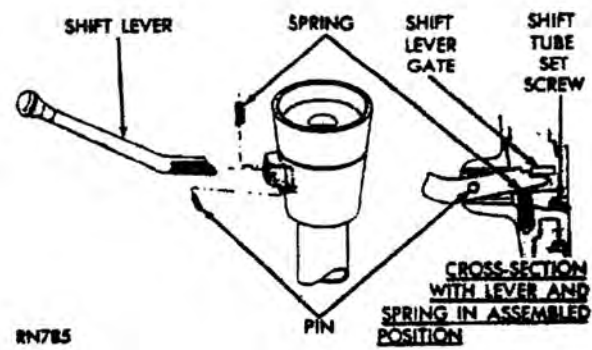
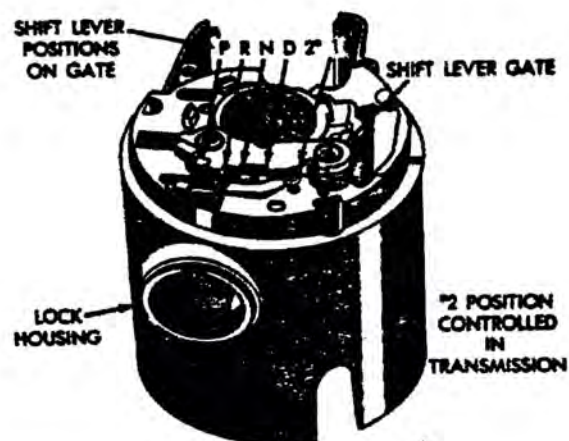
Figure 3. Shift lever installation and lock housing with gate

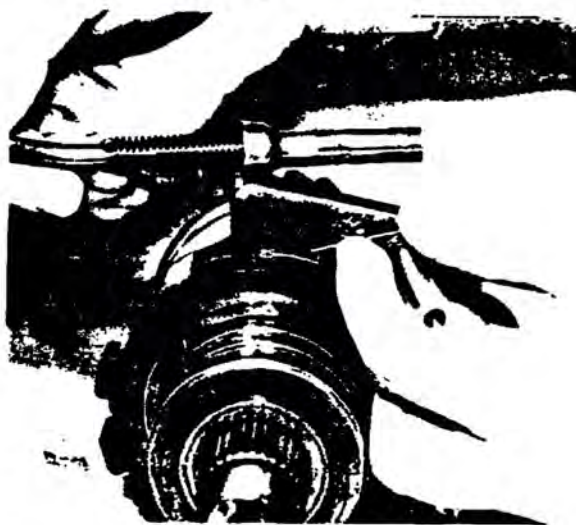
When the transmission is placed in the Park position, the manual lever and rooster comb are rotated so that the detent roller engages the park position of the rooster comb. Simultaneously, rotation of the manual lever assembly linearly displaces the parking rod, actuating the park pawl and engaging the park gear (Figure 5). In this position, the transaxle output shaft is mechanically locked to prevent rotation of the powered wheels. In a properly adjusted gear selector mechanism, the Park position of the shift lever gate will correspond to the Park position of the rooster comb and engagement of the park gear of the transmission. The key can be removed from the ignition switch only when the gear selector is in Park.

- C. Park Applied. Park pawl engages park gear. Transmission output shaft locked.

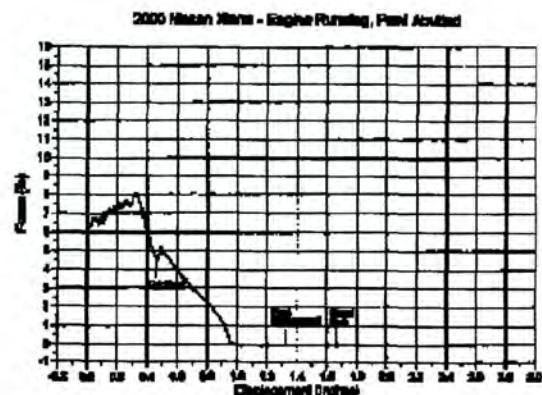
Figure 7.6 - 1995 Mitsubishi Montero

The force vs. displacement plots for the peer vehicles were significantly different from the plots for subject vehicles with the Model 42RE transmission. The plots for peer vehicles (Figures 7.6 through 7.11) show a rapid drop-off of force followed by travel with no applied force to reach gated Park. In comparison, the plots for two of the six 1999 subject vehicles with the Model 42RE transmission (Figure 7.3) show that force must be continuously applied to reach gated Park. The primary reason for this difference was found to be that none of the manual detent levers for the peer vehicles (Figures 7.12 through 7.14) had the flat area between Reverse and Park found on the Model 42RE transmission manual detent lever. Full size data plots are provided in Appendix VI.
