**Subject: S10 APPROPRIATE HANDLING - LETTER FROM [REDACTED] REGARDING A CHRYSLER TOWN AND COUNTRY TRANSMISSION DEFECT**

**Control number:** S10-101110-004      **Action office:** NHTSA  
**Document date:** 11/6/2010      **Due date:**  
**Author(s):** [REDACTED]  
**Subject:** Chrysler Town and Country Transmission Defect  
**Action:** Appropriate Handling

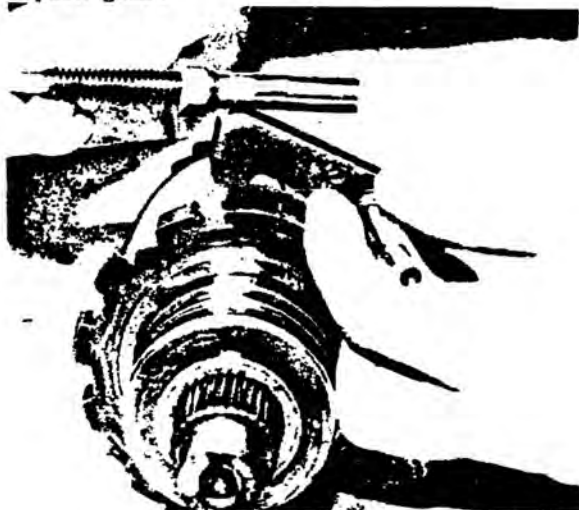
- C. Park Applied. Park pawl engages park gear. Transmission output shaft locked.

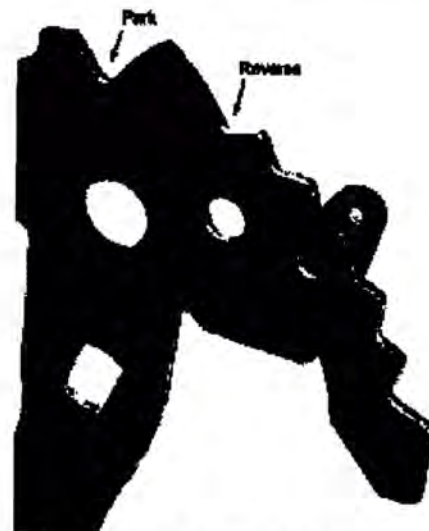
A major factor for UPR appeared to be the significant differences in the shape of the manual detent levers between the subject Grand Cherokees and the peer vehicles. The Grand Cherokee manual detent lever had very shallow detent notches and a flat area between Reverse and Park whereas peer vehicles had deeper detent notches and no flat spot. This flat area allowed the Grand Cherokee transmission to be inadvertently mis-shifted, leaving it between Reverse and Park. UPR appeared to occur only when mis-shifted in this manner. Figure 4.1 shows the Grand Cherokee manual detent lever. Figure 4.2 shows a GM manual detent lever that was typical of the peer vehicles.

**Figure 4.2 – GM Manual  
Detent Lever**

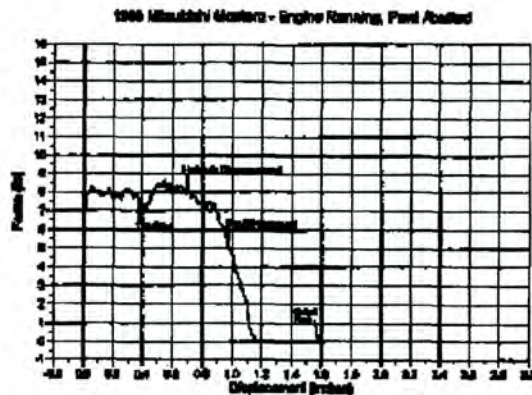
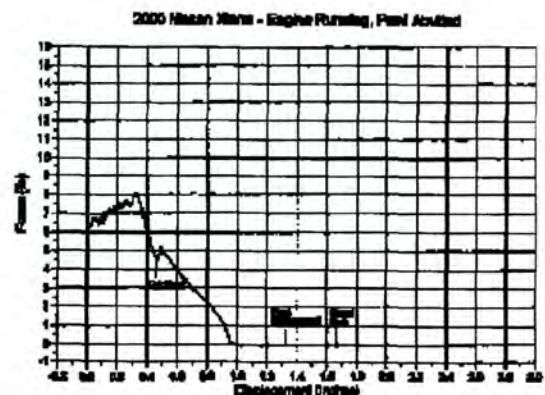
Figure 7.6 - 1995 Mitsubishi Montero

The force vs. displacement plots for the peer vehicles were significantly different from the plots for subject vehicles with the Model 42RE transmission. The plots for peer vehicles (Figures 7.6 through 7.11) show a rapid drop-off of force followed by travel with no applied force to reach gated Park. In comparison, the plots for two of the six 1999 subject vehicles with the Model 42RE transmission (Figure 7.3) show that force must be continuously applied to reach gated Park. The primary reason for this difference was found to be that none of the manual detent levers for the peer vehicles (Figures 7.12 through 7.14) had the flat area between Reverse and Park found on the Model 42RE transmission manual detent lever. Full size data plots are provided in Appendix VI.
