Subject: FW: Material scan into repository 10304297
Date: Wednesday, March 10, 2010 9:42:33 AM
Attachments: [10304297PAR.pdf](#)

Can the attached pdf file (police accident report) be added to the private repository associated with VOQ 10304297?

Iowa Department of Transportation INVESTIGATING OFFICERS REPORT OF MOTOR VEHICLE ACCIDENT

Report #2008120189
I-10 WB to Overland Avenue

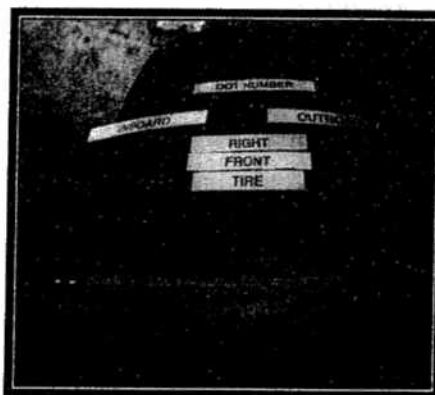
Figures 18 through 21 depict the tire tread for each tire. The left front tire was flat with the bead seated on the rim flange.

ITEM	INFLATION AND TIRE TREAD DEPTHS	
	INFLATION PRESSURE	TREAD DEPTH*
Left Front Tire	0 pounds per square inch	7/32, 8/32, 8/32, 7/32
Left Rear Tire	28 pounds per square inch	10/32, 11/32, 11/32, 11/32
Right Front Tire	28 pounds per square inch	7/32, 8/32, 8/32, 7/32
Right Rear Tire	30 pounds per square inch	9/32, 10/32, 10/32, 9/32

Figure 18 – Left front tire.

Figure 19 – Right front tire.

Figure 20 – Left rear tire.

Figure 21 – Right rear tire.

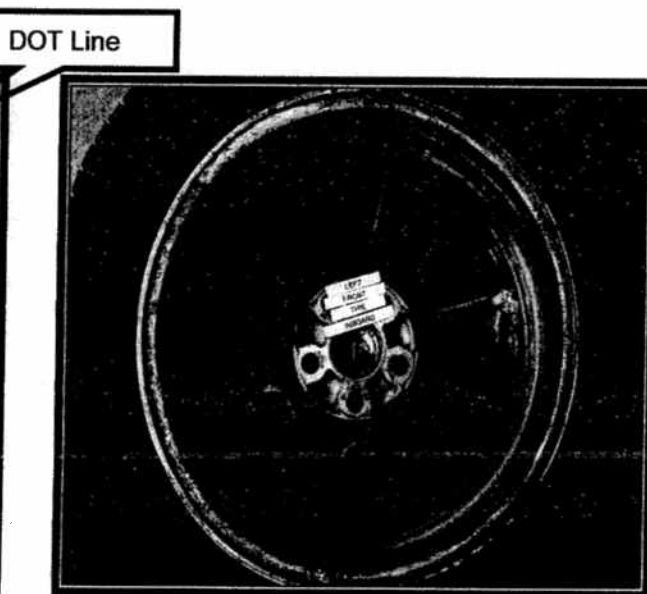
Figure 23 – Left Front wheel and tire.

The left front wheel appeared to have sustained abrasions all around the flange and scratches all around the outboard side of the wheel. Abrasions and scratches were also found all around the inboard side of the wheel (Figure 23). The right front wheel sustained small abrasions around the outboard flange between the 4 and 6 o'clock positions.

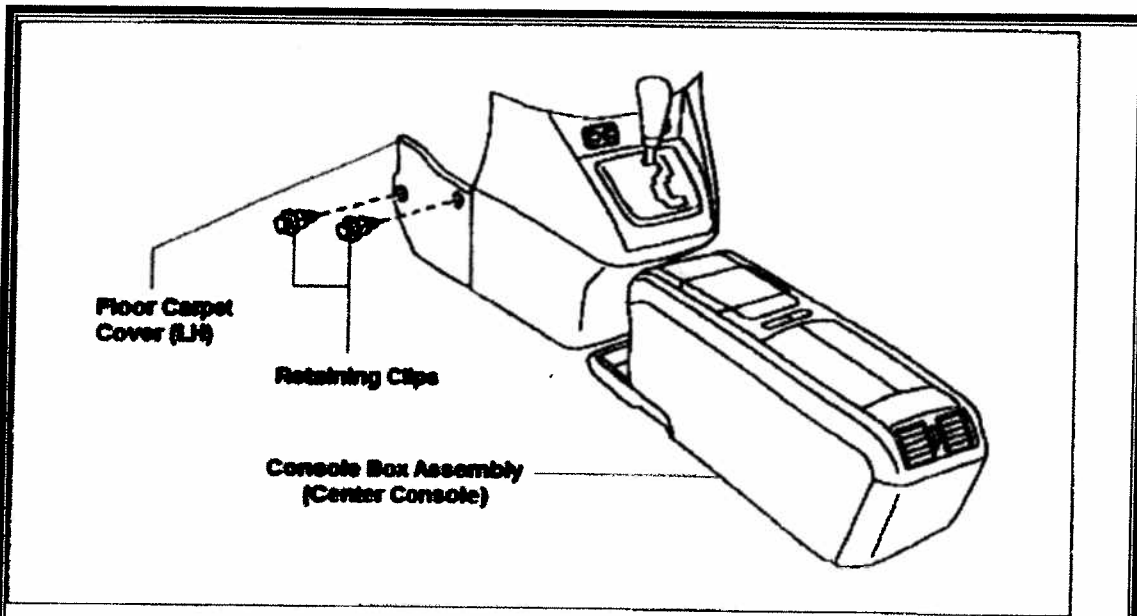
In certain 2004 through 2005 model year Japan produced RX 330 and early 2006 model year RX 400h vehicles, due to improper installation, the two Retaining Clips for the driver's side forward Center Console (Floor Carpet Cover) can become loose. If both clips separate from the Floor Carpet Cover, the cover may lean toward the accelerator pedal, causing interference with the accelerator pedal rod.
