Vehicle Owner's Questionnaire To Report Vehicle Safety Defects

Make KEYSTONE

Model SPRINTER

Vehicle Component Code: 161000 STRUCTURE: FRAME AND MEMBERS

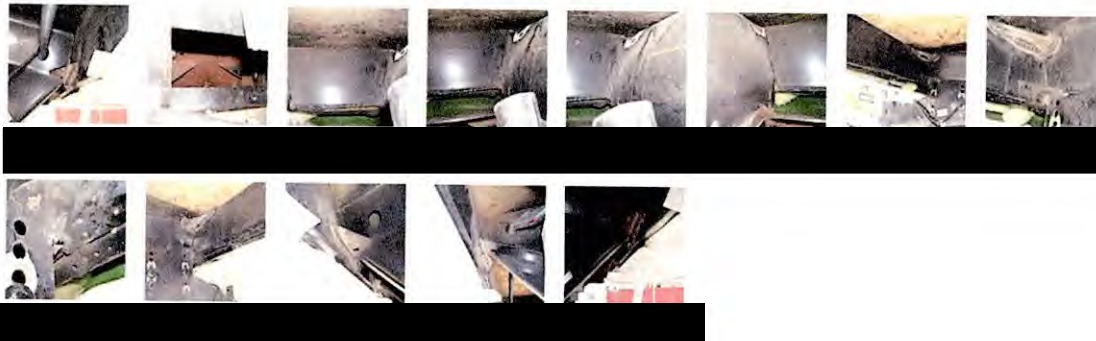
The front beam was bent up into the front closet. The Box and King Pin was only holding by about 2 inches and almost broke off the 5th wheel which caused the 5th wheel to hit the truck. we were told to have the beam replaced with 4 gage tube. they had 11 gage in it which was not strong enough.

Pictures of the beams. If it would of come off we could of killed someone or even ourselves. It was not the right gage tube.
